Placido Bayou Community Association Waterway Inspection Report

Reason for Inspection: Customer Request

Inspection Date: 11/19/2015

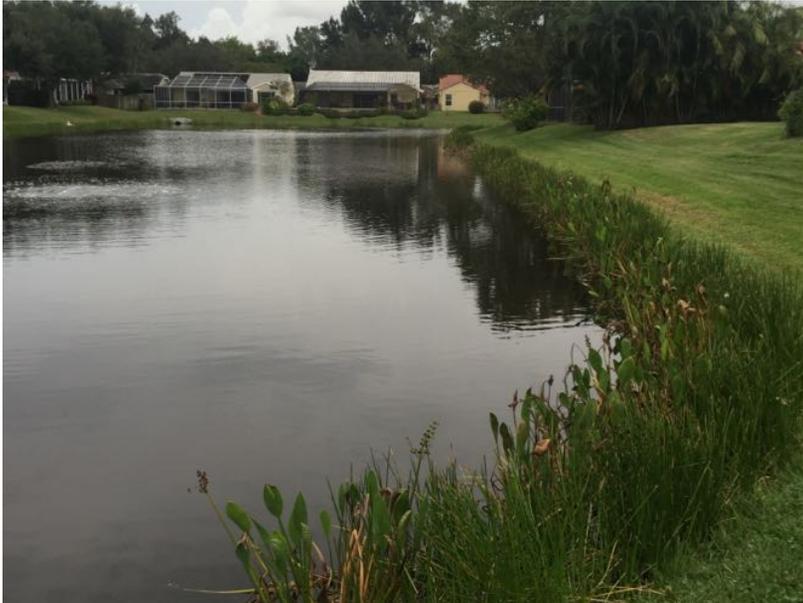
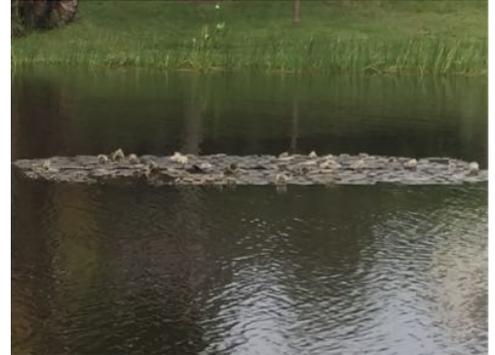
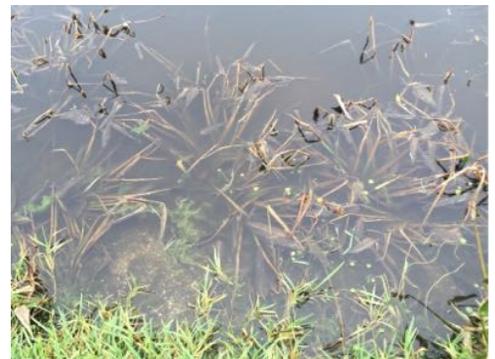
Site: 1

Comments: Site looks good

Beneficial plants are filling in great here. Small area of Pickerelweed appears to have predation. We currently are working with IFAS lead entomologists and pathologists to discover the stress on this plant. The floating mat appears to be damaged, this may be troublesome if planted. I'm currently working on a price to have this planted.

1. Beneficial plants are filling in great here. Small area of Pickerelweed appears to have predation. We currently are working with IFAS lead entomologists and pathologists to discover the stress on this plant. The floating mat appears to be damaged, this may be troublesome if planted. I'm currently working on a price to have this planted.

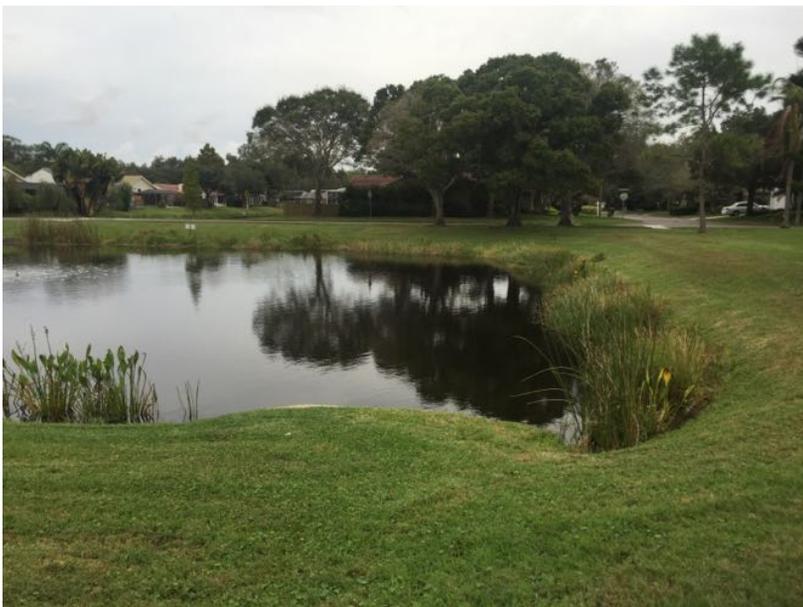
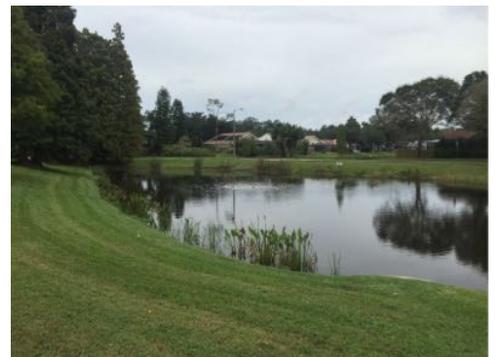
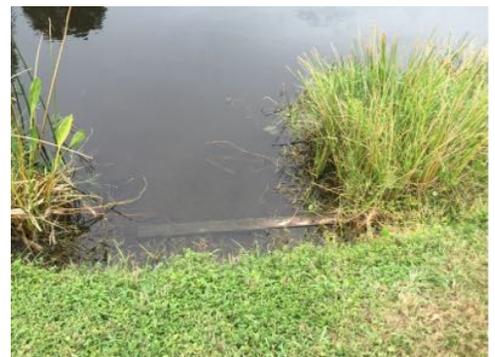
Site: 2

Comments: Site looks good

This site looks good and requires no immediate attention. It should be monitored for duckweed blooms. The beneficial plants here look very full. A piece of wood was noted and should be removed.

2. This site looks good and requires no immediate attention. It should be monitored for duckweed blooms. The beneficial plants here look very full. A piece of wood was noted and should be removed.

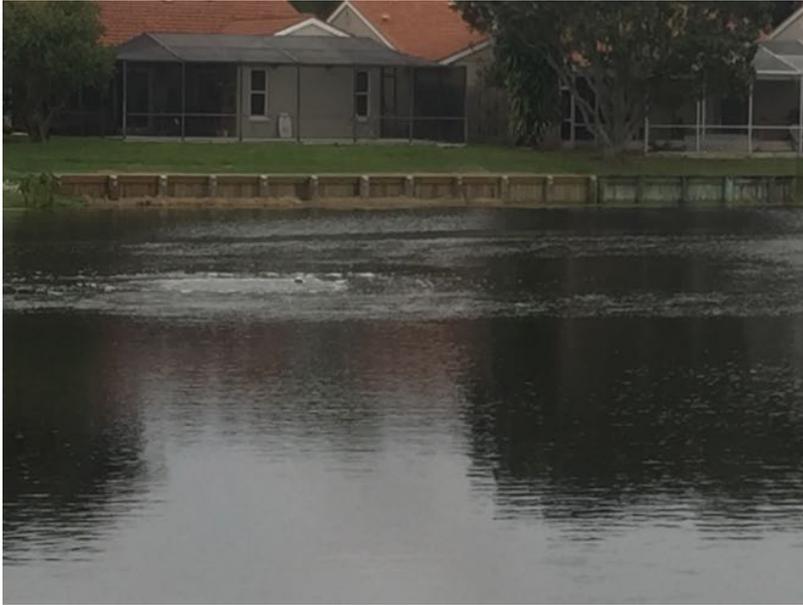
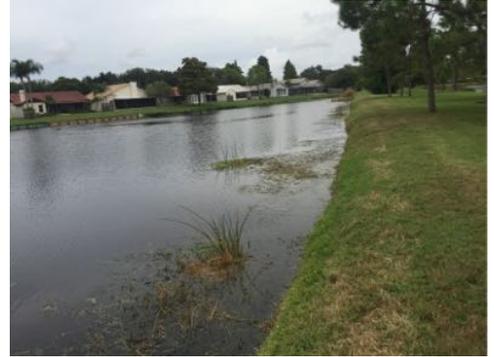
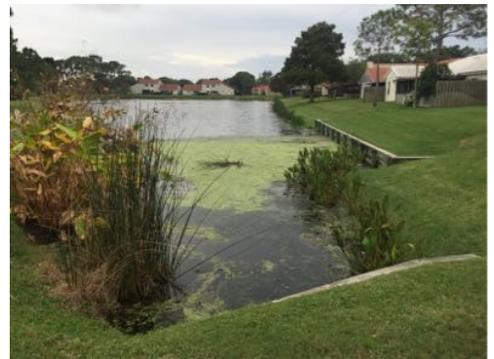
Site: 3

Comments: Normal growth observed

Torpedograss along the seawall is dead and the large amounts of shoreline grasses are almost finished decomposing from previous herbicide treatment. Duckweed is windblown close to site 2 and should be treated as it is close together.

3. Torpedograss along the seawall is dead and the large amounts of shoreline grasses are almost finished decomposing from previous herbicide treatment. Duckweed is windblown close to site 2 and should be treated as it is close together.

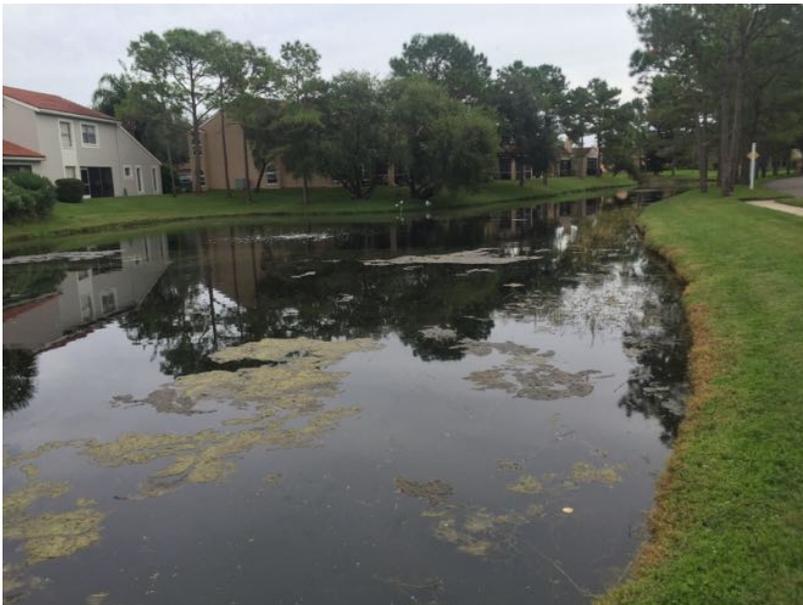
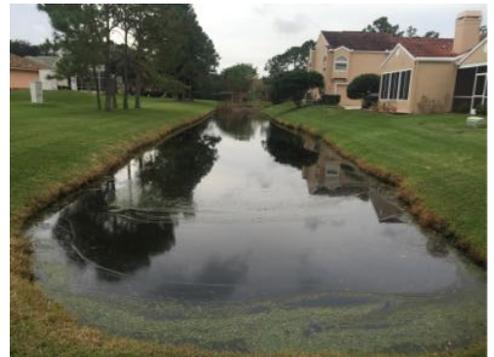
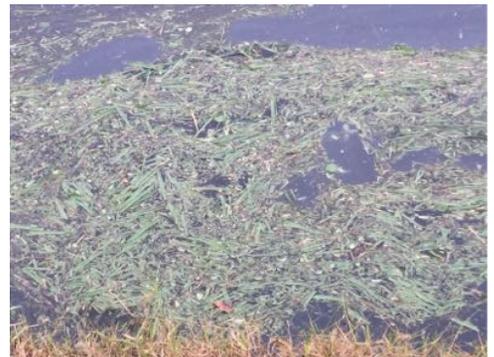
Site: 4

Comments: Normal growth observed

Algae control is improving here, especially in the long finger area. Please note, the finger area has large amounts of grass clippings. This is excess and adds nutrients to the system. There is no need to remove the grass as nutrients leach inside the water column within only 24 hours.

4. Algae control is improving here, especially in the long finger area. Please note, the finger area has large amounts of grass clippings. This is excess and adds nutrients to the system. There is no need to remove the grass as nutrients leach inside the water column within only 24 hours.

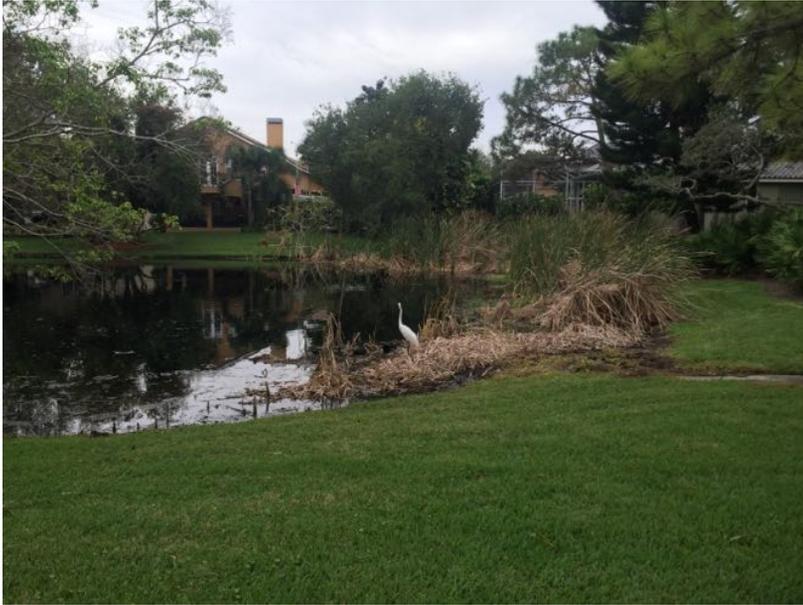
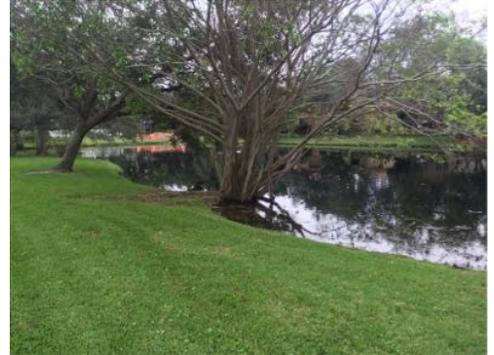
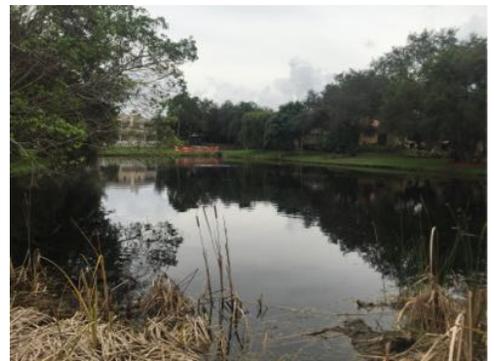
Site: 5

Comments: Site looks good

Wading birds have found this ecosystem as home. The cattails are being contained in one area.

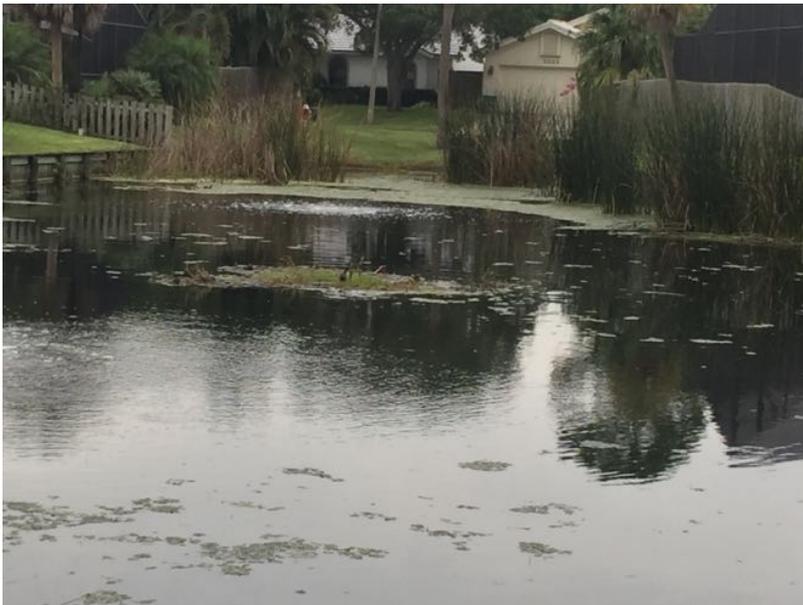
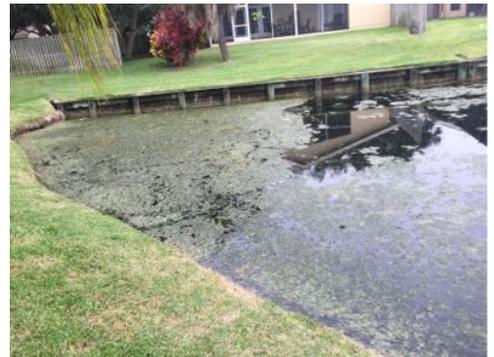
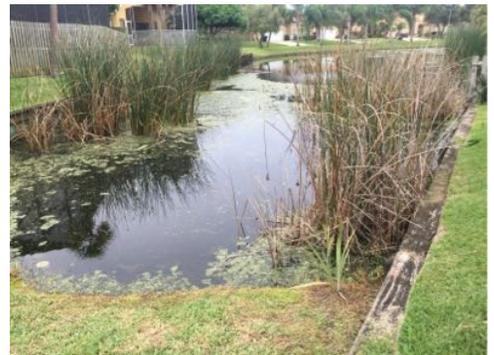
Site: 6

Comments: Requires attention

This site needs continued algaecides, nutrient reducers and dye to help control excess algae. Birds and turtles continue to rest on the floating matt. Note one healthy Blue Flag Iris in the bottom right corner.

Recommend additional alum treatments in ponds 6 and 8.

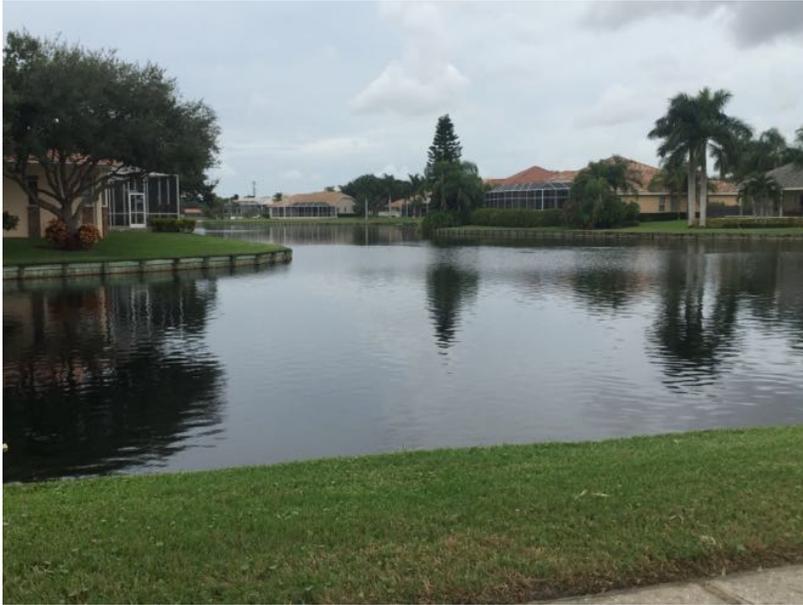
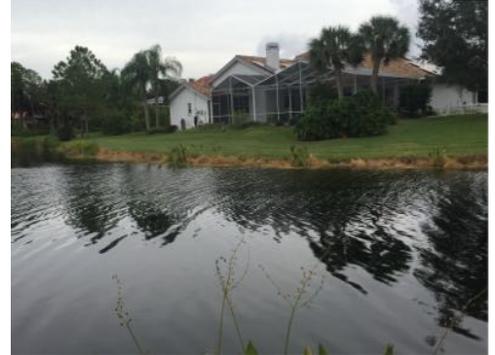
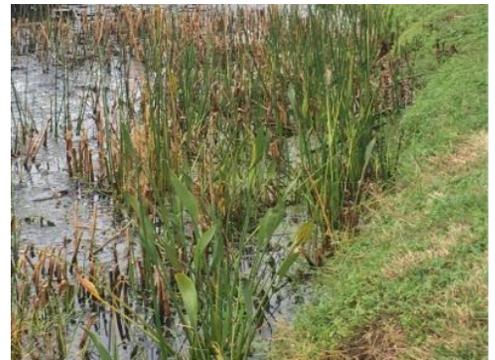
Site: 7

Comments: Site looks good

Algae is under control here. Torpedograss was spot sprayed between beneficial plants. Looks to be a great treatment. Duck Potato continue to replace the physically removed Bulrush. Next treat we will help control regrowth of Bulrush using herbicide.

7. Algae is under control here. Torpedograss was spot sprayed between beneficial plants. Looks to be a great treatment. Duck Potato continue to replace the physically removed Bulrush. Next treat we will help control regrowth of Bulrush using herbicide.

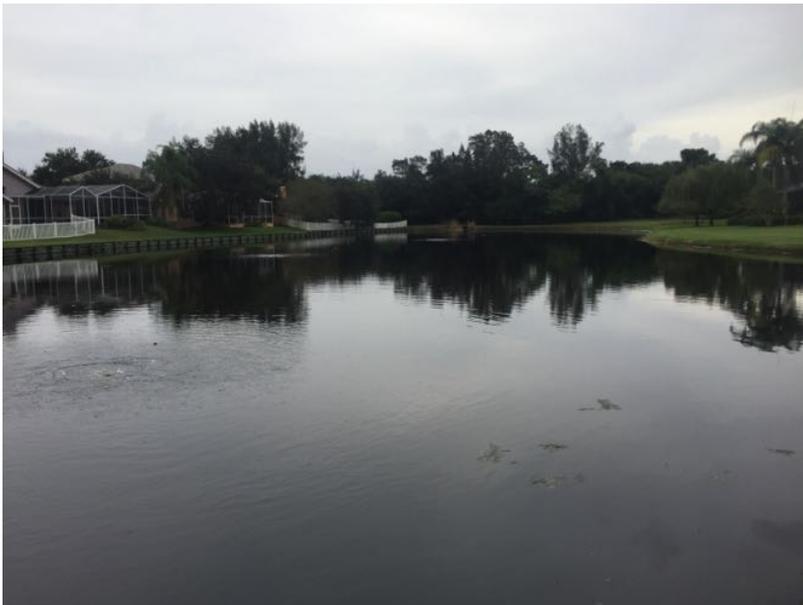
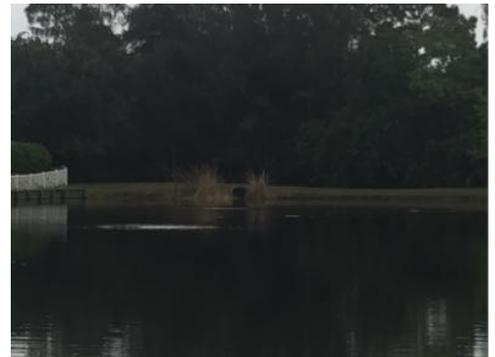
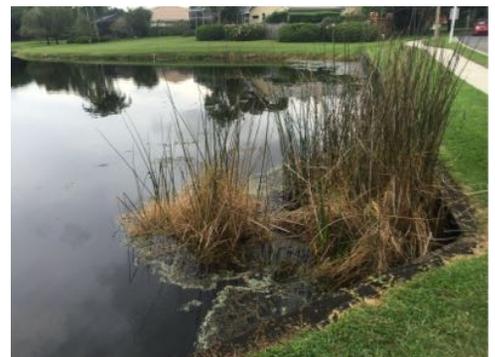
Site: 8

Comments: Site looks good

Overgrowth near outflow has been treated, allow time to decompose into the lake. Excellent spot spray treatment was noted around the Bulrush targeting some Torpedograss.

8. Overgrowth near outflow has been treated, allow time to decompose into the lake. Excellent spot spray treatment was noted around the Bulrush targeting some Torpedograss.

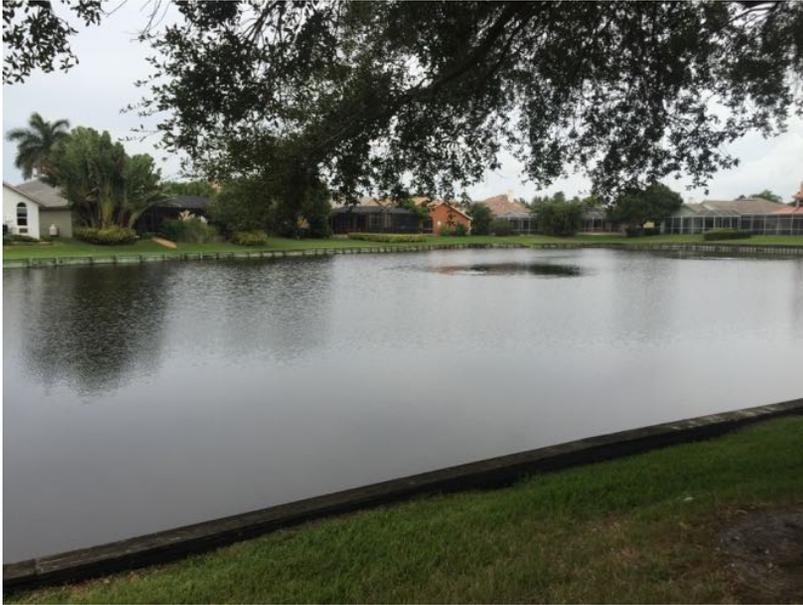
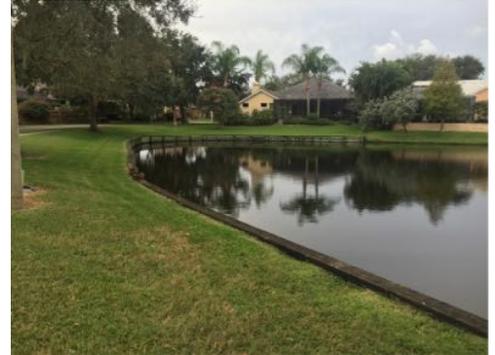
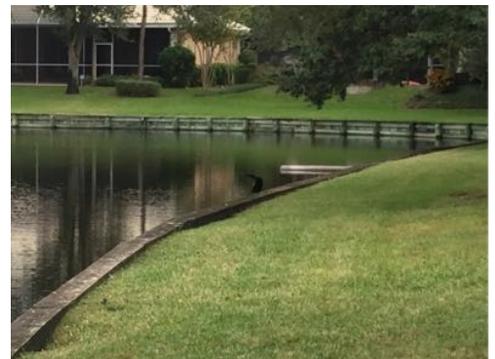
Site: 9

Comments: Site looks good

I am working on quote for a test planting here. Two areas of 40 plants each will be planted. This totals 80 plants.

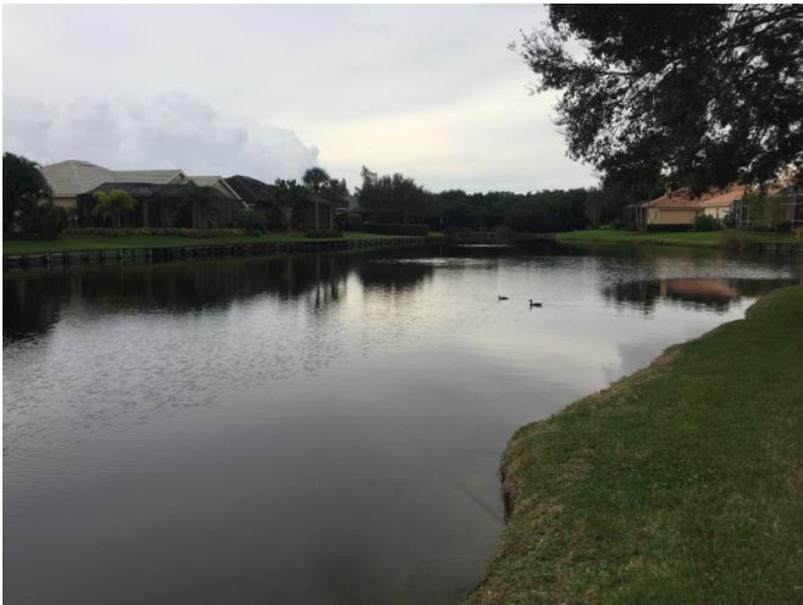
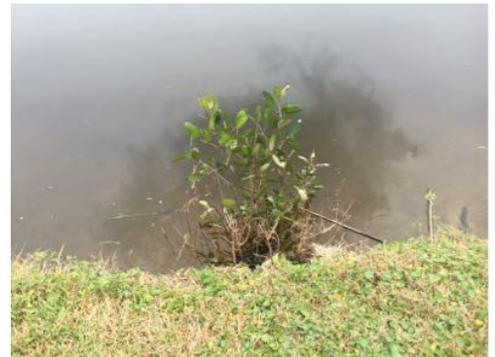
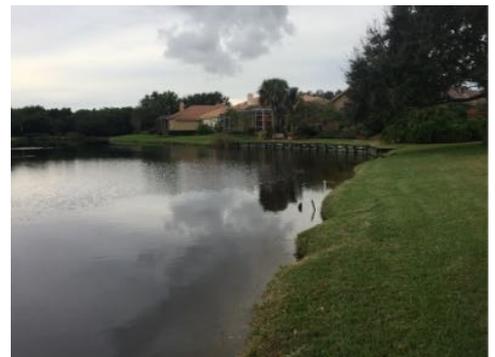
Site: 10

Comments: Site looks good

I am working on quote for a test planting here. Two areas of 40 plants each will be planted. This totals 80 plants. This is a total of 160 plants for ponds 9 and 10. After approval we will begin working on a quote for a large planting in these test plantings. Beneficial plantings help reduce erosion and nutrient levels.
