Placido Bayou Community Association Waterway Inspection Report

Reason for Inspection: Routine Scheduled - Monthly

Inspection Date: 8/21/2017

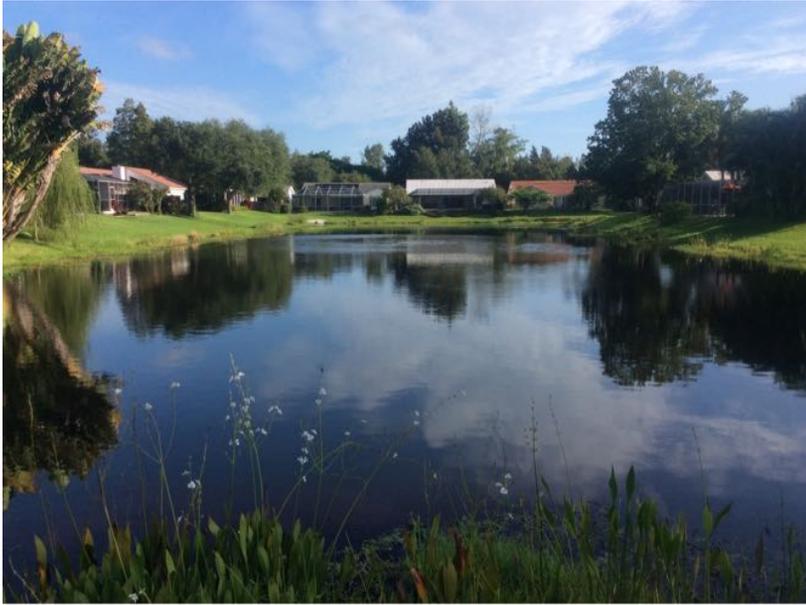
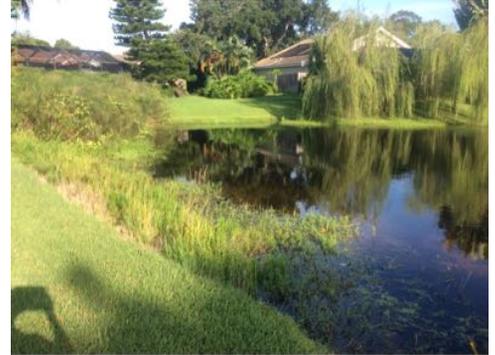
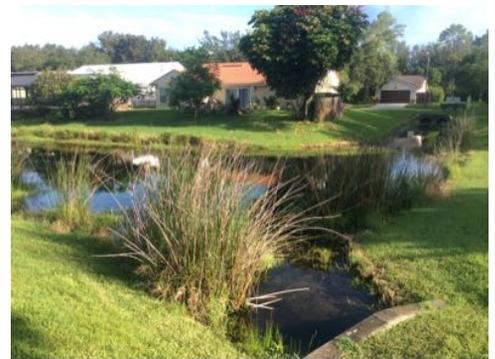
Site: 1

Comments: Normal growth observed

Site #1 had some regrowth of Alligator Weed and Torpedo Grass growing along the shoreline. This will be targeted during an upcoming scheduled visit.

- Target the regrowth of shoreline Torpedo Grass within Site #1.
- Closely monitor site #2 for regrowth of shoreline grasses and algae, applying treatments as necessary.

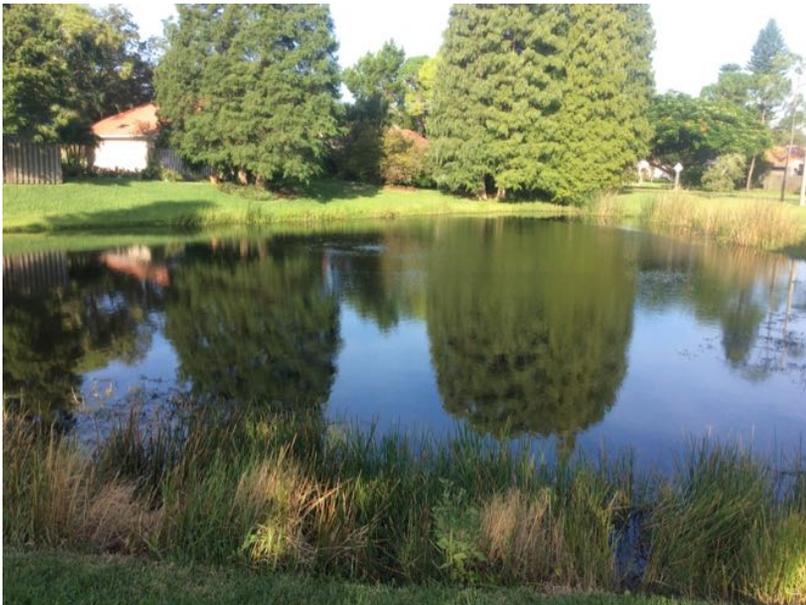
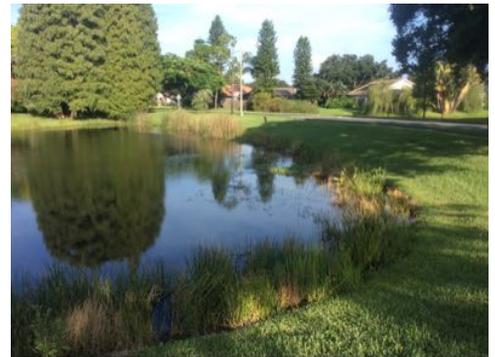
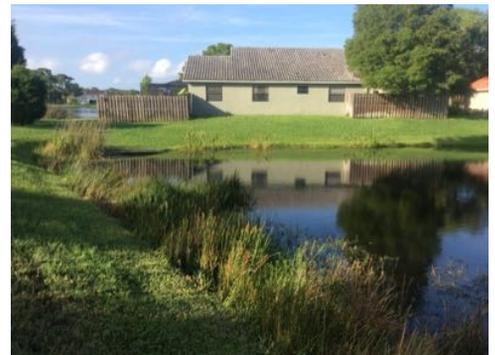
Site: 2

Comments: Site looks good

Site #2 was in good condition during the time of this inspection. We will continue to closely monitor this site, applying additional treatments as regrowth of undesired vegetation and algae are observed.

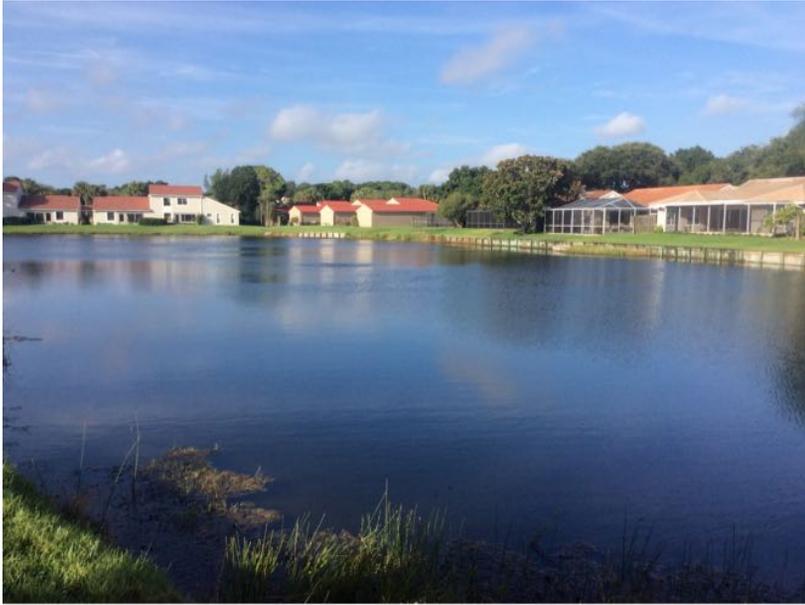
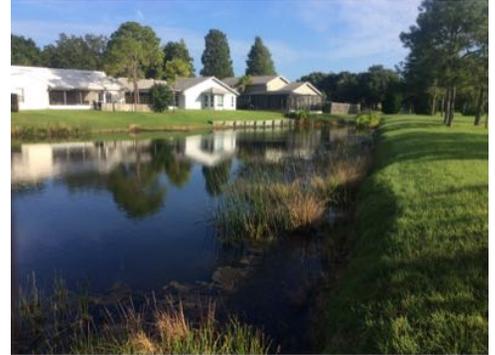
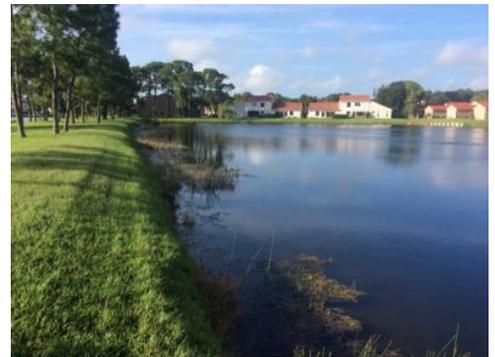
Site: 3

Comments: Normal growth observed

Site #3 had algae growth along the perimeter of the waterway. This will be targeted during an upcoming, routinely scheduled visit.

- Perform a treatment on site #3 to target the band of filamentous algae.
- Target the Water Primrose and Torpedo Grass growing out from the perimeter at site #4.

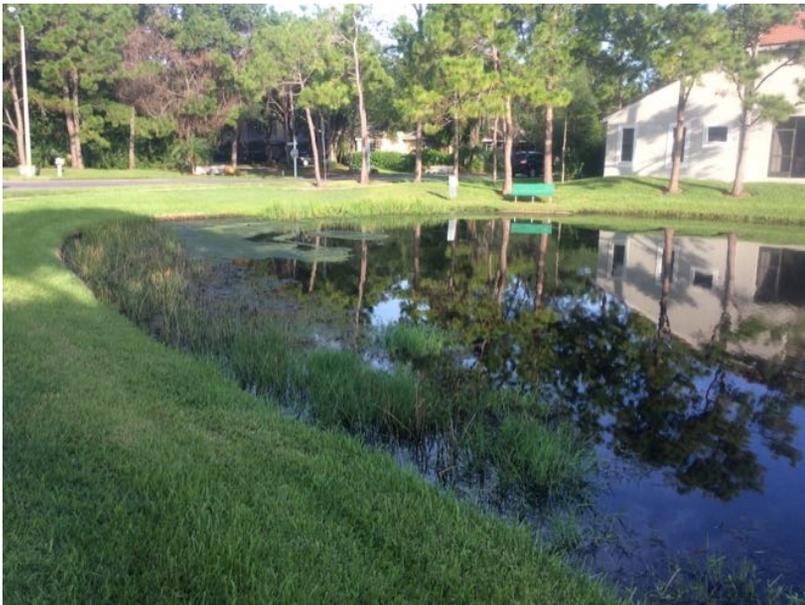
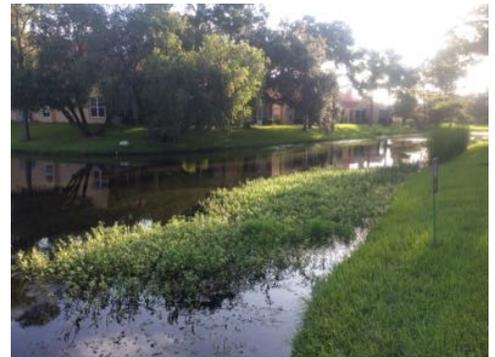
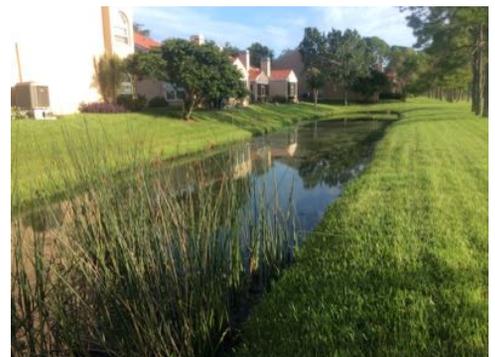
Site: 4

Comments: Requires attention

Site #4 had Torpedo Grass and Water Primrose growing out from the waters edge. Water Primrose can spread rather quickly. This will be targeted during the next scheduled treatment. We will monitor the efficacy of this application, performing additional treatments as needed.

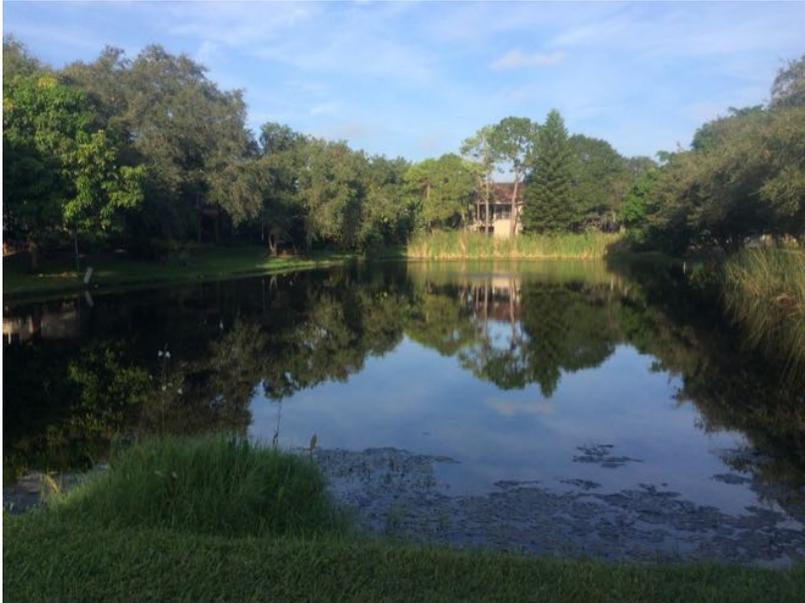
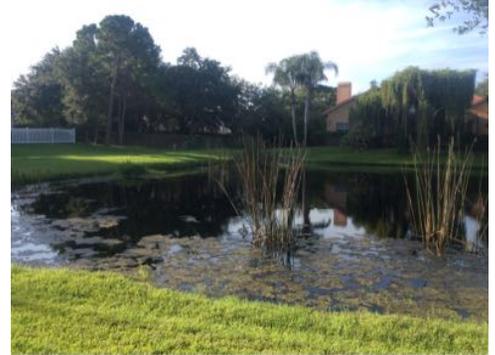
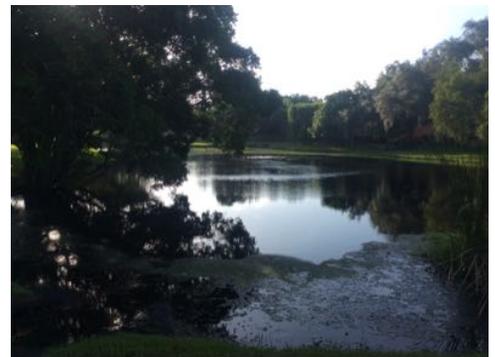
Site: 5

Comments: Normal growth observed

Site #5 was experiencing a continued algae bloom due to reclaimed water entering the waterbody. This will be targeted during our next scheduled visit.

- Apply a treatment to site #5 to target the bloom of filamentous algae.
- Perform an aggressive algae treatment at site #6.
- Target all filamentous and planktonic algae growth within site #7.

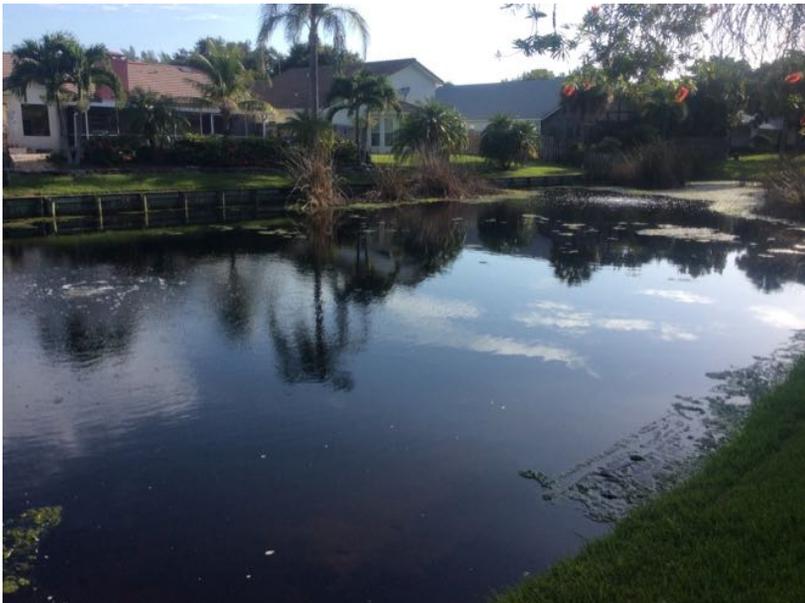
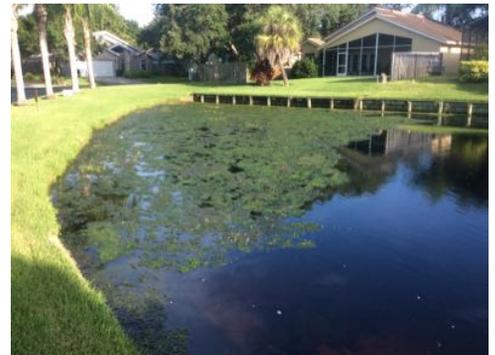
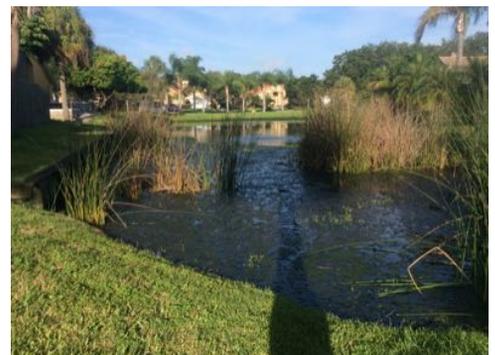
Site: 6

Comments: Requires attention

Site #6 was experiencing an algae bloom. This will be targeted during our next scheduled visit. Algae blooms are common during the summer months, due to increased temperatures, and precipitation which brings nutrient-rich storm water runoff into the waterways.

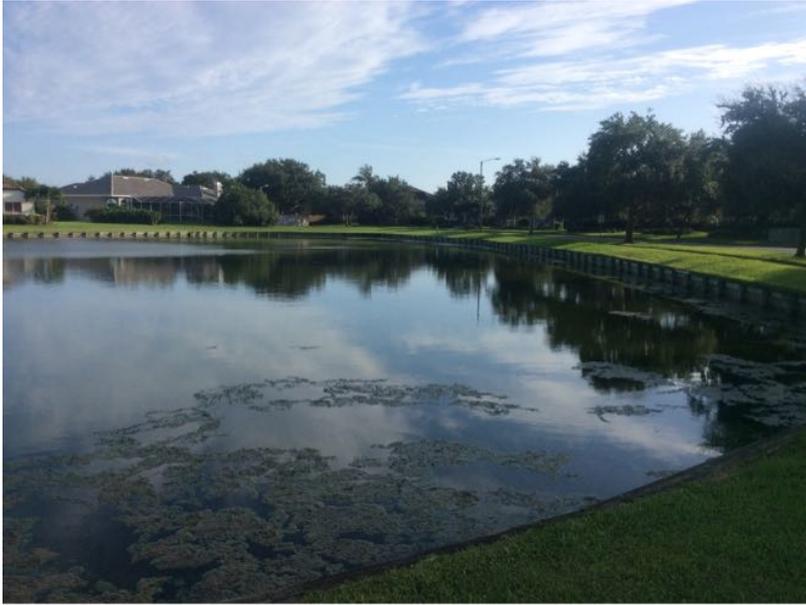
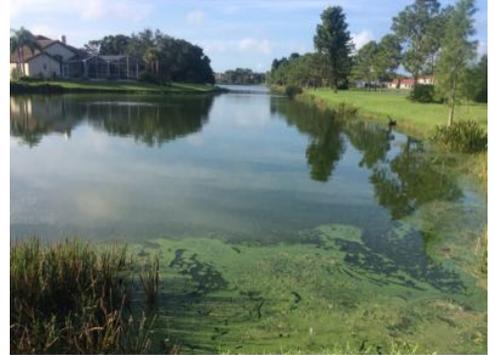
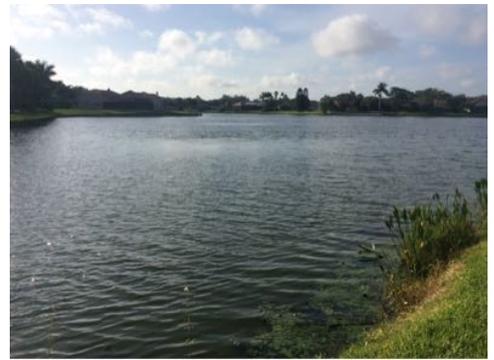
Site: 7

Comments: Requires attention

Site #7 was experiencing planktonic and filamentous algae blooms. This will be aggressively targeted during the next scheduled visit. We will closely monitor this site to ensure desired results are achieved.

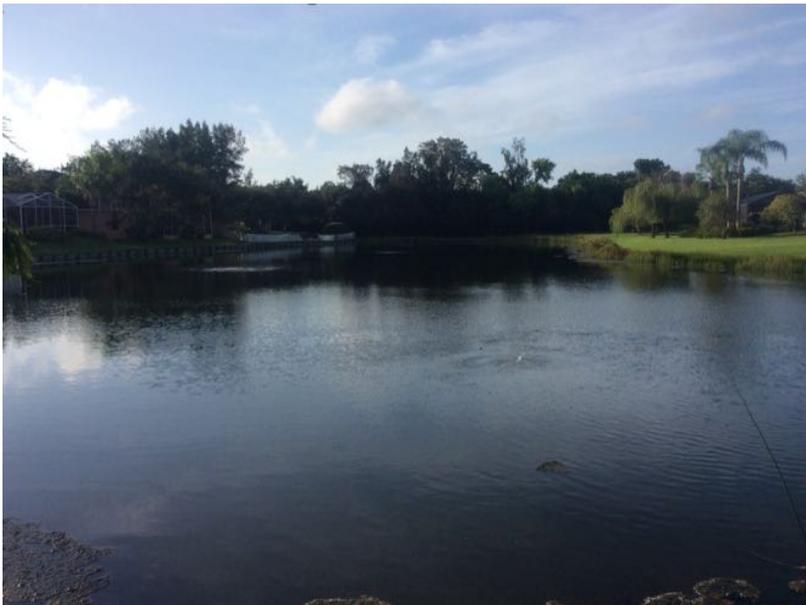
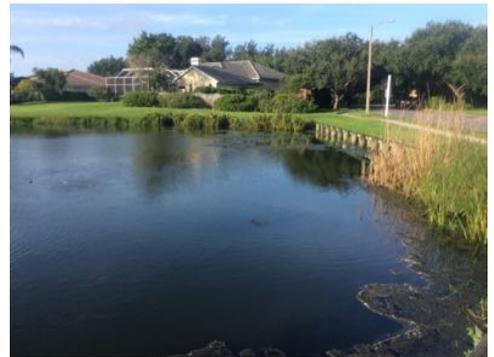
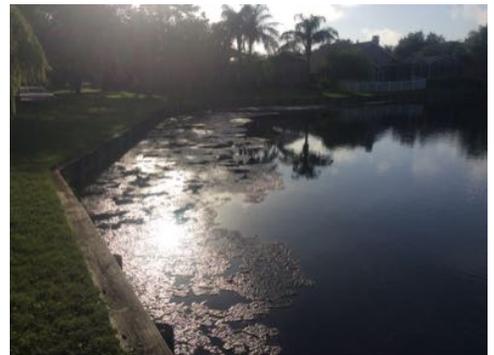
Site: 8

Comments: Normal growth observed

Site #8 had filamentous algae growing along the perimeter of the lake at a 3-5 foot band. This will be targeted during our next scheduled visit.

- Target perimeter band of filamentous algae within site #8.
- Continue to monitor site #9 for regrowth of shoreline grasses and algae, performing additional treatments as necessary.

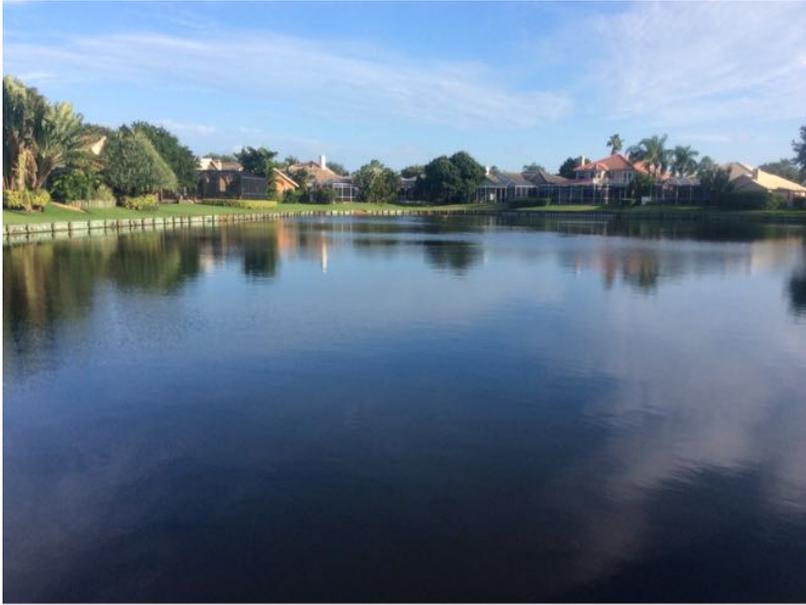
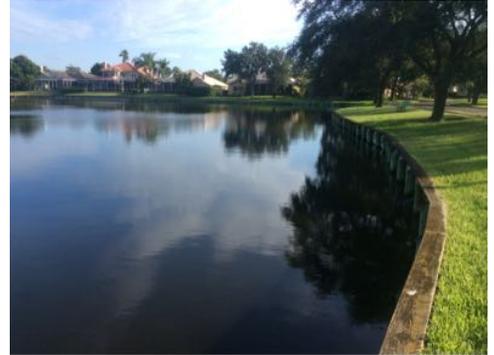
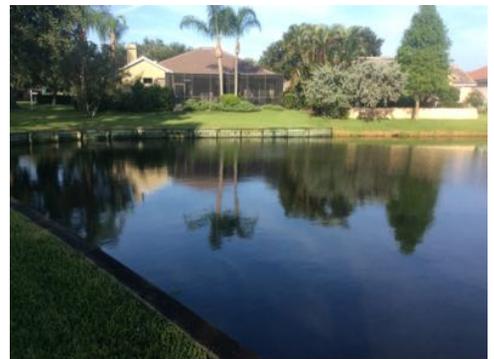
Site: 9

Comments: Site looks good

Site #9 was in excellent condition. We will monitor this site for undesired growth, applying treatments as needed.

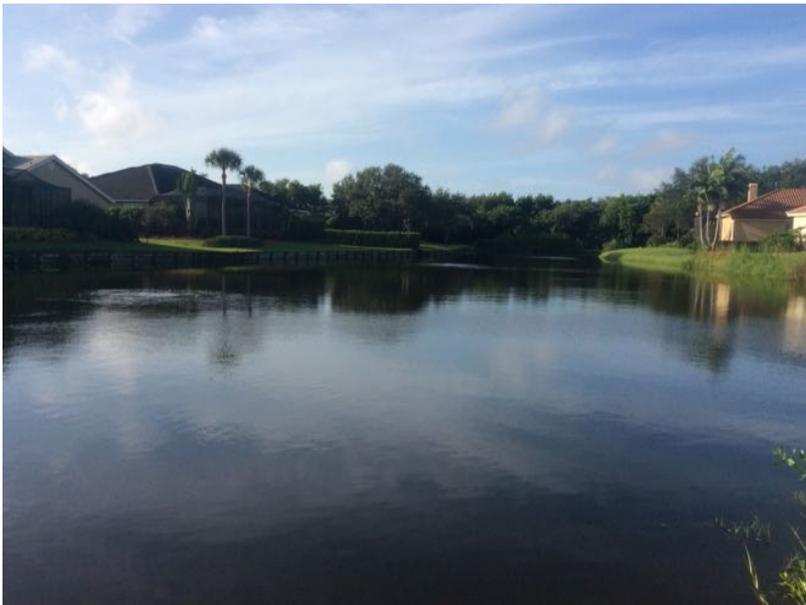
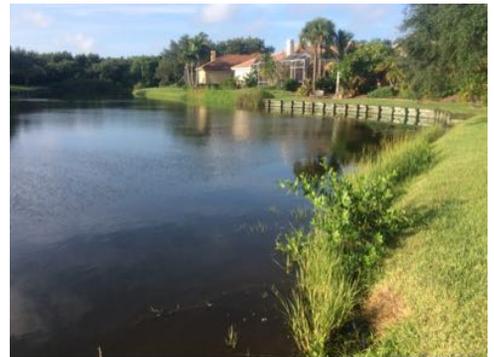
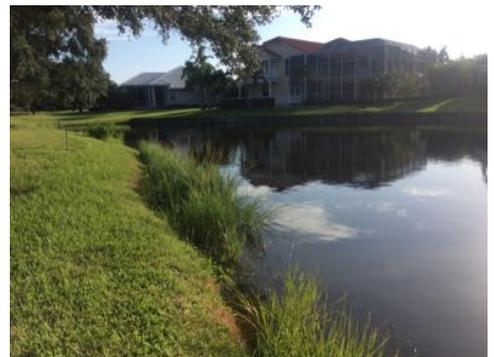
Site: 10

Comments: Site looks good

Site #10 looked great during this inspection. We will apply additional treatments as necessary to maintain desired results.

- Closely monitor site #10 for new growth of algae and shoreline grasses, targeting as required.
- Follow up with all previous treatments to ensure desired results are achieved.
