Placido Bayou Community Association Waterway Inspection Report

Reason for Inspection: Routine Scheduled - Monthly

Inspection Date: 10/19/2017

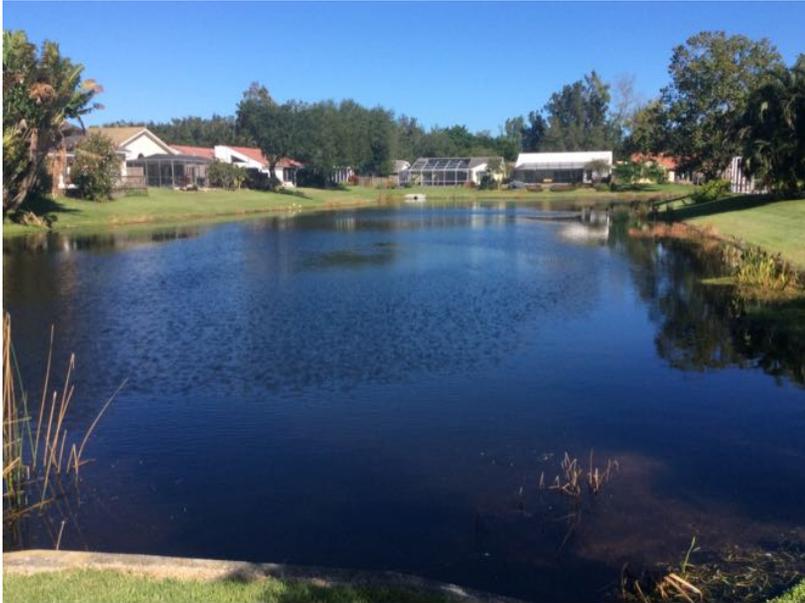
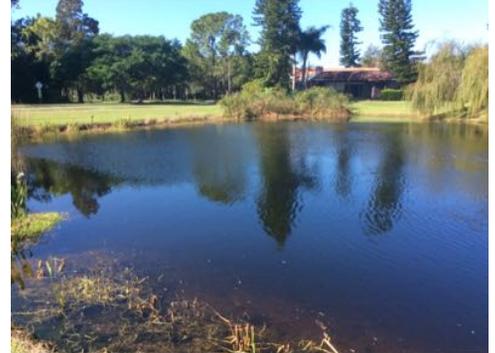
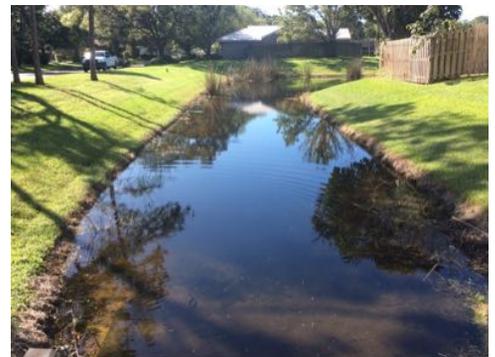
Site: 1

Comments: Site looks good

Site #1 showed evidence of a successful grass treatment along the perimeter of the site, performed weeks prior to this inspection in anticipation of the 3-Square Bulrush planting to occur. We will closely monitor the success of the planting site to ensure optimal survival and establishment is achieved.

- Closely monitor the 3-Square Bulrush planting within site #1.
- Target the filamentous algae growth within site #2, while monitoring the decomposition of shoreline vegetation.

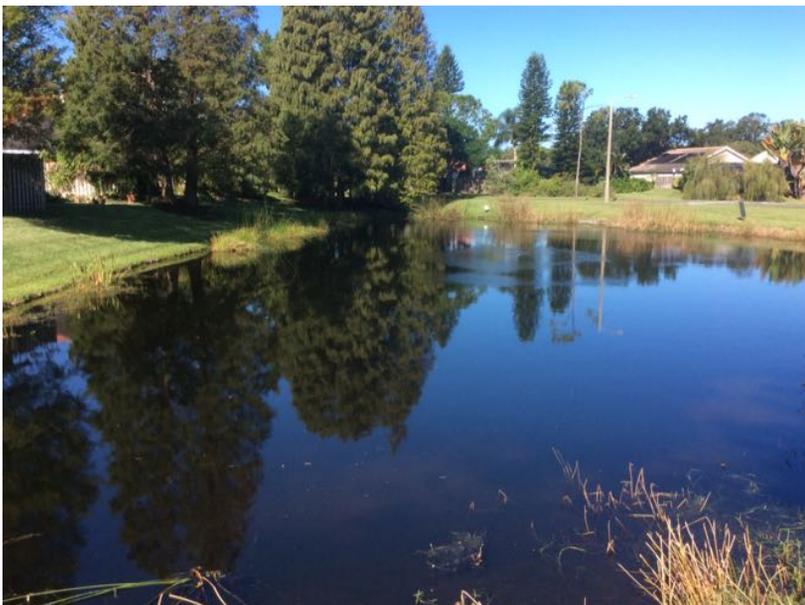
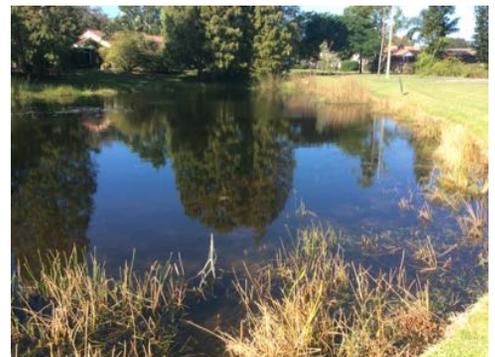
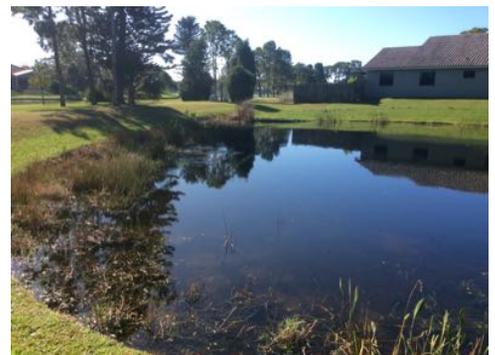
Site: 2

Comments: Normal growth observed

Traces of filamentous algae were observed within the decomposing shoreline vegetation. This will be targeted during an upcoming scheduled visit, while monitoring the decomposition of the shoreline grasses.

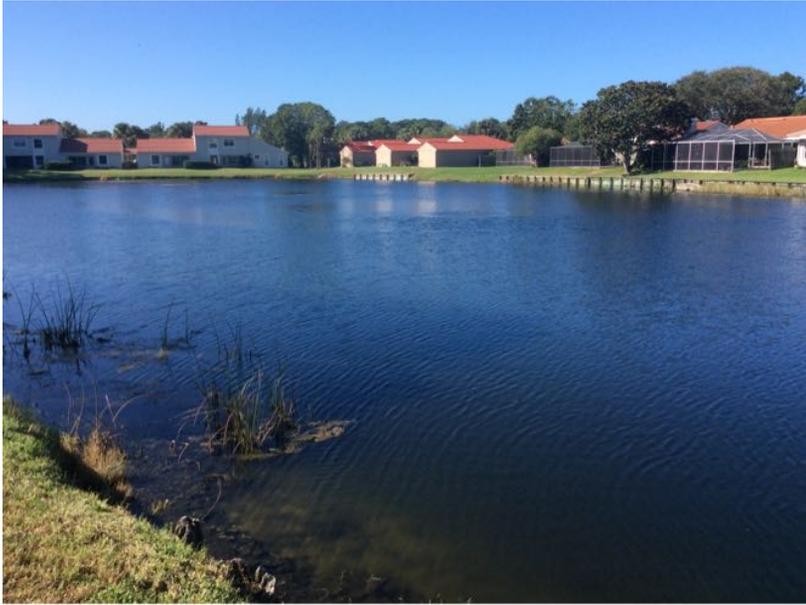
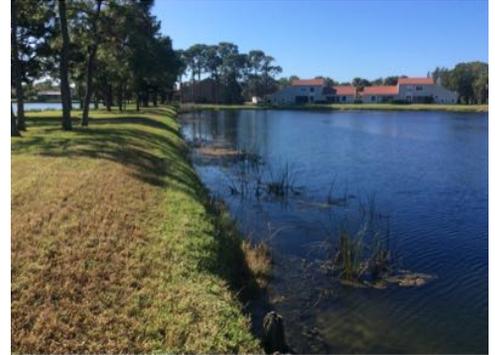
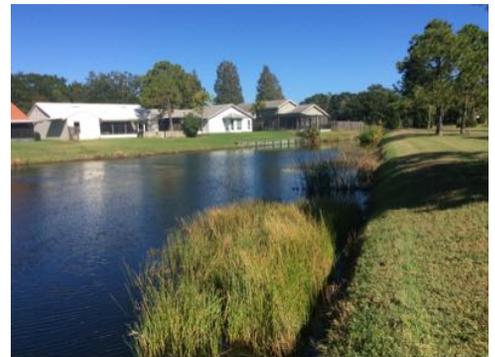
Site: 3

Comments: Normal growth observed

Normally observed growth of filamentous algae was present within site #3. An algae treatment will be performed during an upcoming scheduled visit.

- Apply an algae treatment within site #3 during an upcoming visit.
- Perform an algae application within site #4 on the next scheduled visit.
- Target the filamentous algae within site #5, while closely monitoring for algal blooms as this site is connected with site #4, which had received reclaimed water.

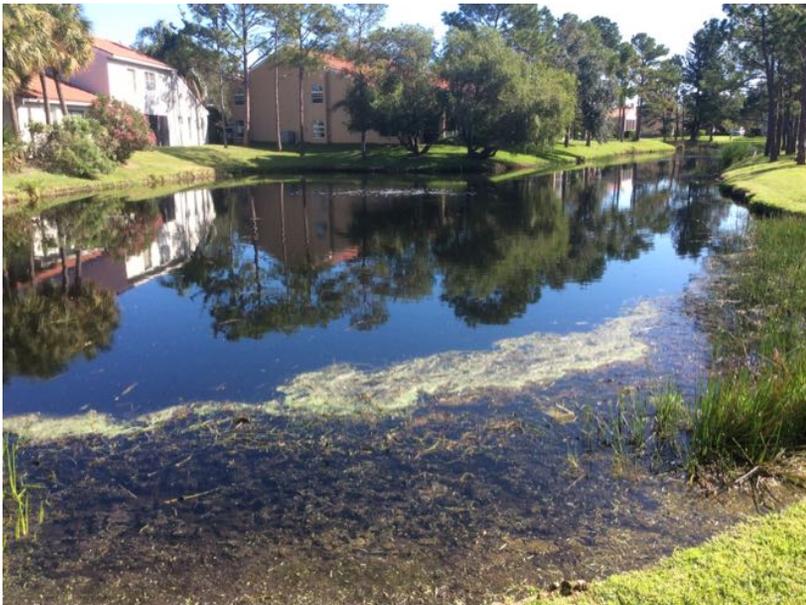
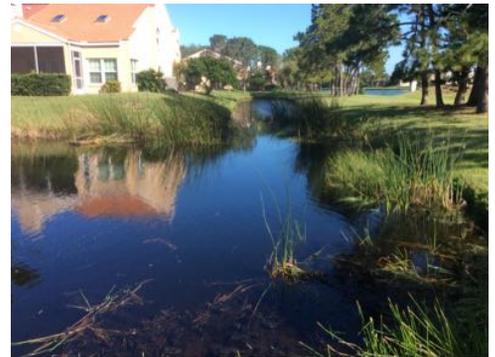
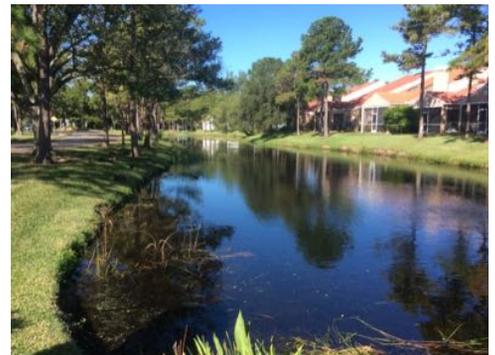
Site: 4

Comments: Requires attention

Site #4 was experiencing an filamentous algae bloom during this inspection, and will be targeted during the next scheduled visit. The site was kept free of undesired shoreline vegetation.

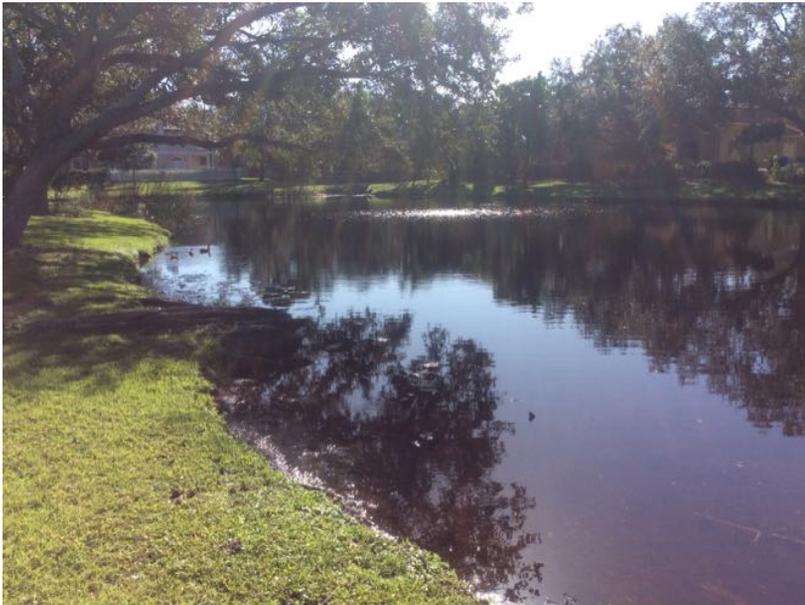
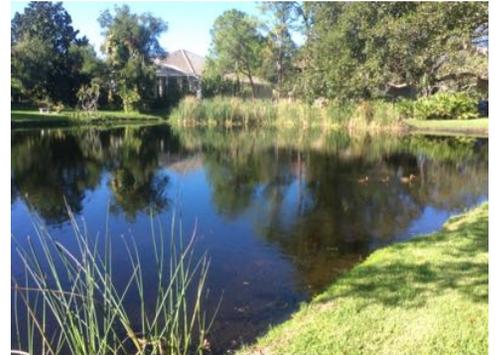
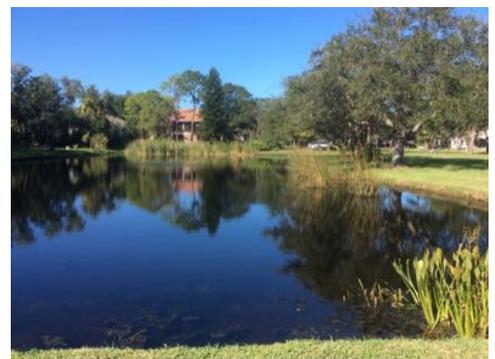
Site: 5

Comments: Normal growth observed

Filamentous algae was observed in small quantities along the perimeter of the pond, and will receive an algae treatment during an upcoming scheduled visit.

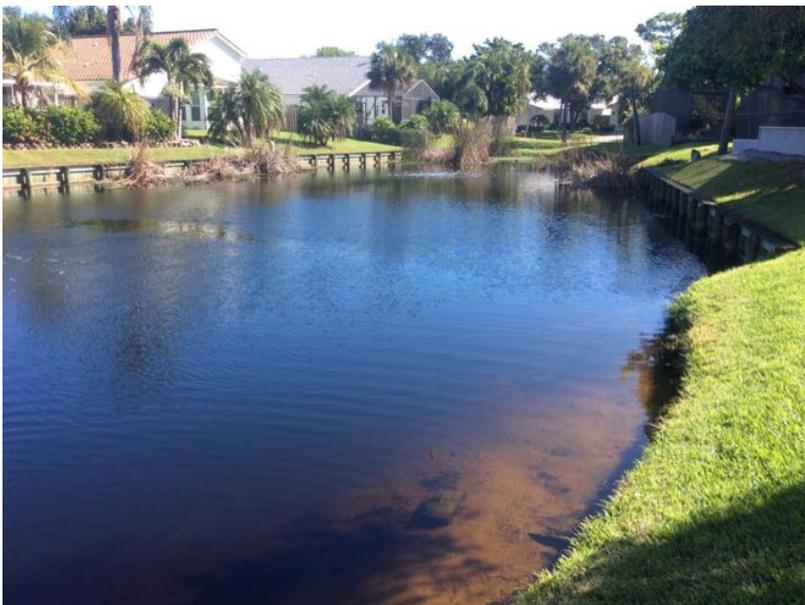
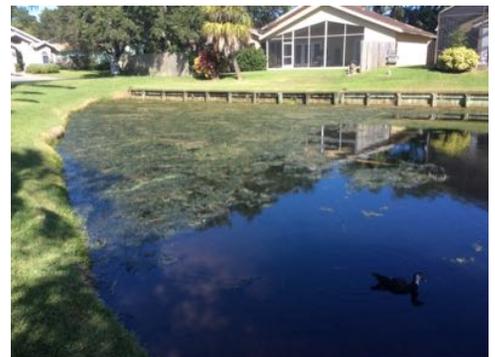
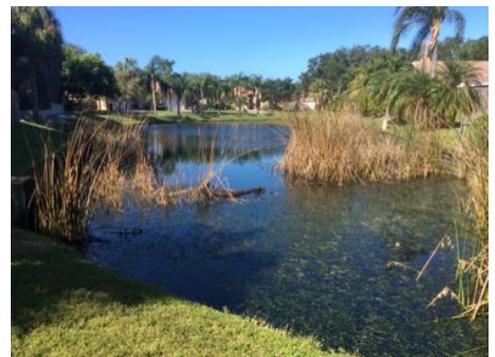
Site: 6

Comments: Requires attention

Site #6 continued to facilitate algae growth during the October inspection. An algae treatment will be applied on the next scheduled visit. Additionally, the Bulrush populations had been prepared for the upcoming removal.

- Target the filamentous algae growth within site #6 on the next scheduled visit. Follow up treatments to occur after the physical removal of Bulrush to prevent regrowth.

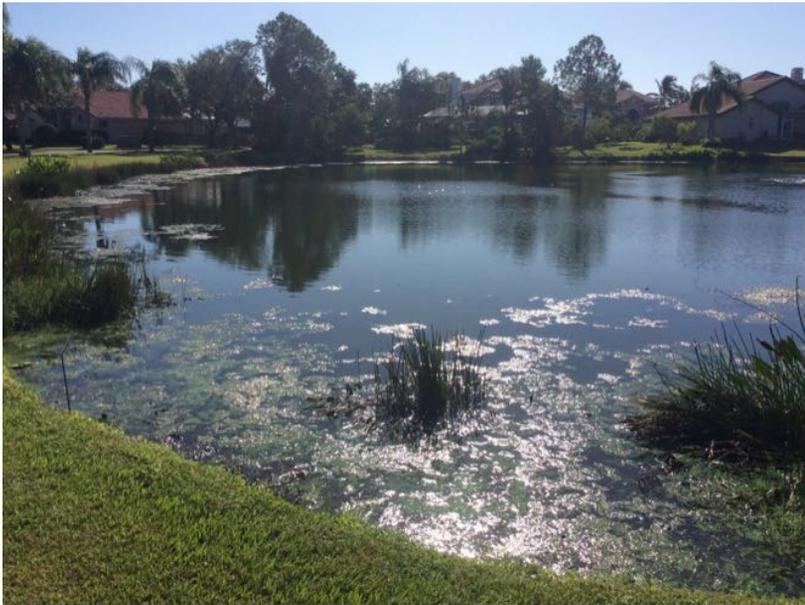
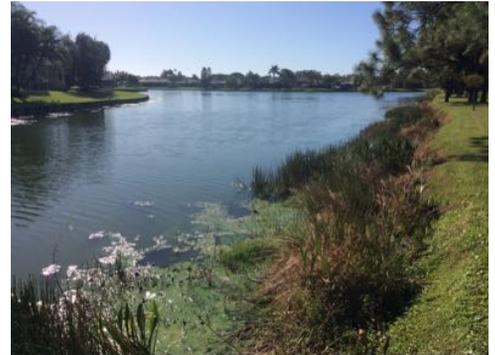
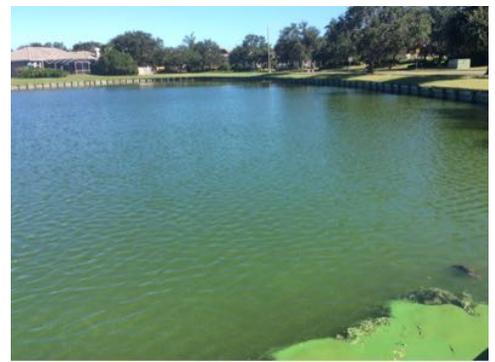
Site: 7

Comments: Requires attention

During this inspection, site #7 was experiencing a large planktonic algae bloom throughout the water column, as well as filamentous algae growth along the perimeter of the site. This will be aggressively targeted during the next scheduled visit.

- Aggressively target the planktonic and filamentous algae growth within site #7 on the next scheduled visit.
- Apply an algae treatment within site #8.

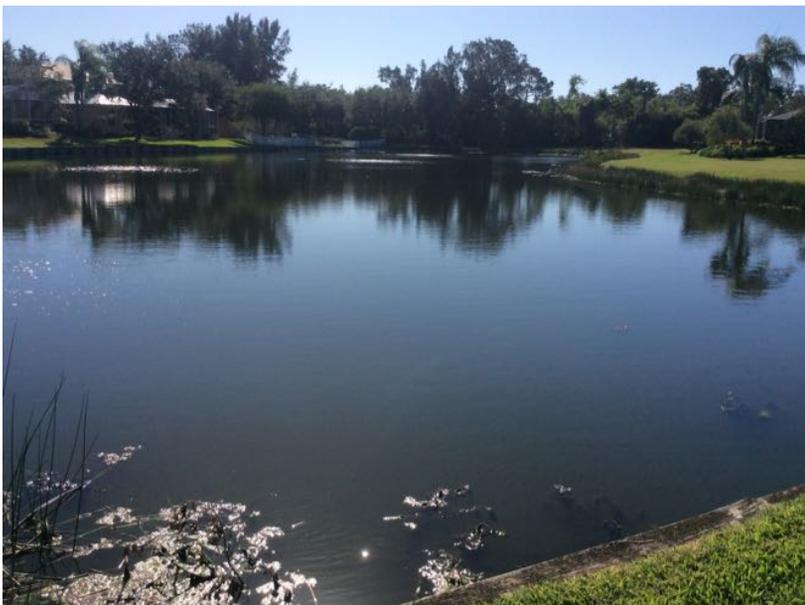
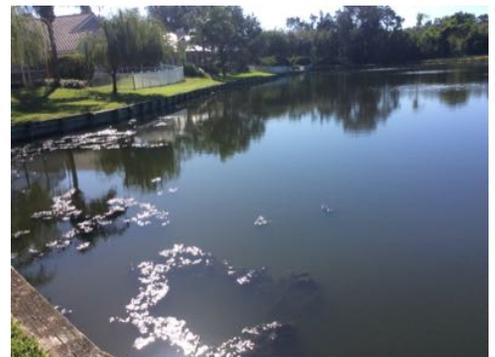
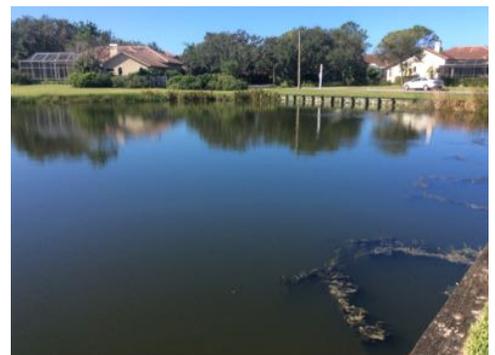
Site: 8

Comments: Normal growth observed

Site #8 had shown significant improvement during the October account inspection. The planktonic algae bloom present in September had been successfully targeted. Regrowth of filamentous algae was present along the perimeter of the site, and will receive an algae treatment during an upcoming scheduled visit.

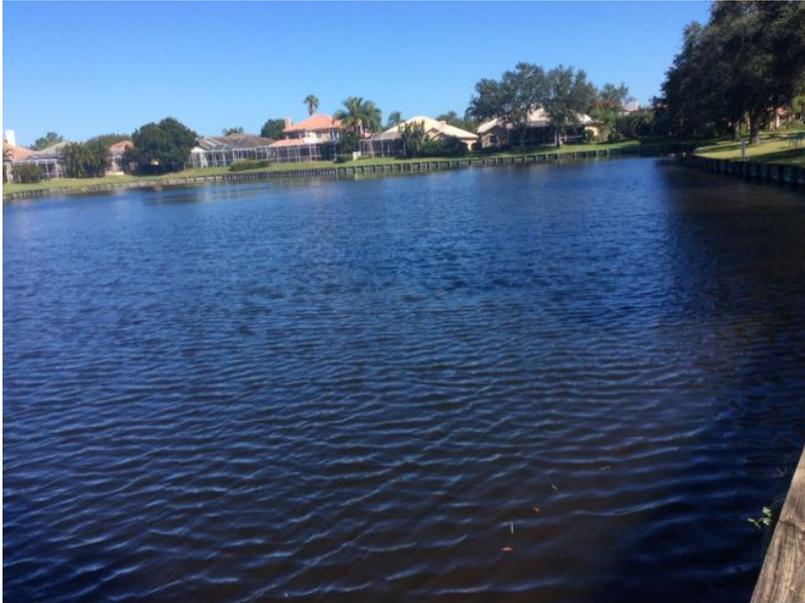
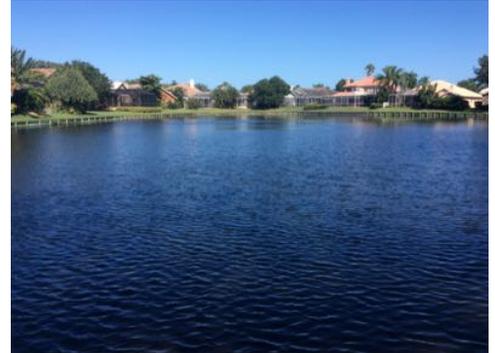
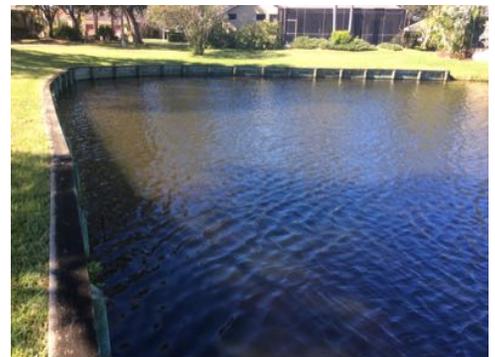
Site: 9

Comments: Site looks good

Site #9 was in excellent condition during the time of this inspection. We will continue to closely monitor this site, performing additional treatments as required to ensure desired results are maintained.

- Closely monitor site #9 for regrowth of algae or undesired vegetation, treating as necessary.
- Monitor site #10 for growth of undesired vegetation and algae, performing additional treatments as required.

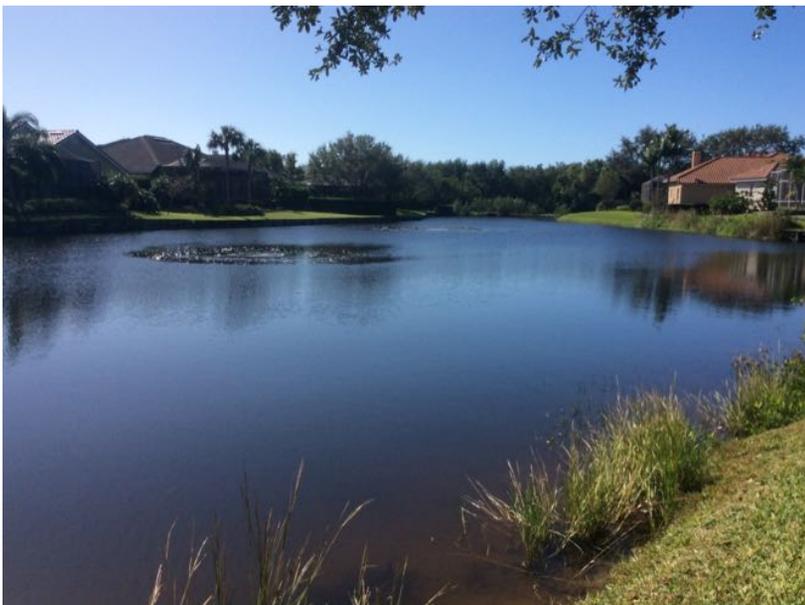
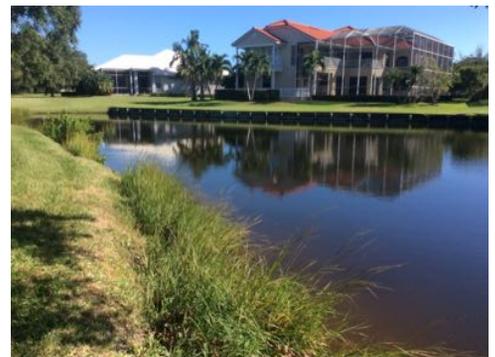
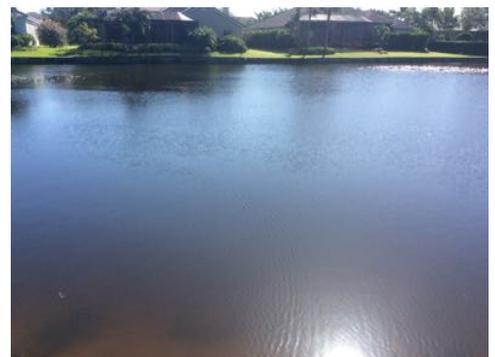
Site: 10

Comments: Site looks good

Site #10 looked great during this inspection, and had been maintained free of algae and undesired shoreline vegetation. This will be closely monitored to maintain these desired conditions.
