Placido Bayou Community Association Waterway Inspection Report

Reason for Inspection: Customer Request

Inspection Date: 8/13/2014

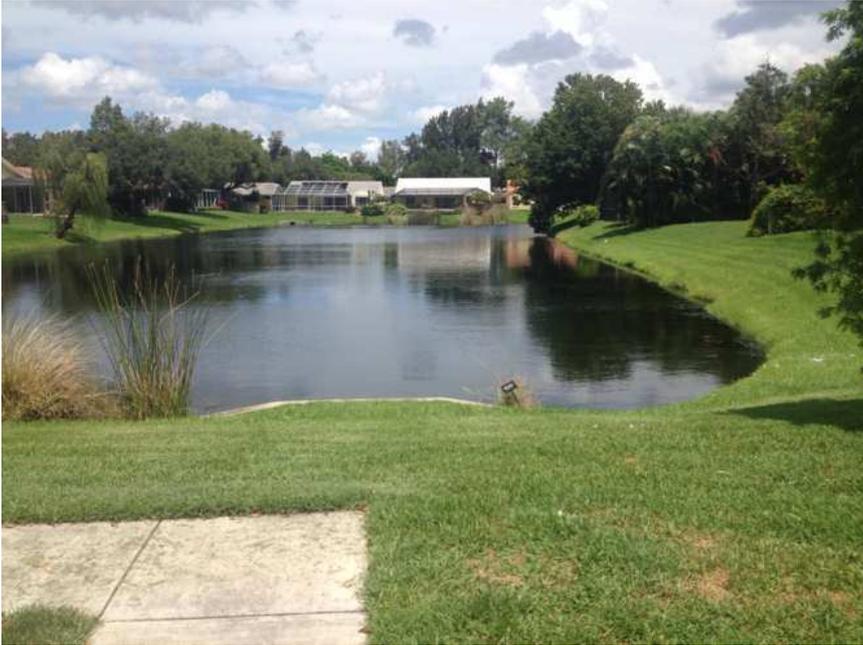
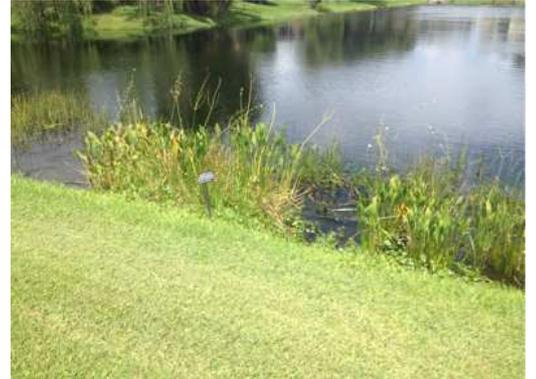
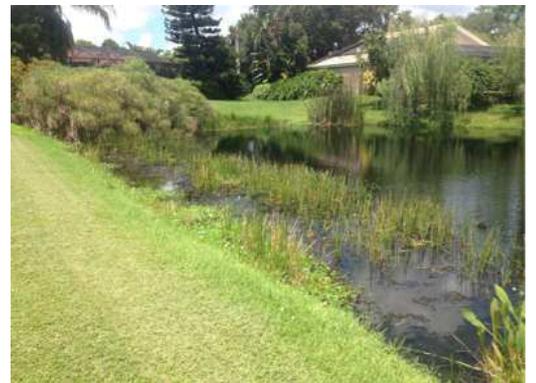
Site: 1

Comments: Site looks good
Beneficial's appear healthy. No algae observed.

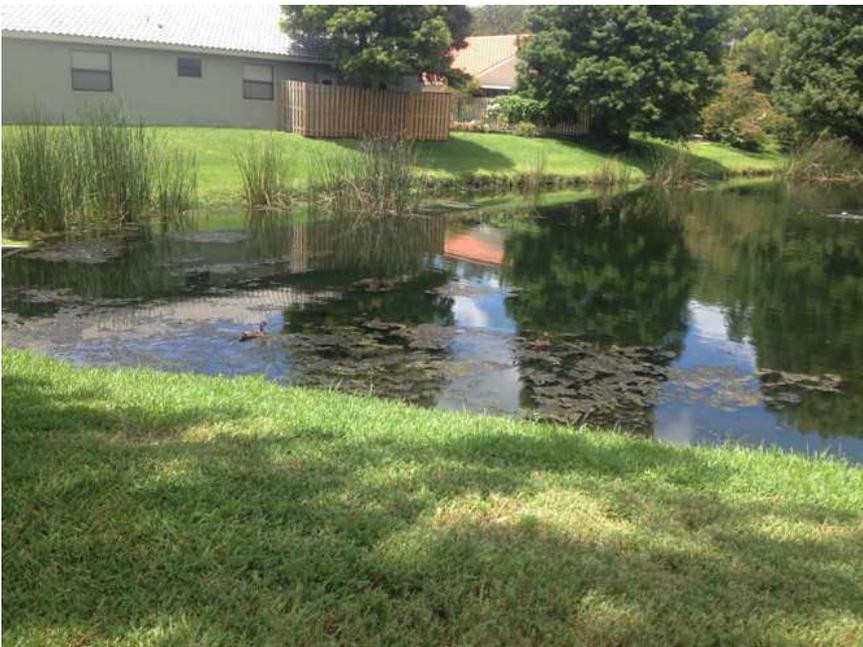
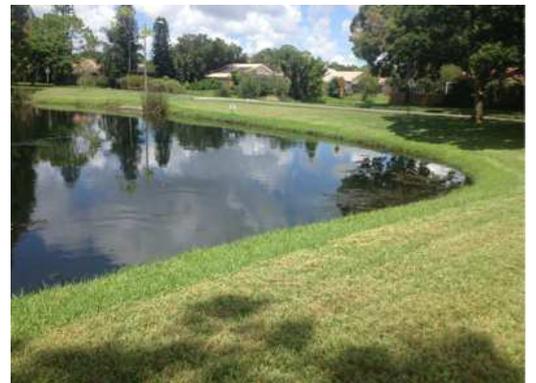
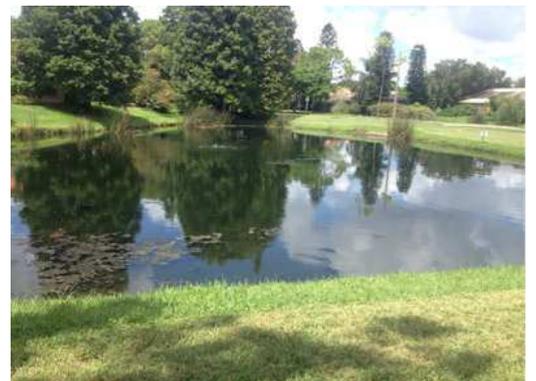
Site: 2

Comments: Normal growth observed
Trace algae observed.

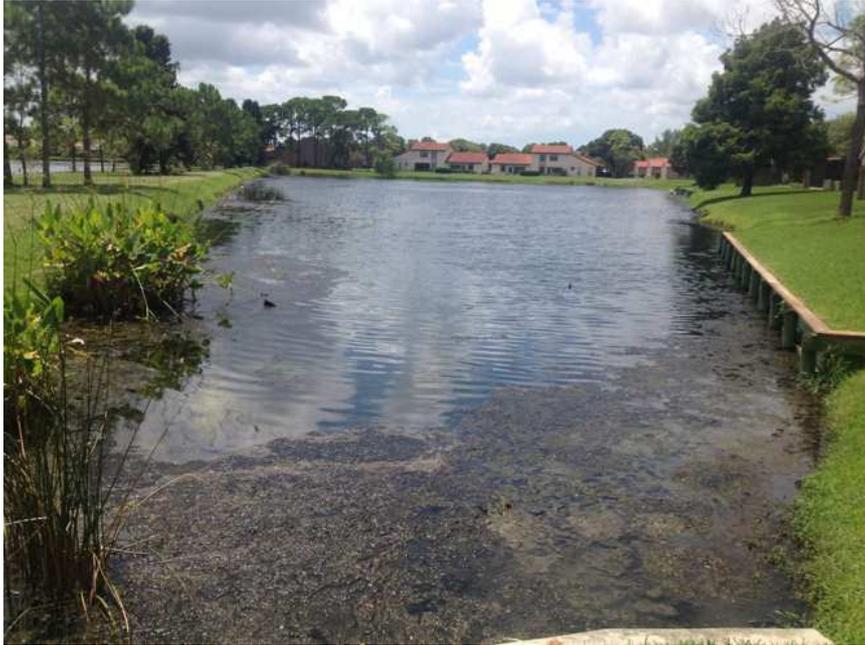
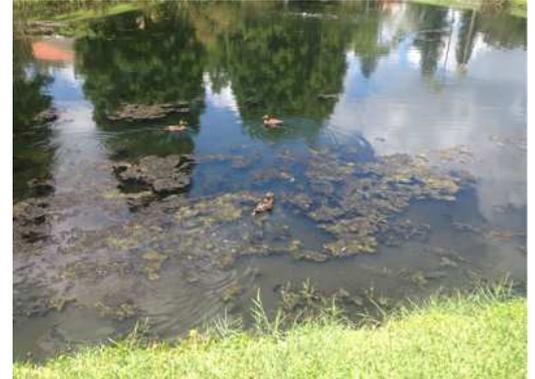
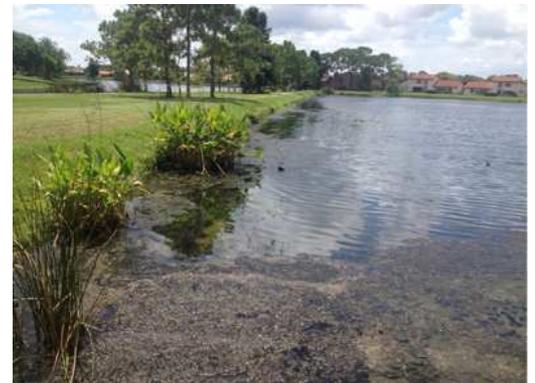
Site: 3

Comments: Normal growth observed

This end consistently has resistant algae. Likely due to shallow nature. Recommend dredging before flow becomes impeded.

One immediate point regarding pond #3. The north end of this pond is accumulating a large quantity of sediment and will likely soon, if not already, begin to block the flow of water through the drainage pipe allowing water to flow from pond #3 into pond 2 on its way out of the system. It is critical that this area be dredged out in order to stay in compliance with SWFWMD regulations. We can refer you to GA Nichols, a general contractor, to help you with this if you are interested. His information is available upon request.

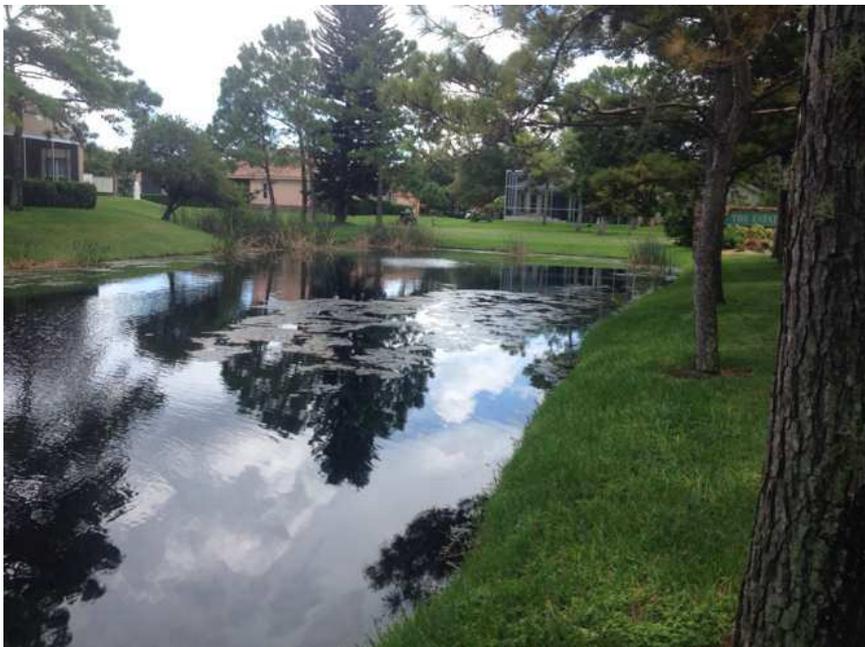
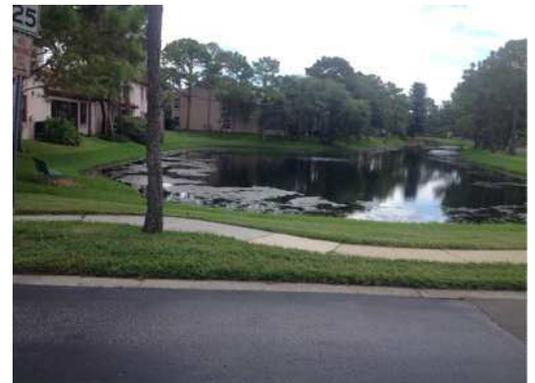
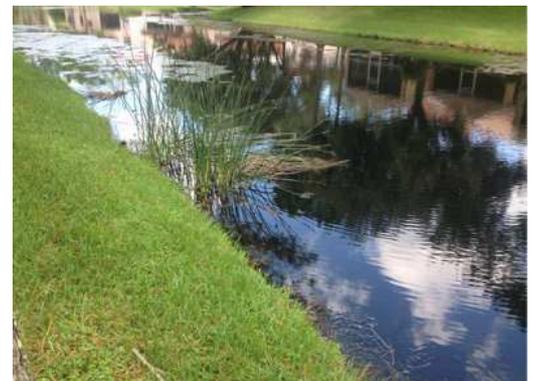
Site: 4

Comments: Normal growth observed

Selective treatment for torpedo grass amongst beneficial's successful. Will monitor for regrowth. Trace algae observed to be treated next

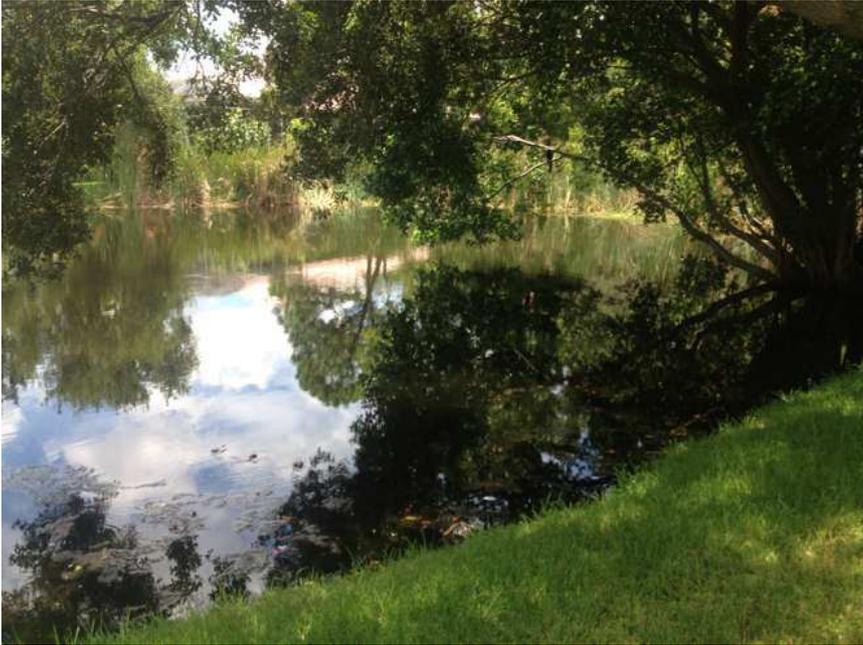
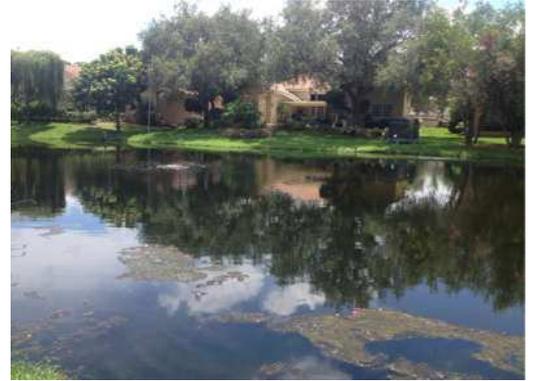
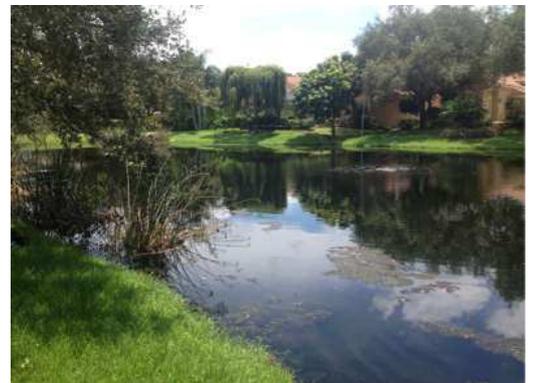
Site: 5

Comments: Normal growth observed
Trace algae observed to be treated on next scheduled visit.

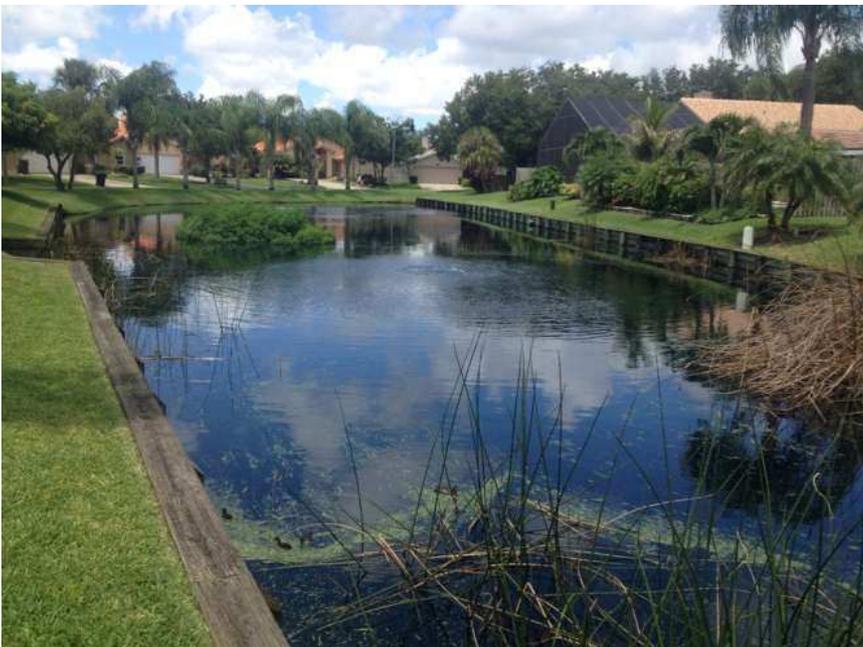
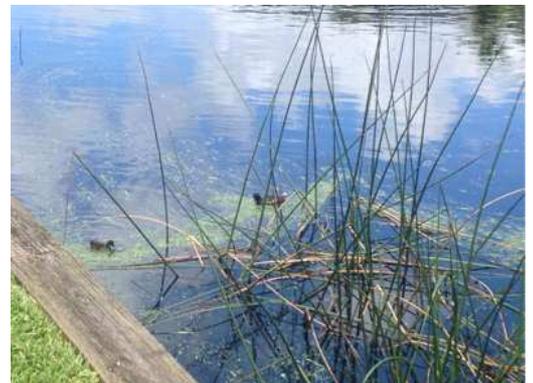
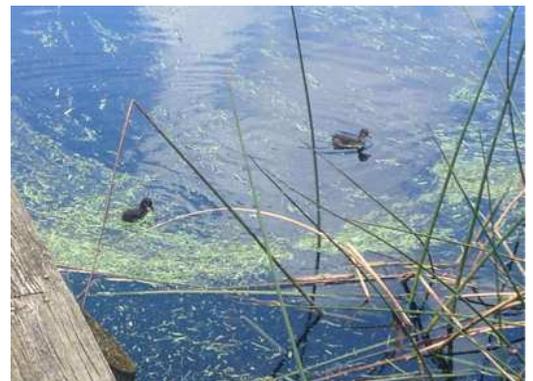
Site: 6

Comments: Requires attention
Grass clippings observed. See recommendations/actions section for further information regarding site #6.

1. Landscapers must obey the laws in this neighborhood and throughout the community to reduce the nutrient input. They must be held accountable and directed to change. If not, then we will all be fighting a losing battle.

2. Reclaimed water needs to be turned off completely during the rainy season around pond #6, at a minimum, if not for the entire community of Placido Bayou. Same rationale as expressed within Point 1.

3. The remainder of the giant bulrush should be removed in this pond. We agree that it would minimize disruption/turbidity in the immediate future to flush cut first and spray second, however because what we leave behind will simply decompose and add to the existing detritus we think complete removal is the best solution in this specific instance. (See Point 4)

4. The detritus on the bottom of pond # 6 needs to be removed from the system. There is 1-2 feet of muck that will not go away on its own. There are two options:

- a) Application of bacterial enzymes and an oxidizer on a monthly basis (\$77/month additional cost)
 - b) Dredging

For a pond this small, we believe the enzymes and oxidizer are a more viable option especially relative to the challenges/costs of dredging.

5. Following steps 1-4 on October 1st, 2014 ASI recommends moving forward with the proposed planting of pickerelweed along with the rest of the community.
6. In addition to the pickerelweed, we recommend a terrestrial buffer zone (*Juncus*) be planted around the entire perimeter of this pond to help minimize the influx of all kinds of surface runoff. (Barley straw is suggested as a mulch alternative here).

7. Following steps 5 & 6, we recommend retreatment of pond #6 with an 80 ppb dose of Alum. Following the initial Alum treatment we recommend consistent ultra-low dose (10 gallon) treatments of Alum monthly.
8. Water samples should continue to be taken at the regularly scheduled annual interval (October) to monitor progress.
9. Application of selective herbicide (when used properly) is the best method for managing invasive species amongst beneficial's. Manual Aquascaping is an option available to you, but perhaps best used only during the first 90 days of the planting due to its cost.
10. The last recommendation we have for the floating mat is complete removal or at least relocation ASAP to a low visibility area. Then, pond 6 will be to be the showcase pond that we all desire to it to be.

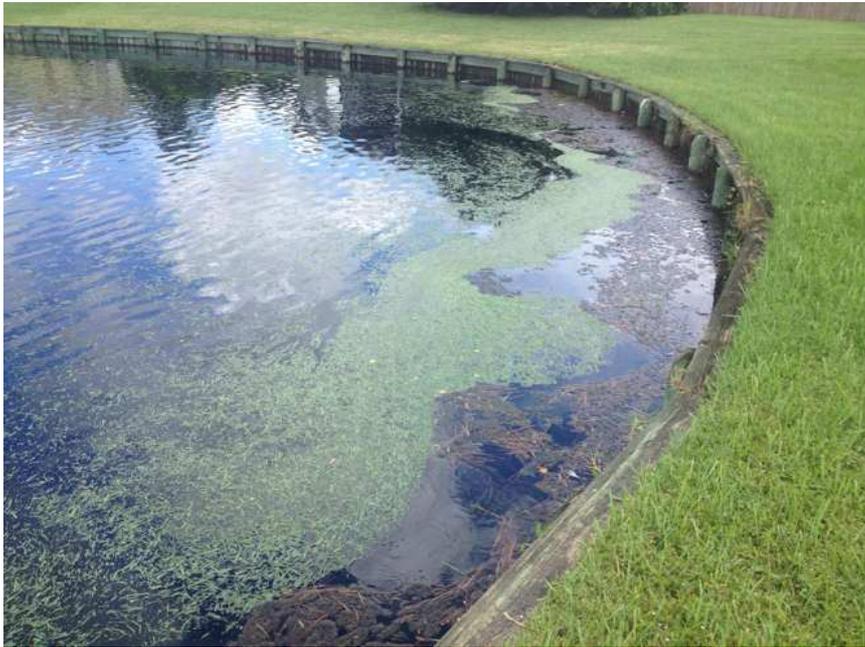
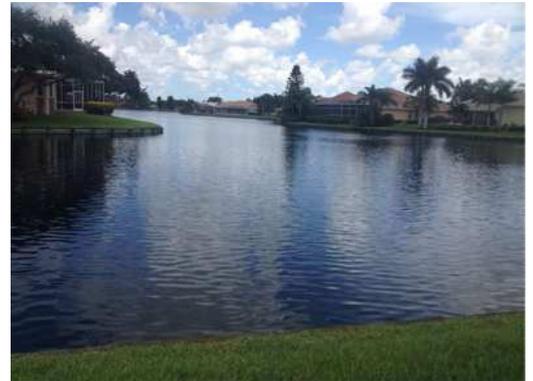
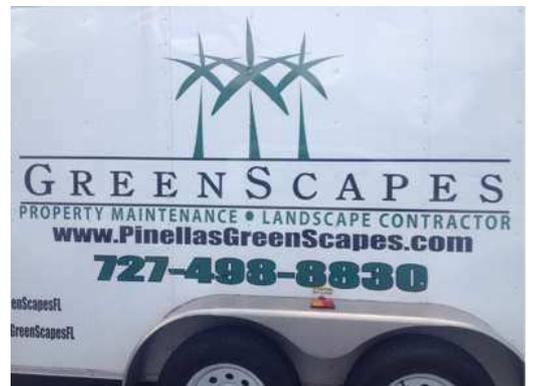
Site: 7

Comments: Requires attention

Large quantities of grass clippings observed in waterway and throughout community during this site inspection.

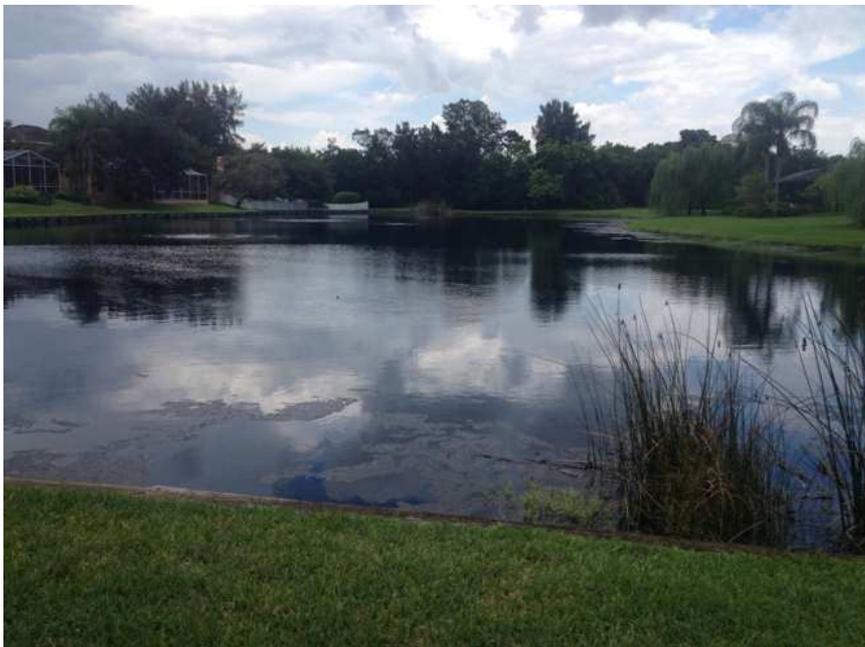
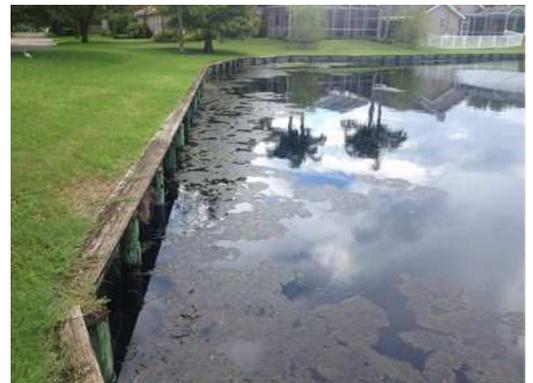
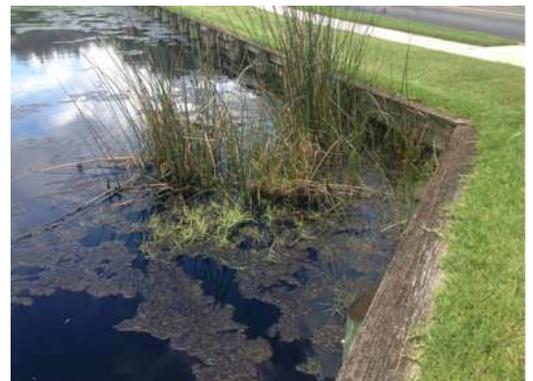
Site: 8

Comments: Requires attention

Trace grasses and resistant algae observed to be treated on next scheduled visit.

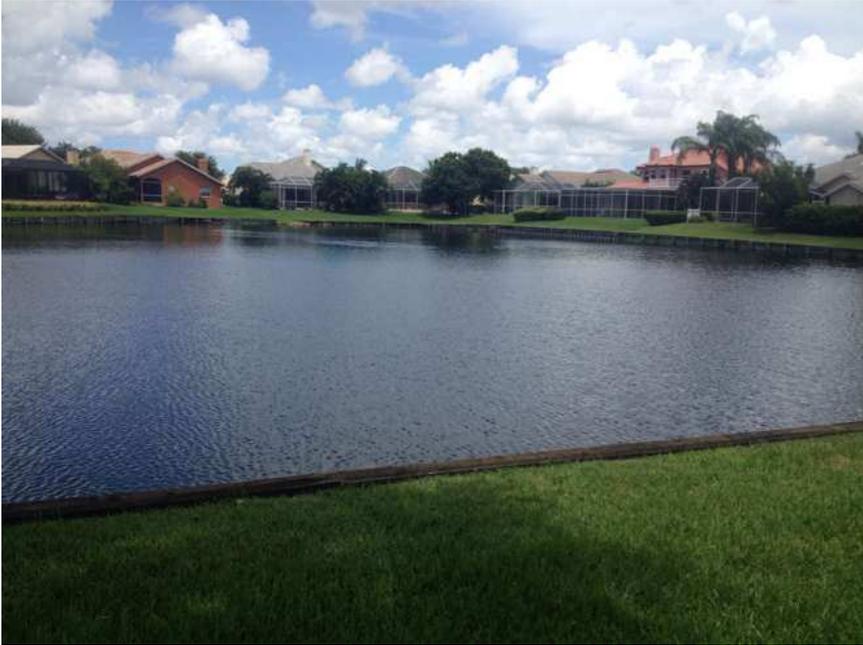
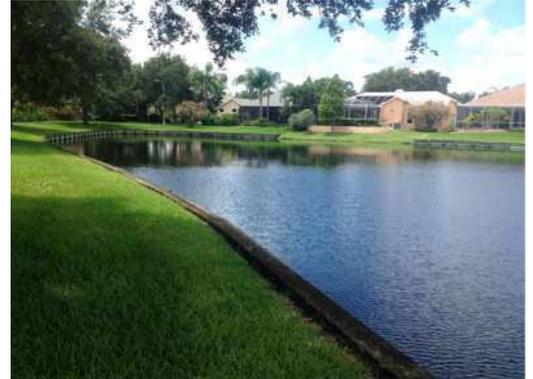
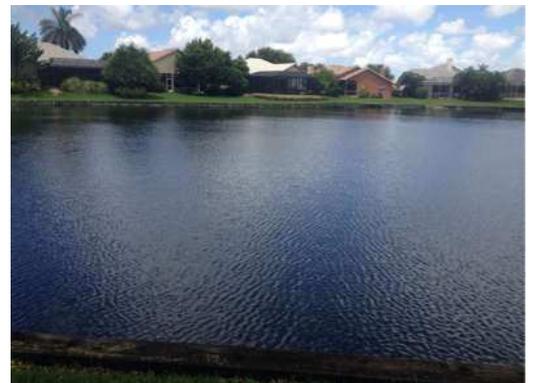
Site: 9

Comments: Site looks good

No issues at this time. Cattails decomposing at expected rate.

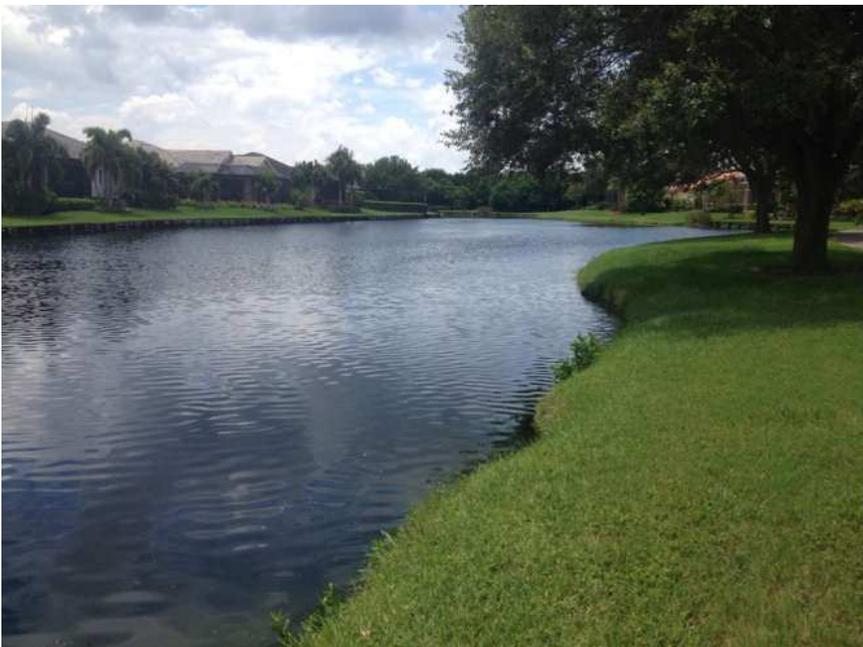
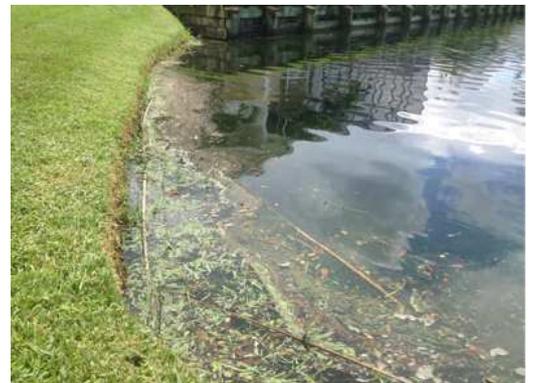
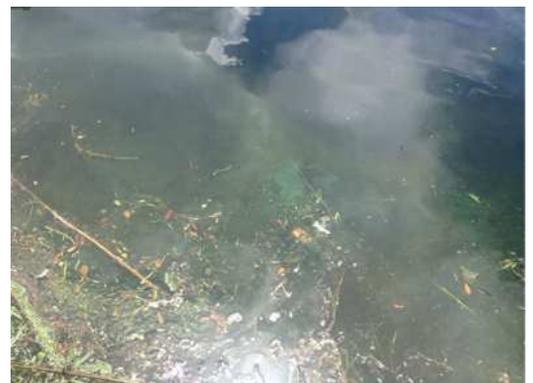
Site: 10

Comments: Requires attention

Planktonic algae blooming in immediate vicinity of grass clippings.

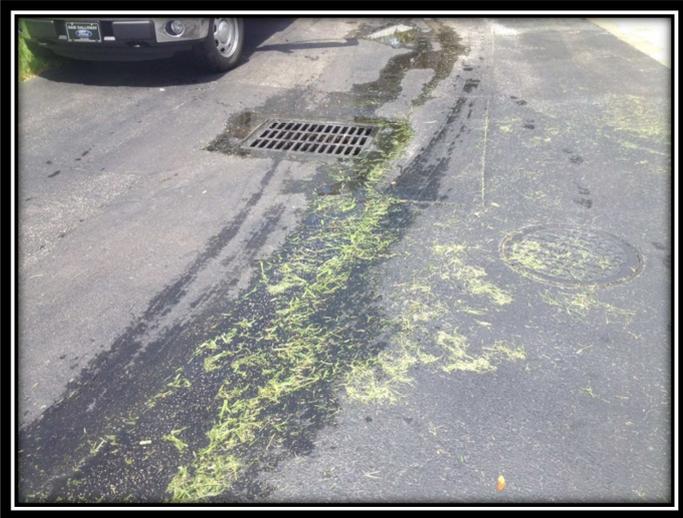
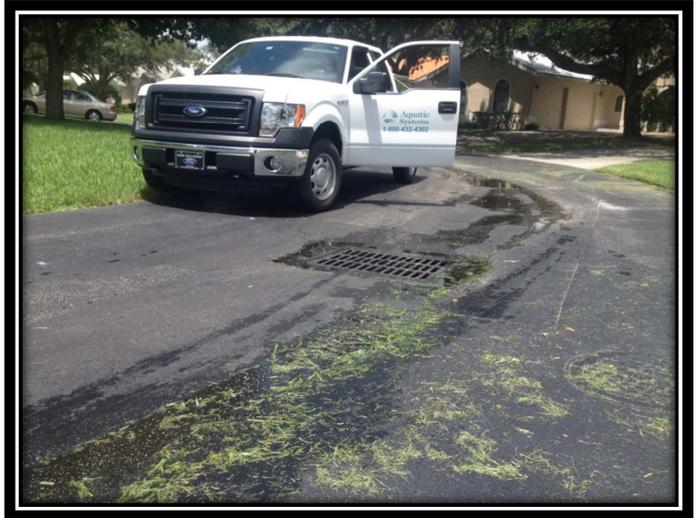
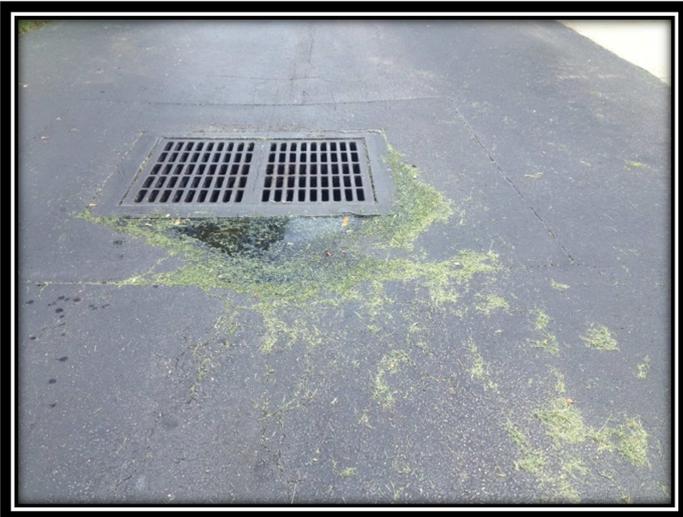
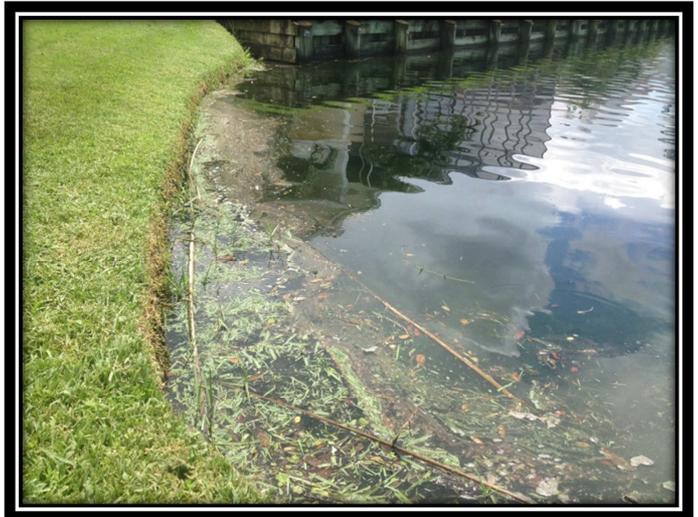
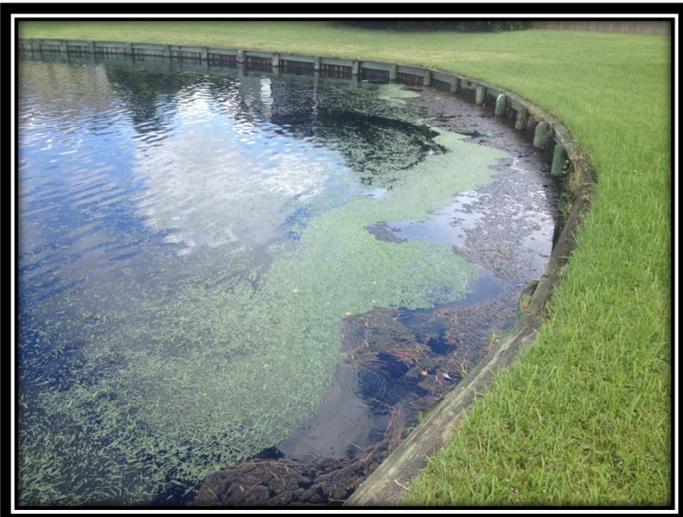
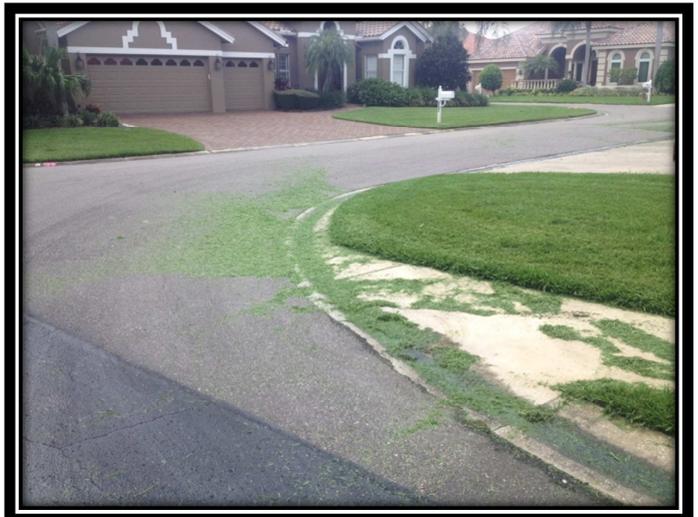
All landscapers will have to start being held fully accountable for their repeated violations of proper management of grass clippings and vegetative material. During our last inspection (8/13/14), we observed massive quantities of grass clippings in the roadways, flowing into drains and directly into the ponds (photos attached).

The common area landscapers (Green Scapes) mowed the entire area just prior to a heavy rainfall that washed high volumes of fresh grass clippings into the ponds. To their credit, they waited until after the rain ceased to blow what was left of the clippings back into the yards. However, the end result is continued, significant quantities of clippings directly into the ponds. This is a clear violation of Pinellas County (Ord. No. 10-06, § 1, 1-19-10) Sec. 58-479. Management of grass clippings and vegetative material which states:
