Placido Bayou Community Association Waterway Inspection Report

Reason for Inspection: Routine Scheduled - Monthly

Inspection Date: 12/10/2015

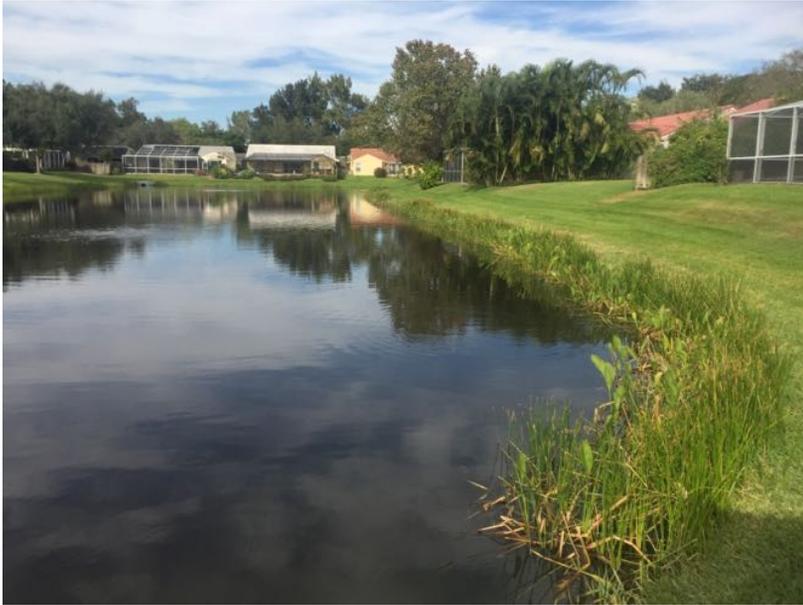
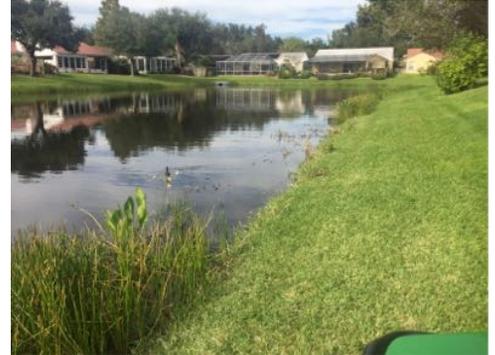
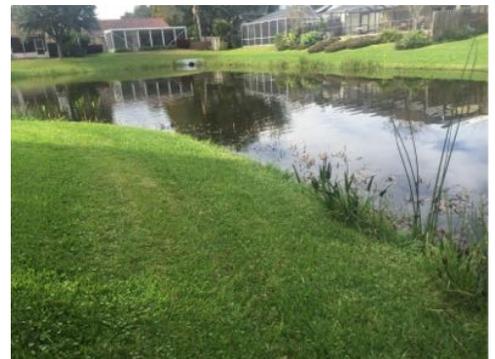
Site: 1

Comments: Site looks good

Beneficial vegetation is spreading throughout the pond. We will continue to monitor the Pickerelweed for disease. There is good chance that the diseased areas will recover. We will continue with hand removal here for the next few months.

1. Beneficial vegetation is spreading throughout the pond. We will continue to monitor the Pickerelweed for disease. There is good chance that the diseased areas will recover. We will continue with hand removal here for the next few months.

1. We will perform hand removal of invasive weeds as we closely monitor the diseased Pickerelweed. I recommend waiting until spring and then reevaluate the success of the Pickerelweed.

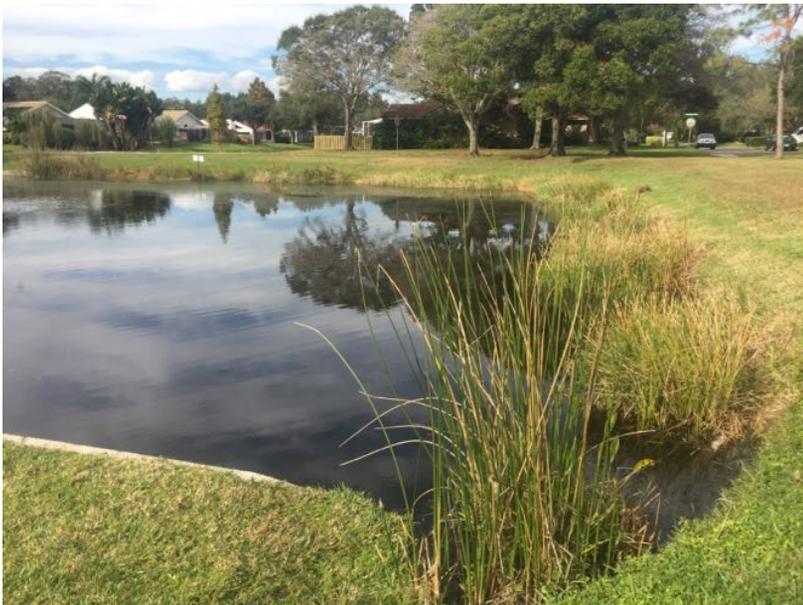
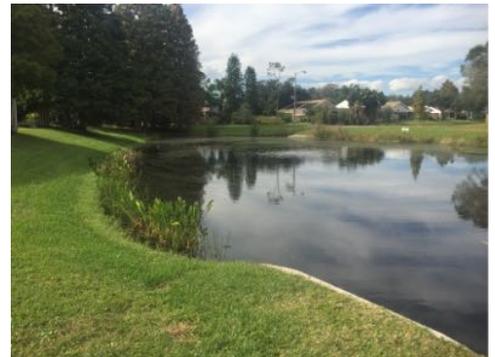
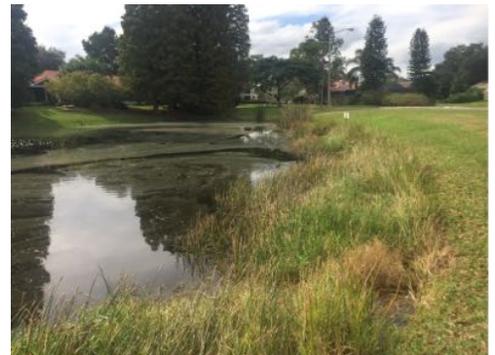
Site: 2

Comments: Site looks good

This site is in good condition. I notice a small area of Pickerelweed showing signs of disease. These plants are very likely to come back in the spring time. A film of pollen covered areas of the pond. The pollen will sink and decompose inside the pond.

2. This site is in good condition. I notice a small area of Pickerelweed showing signs of disease. These plants are very likely to come back in the spring time. A film of pollen covered areas of the pond. The pollen will sink and decompose inside the pond.

2. We will perform hand removal of invasive weeds as we closely monitor the diseased Pickerelweed.
3. Nothing required at this time.
4. Nothing required at this time.

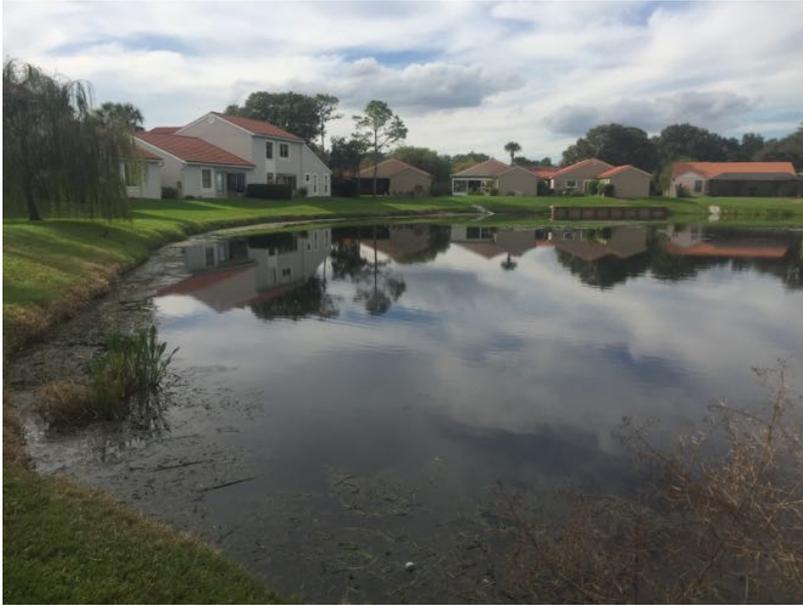
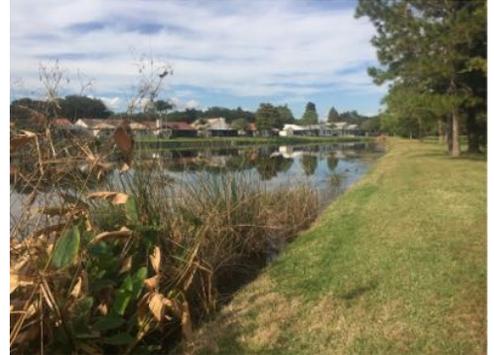
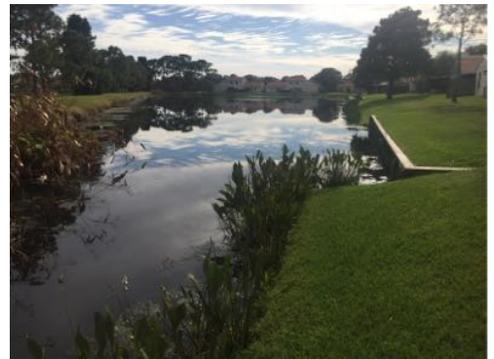
Site: 3

Comments: Site looks good

Shoreline weeds continue to decompose inside the lake. The planted aquatic vegetation is doing well. The floating duckweed has disappeared since last months treatments.

3. Shoreline weeds continue to decompose inside the lake. The planted aquatic vegetation is doing well. The floating duckweed has disappeared since last months treatments.

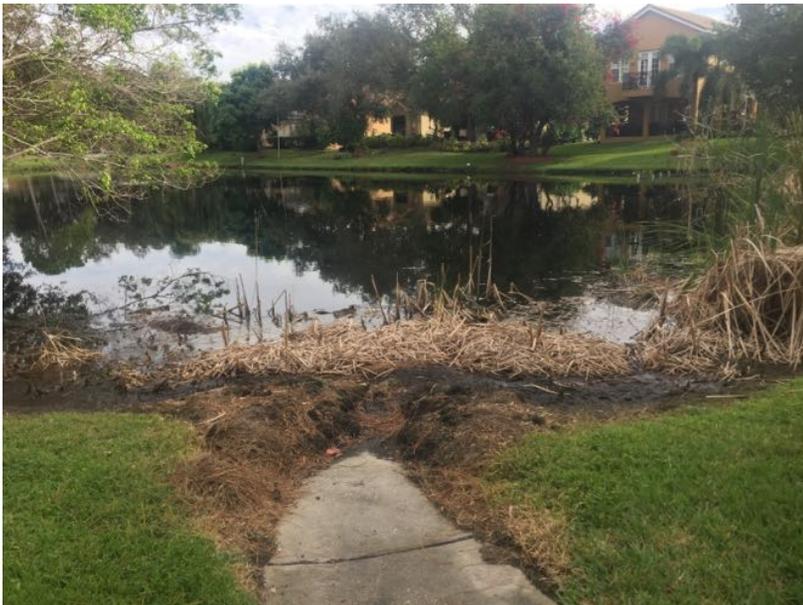
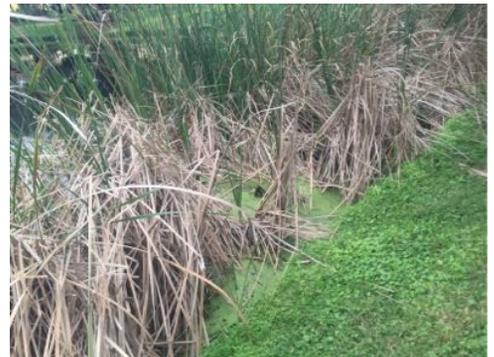
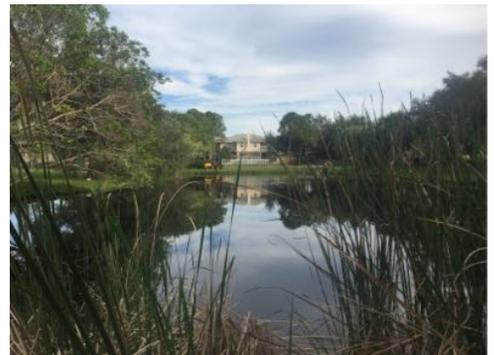
Site: 4

Comments: Site looks good

Cattails continue to decompose near inflow. Trace amounts of duckweed continue to grow inside cattails. Duckweed will be targeted if it becomes an issue inside retention pond.

4. Cattails continue to decompose near inflow. Trace amounts of duckweed continue to grow inside cattails. Duckweed will be targeted if it becomes an issue inside retention pond.

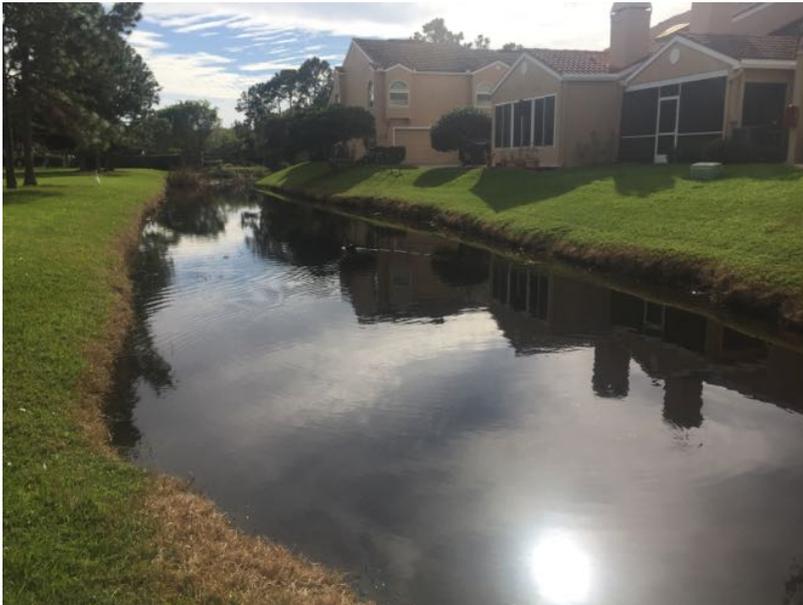
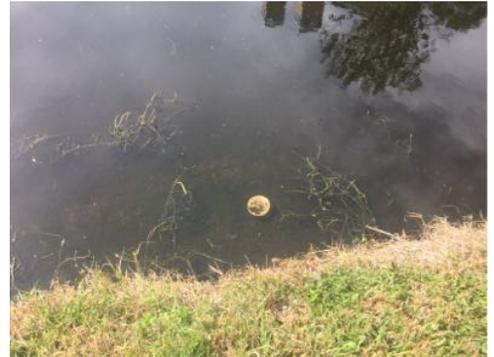
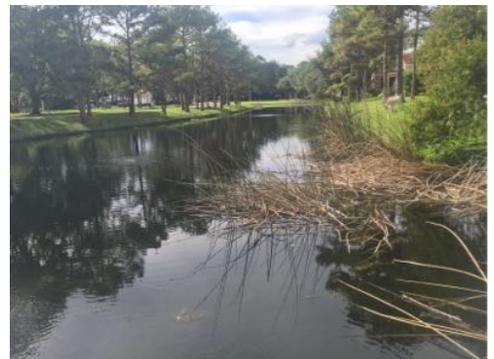
Site: 5

Comments: Site looks good

The finger shaped area of this retention pond has been an area with persistent algae blooms. Note the probiotics we have been using in the top right. This with our algacides have provided good control. The probiotics will help break down organic material and assist in reducing nutrient levels.

5. The finger shaped area of this retention pond has been an area with persistent algae blooms. Note the probiotic block we have been using in the top right. This with our algaecides have provided good control. The probiotics will help break down organic material and assist in reducing nutrient levels.

5. We will closely monitor the possible spread of duckweed.
6. We will continue to use probiotics, dye and nutrient reducers at this site.
7. Continued use of algaecides for better control.

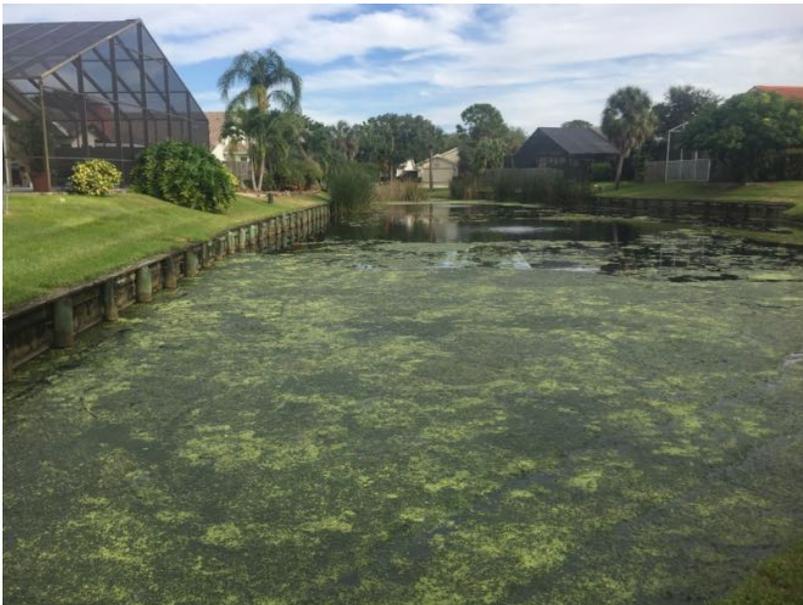
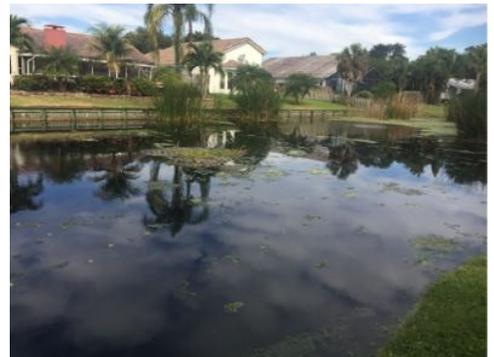
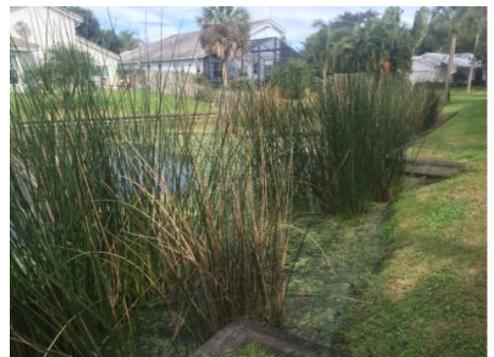
Site: 6

Comments: Requires attention

This pond has an algae and duckweed bloom. It was treated with an algacide, a duckweed contact and a nutrient reducer. We will continue dye use here. The turtles continue to use the floating mat as a resting place.

6. This pond has an algae and duckweed bloom. It was treated with an algaecide, a duckweed contact and a nutrient reducer. We will continue dye use here. The turtles continue to use the floating mat as a resting place.

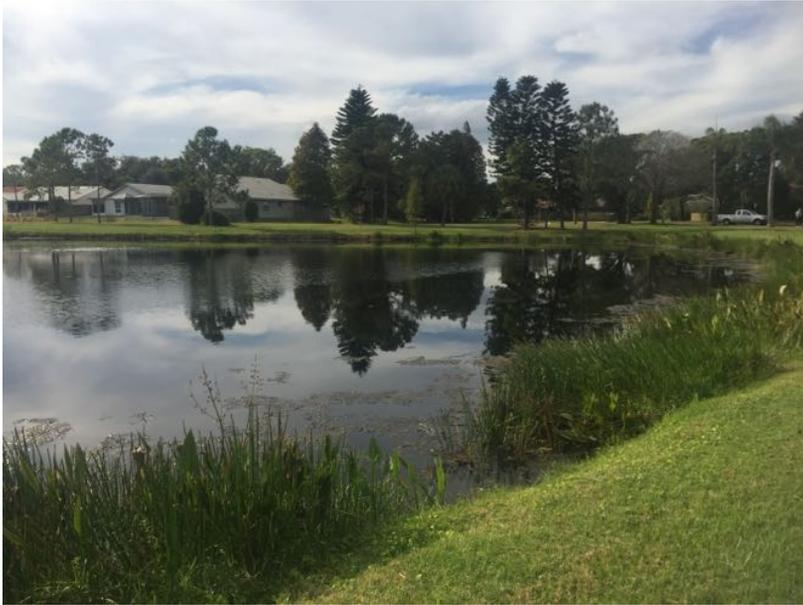
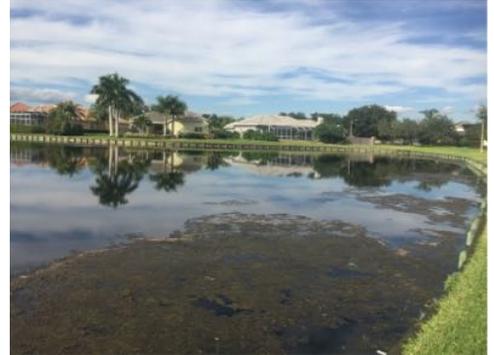
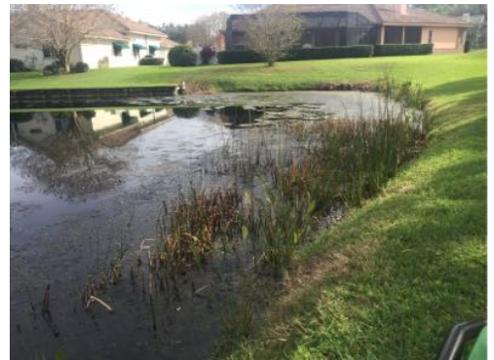
Site: 7

Comments: Requires attention

Algaecides from previous treatment are showing progress. We will continue to target growing algae. Duck Potato in the area of the Bulrush removal is beginning to spread.

7. Algaecides from previous treatment are showing progress. We will continue to target growing algae. Duck Potato in the area of the Bulrush removal is beginning to spread.

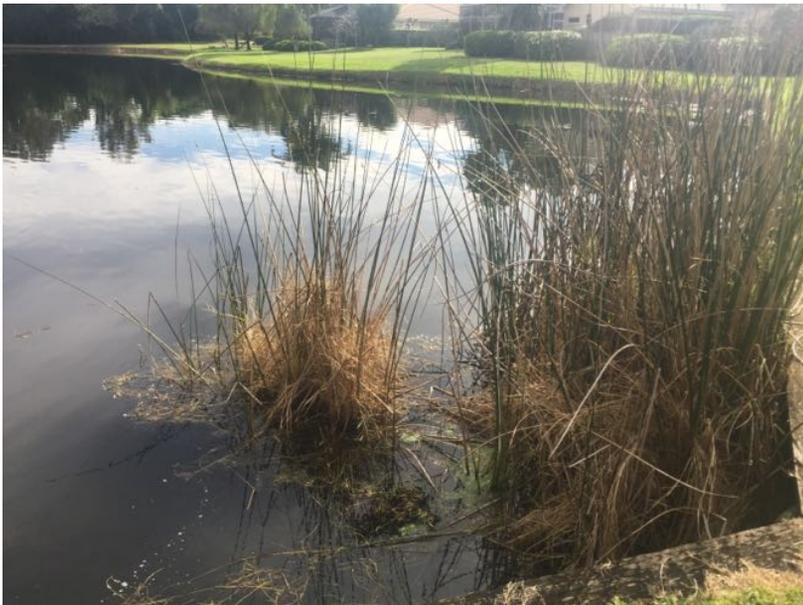
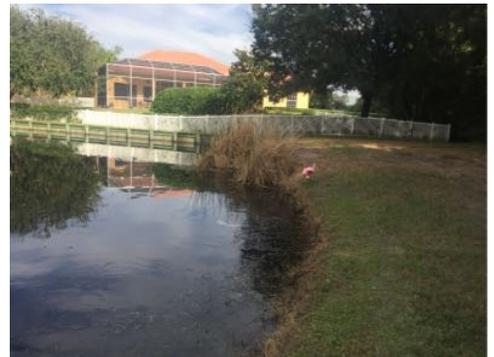
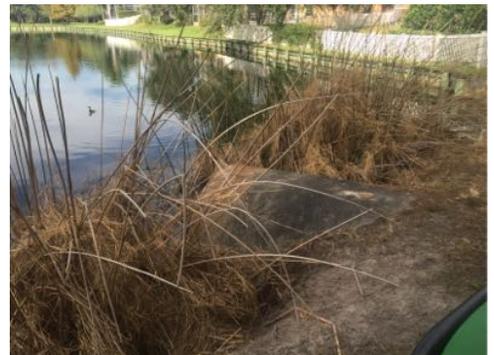
Site: 8

Comments: Site looks good

Selective spot spraying shows death of torpedograss near beneficials. The area near the outflow has been sprayed out to help increase flow during Summer storms.

8. Selective spot spraying shows death of torpedograss near beneficials. The area near the outflow has been sprayed out to help increase flow during Summer storms

8. Recommend removing/spraying vegetation such as Brazilian Peppers and Australian Pines that are growing near the outflow pipe near the conservation area. This will be preventative for flooding and damage to your control structure.

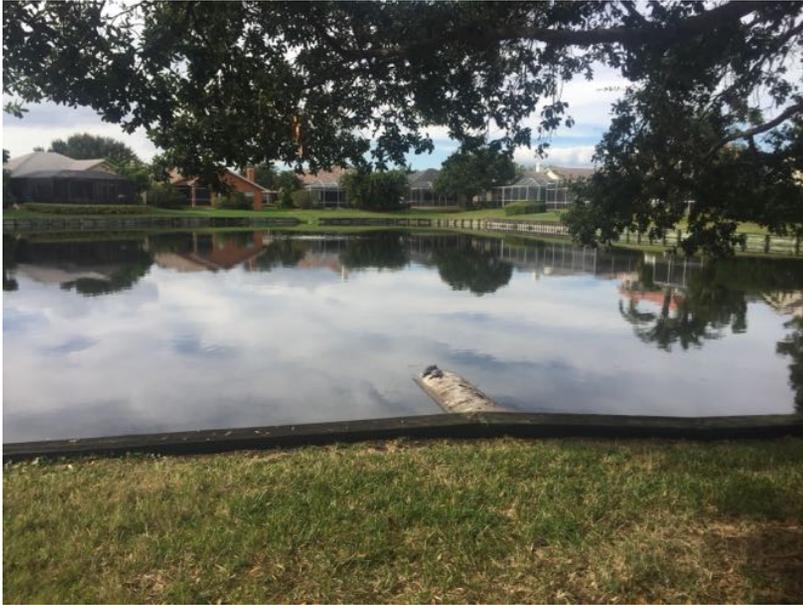
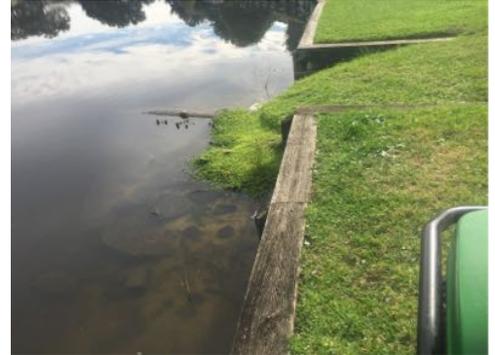
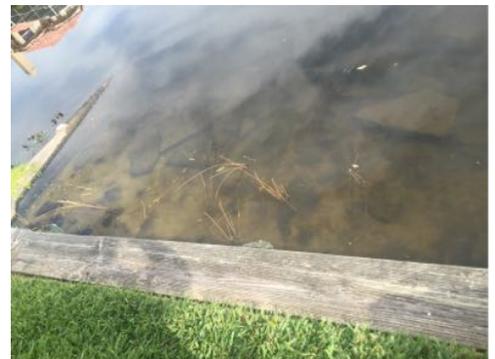
Site: 9

Comments: Site looks good

Smooth Cord Grass and Black Needle Rush has survived it's first month as a test plot. We will not use herbicide near the test plots until Spring. The new plants will continue to proliferate very slowly as it is Winter.

9. Smooth Cord Grass and Black Needle Rush has survived it's first month as a test plot. We will not use herbicide near the test plots until Spring. The new plants will continue to proliferate very slowly as it is Winter.

- 9 and 10. Recommend educating any concerned homeowners why the plants will be growing slowly for the next few Winter months. Ex: cold weather, less sunlight, less rainfall.

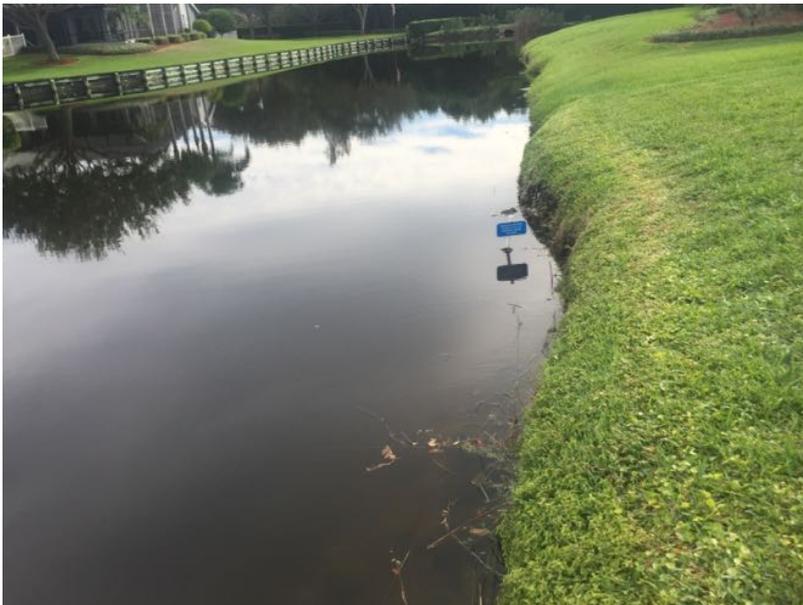
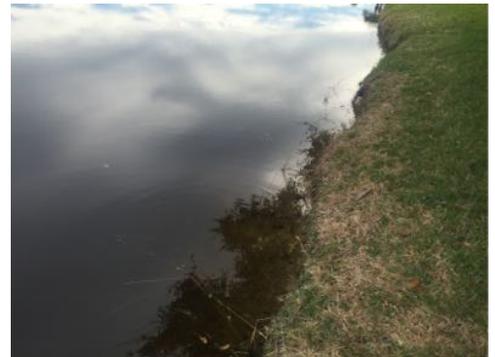
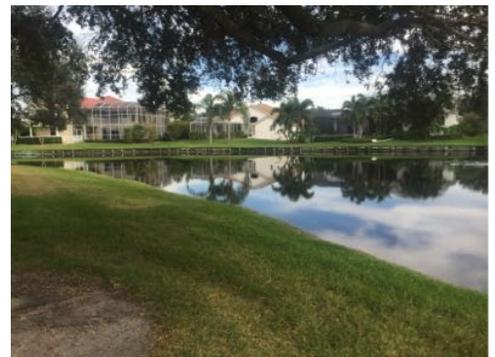
Site: 10

Comments: Site looks good

Smooth Cord Grass and Black Needle Rush has survived it's first month as a test plot. We will not use herbicide near the test plots until Spring. The new plants will continue to proliferate very slowly as it is Winter.

10. Smooth Cord Grass and Black Needle Rush has survived it's first month as a test plot. We will not use herbicide near the test plots until Spring. The new plants will continue to proliferate very slowly as it is Winter.
