# Placido Bayou Community Association Waterway Inspection Report

**Reason for Inspection:** Customer Request

**Inspection Date:** 5/5/2015

Kyle Vincent, Service Manager  
Aquatic Systems, Inc. – St. Petersburg Field Office  
Corporate Headquarters  
2100 N.W. 33<sup>rd</sup> Street, Pompano Beach, FL 33069  
1-800-432-4302

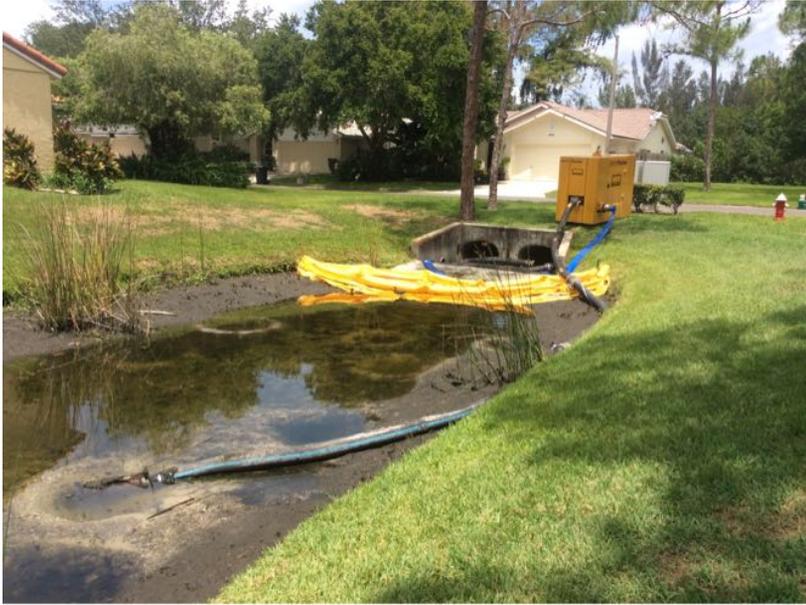
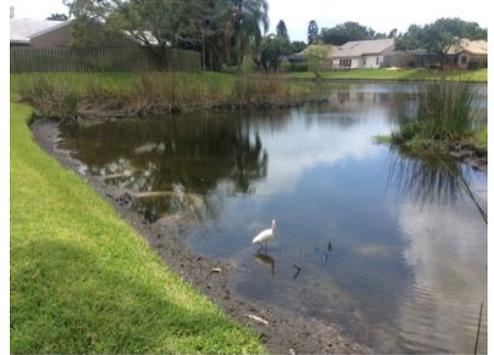
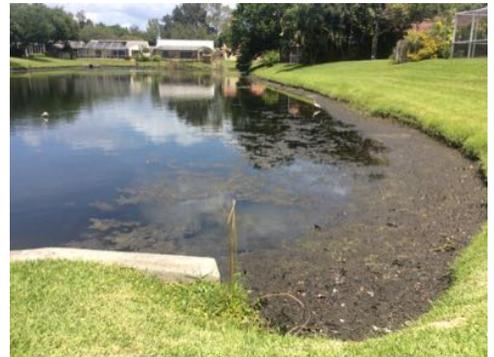
Site: 1

**Comments:** Site looks good  
Day #1 of pumping down Sites #1, #2 and #3.

Overall things continue to look good moving into the month of May. At this time we have limited herbicide application on sites #1, #2 and #3 until the work being performed by Cardno Entrix is complete. Planting for these sites is pending completion of the bank project and until a consensus is reached regarding vegetation choice between all three (3) parties involved. Replanting for sites #4, #6 and #10 in the form of test plots is being scheduled as soon as possible. This may occur as early as this week (5/11-5/15). We are awaiting confirmation on the availability of plants selected.

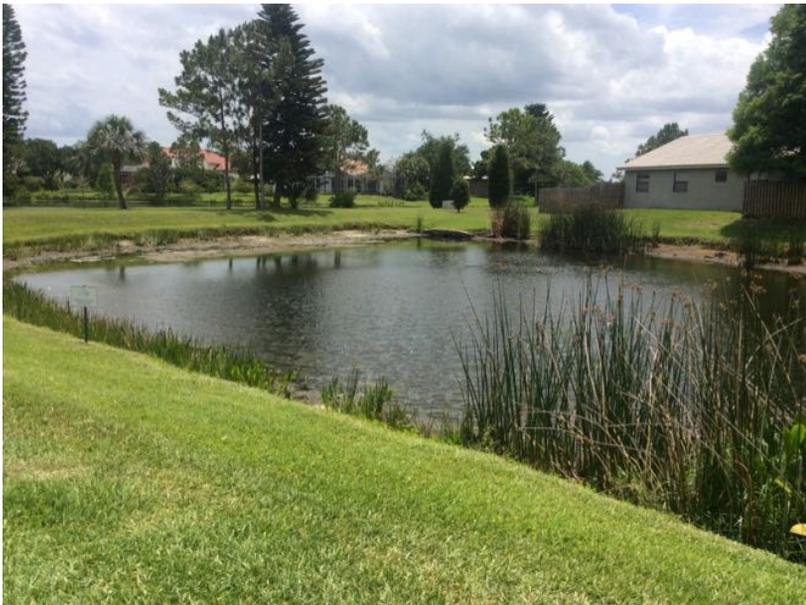
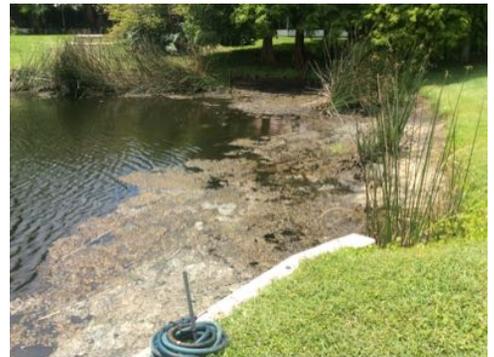
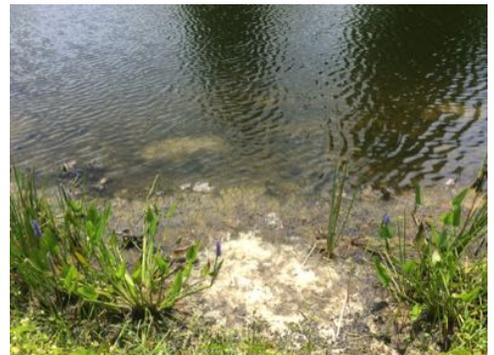
Site: 2

**Comments:** Normal growth observed  
Shoreline plants are now exposed. Likely stressed to some degree.

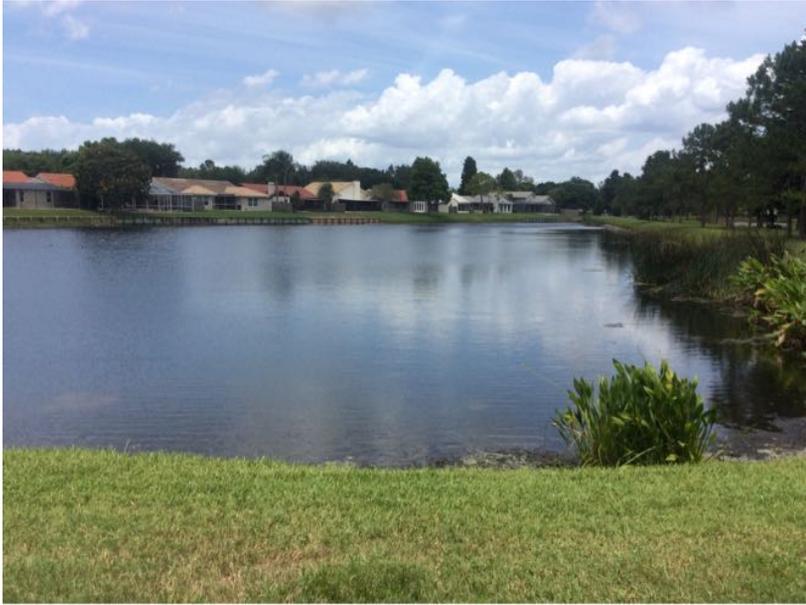
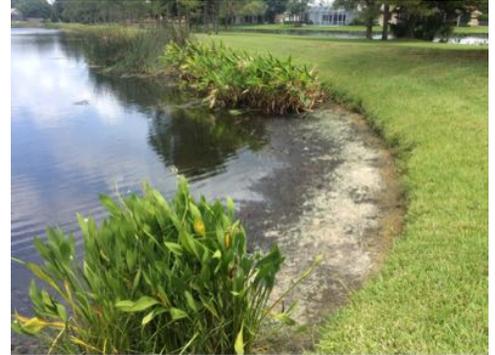
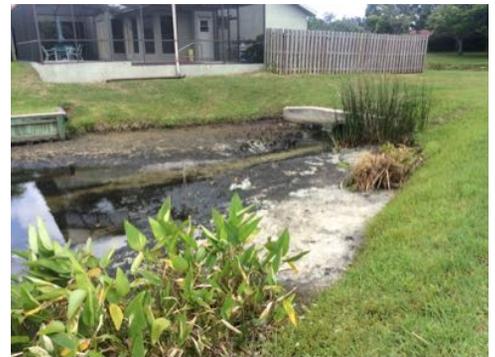
Site: 3

**Comments:** Site looks good

North end of site #3 is clearly in need of excavation!

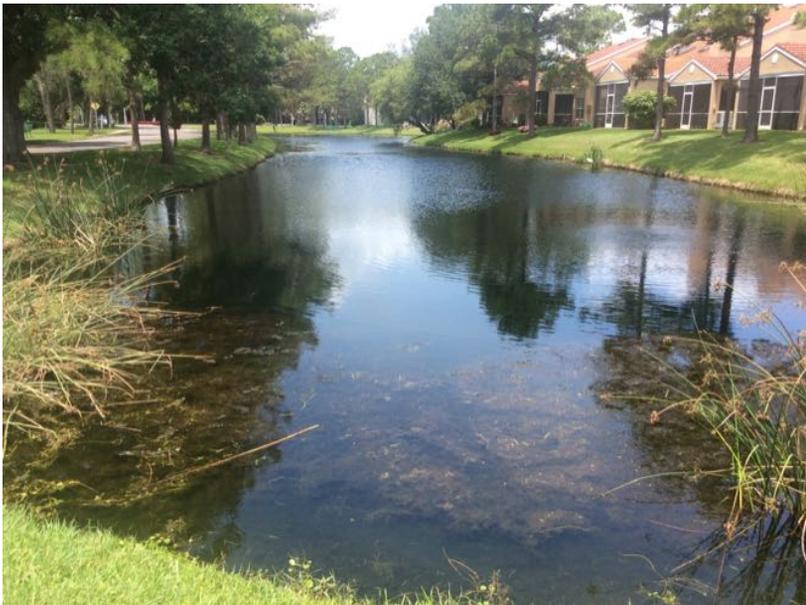
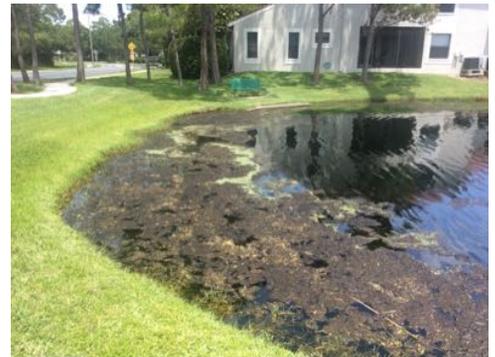
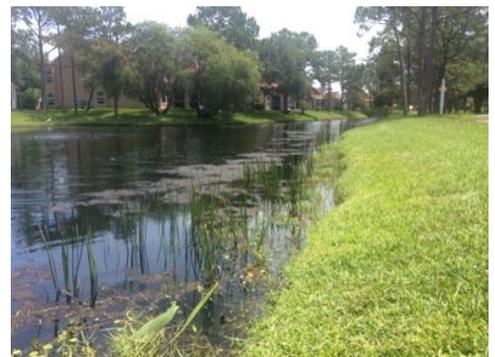
Site: 4

**Comments:** Normal growth observed

Gulf Spikerush can be seen thriving in some areas now. Algae and submersed weeds also developing however. Depending on the replanting schedule a follow up treatment to the application made on 5/4 may be made next scheduled visit.

To that end, we would strongly recommend that we begin with sites #4 and #6 to get some semblance of a baseline to work with to more accurately monitor the progress being achieved with the existing regimens. While the PVC method can be used as an indication of the direction of movement, its accuracy and ability to paint a vivid picture is somewhat lacking.

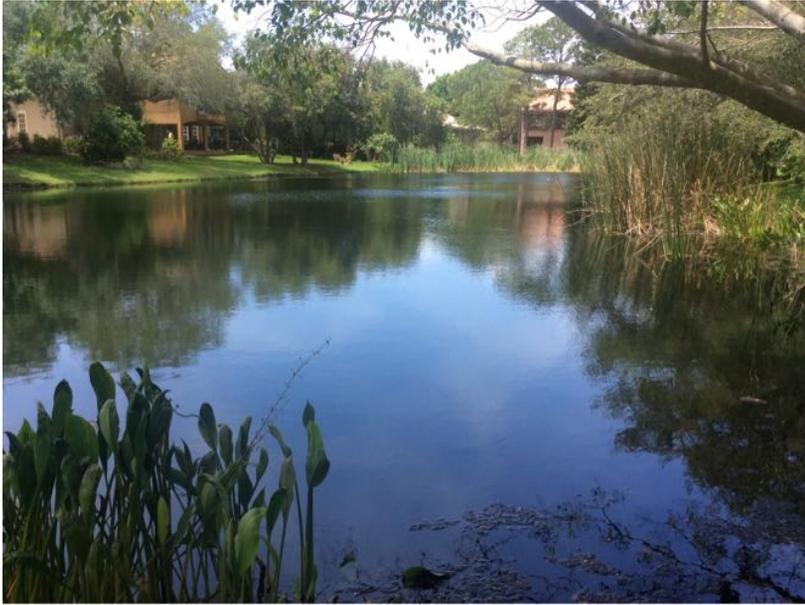
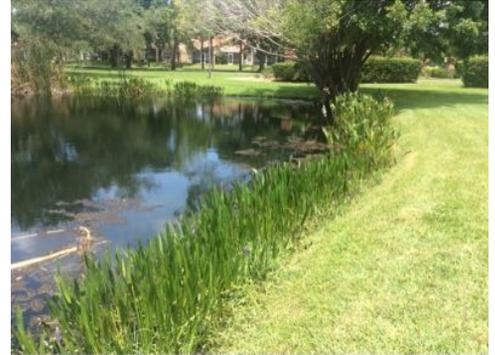
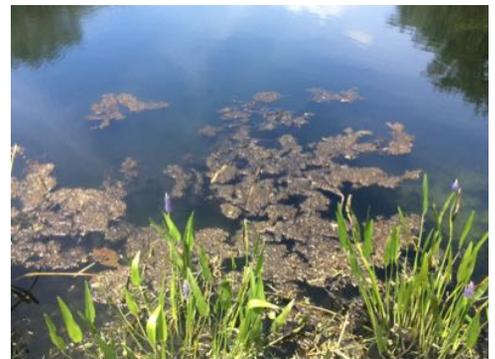
Site: 5

**Comments:** Normal growth observed

Trace algae observed. Normal at this time of year. Algaecide treatment was performed on 5/4. Results to show in 7-10 days.

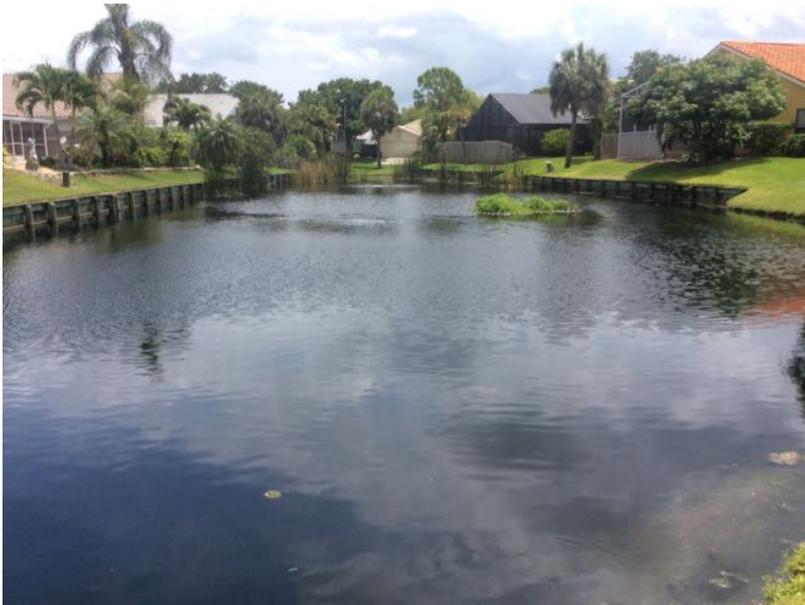
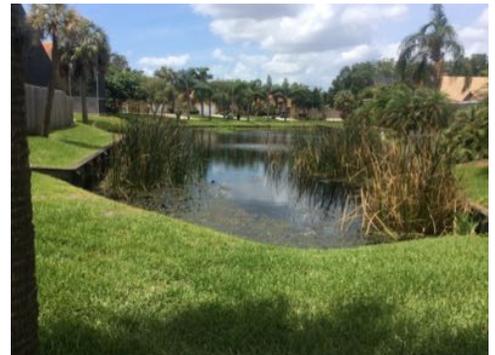
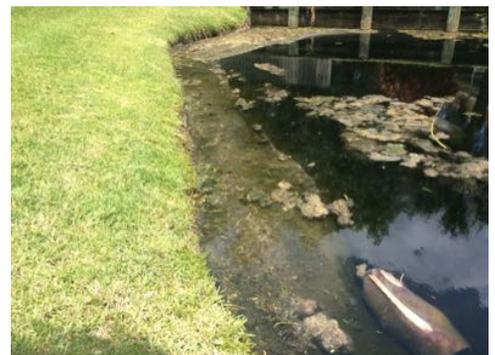
Site: 6

**Comments:** Normal growth observed

Pond liner is a potential cause for planting failure and concern for replanting. Will need to discuss concerns and options before replanting occurs.

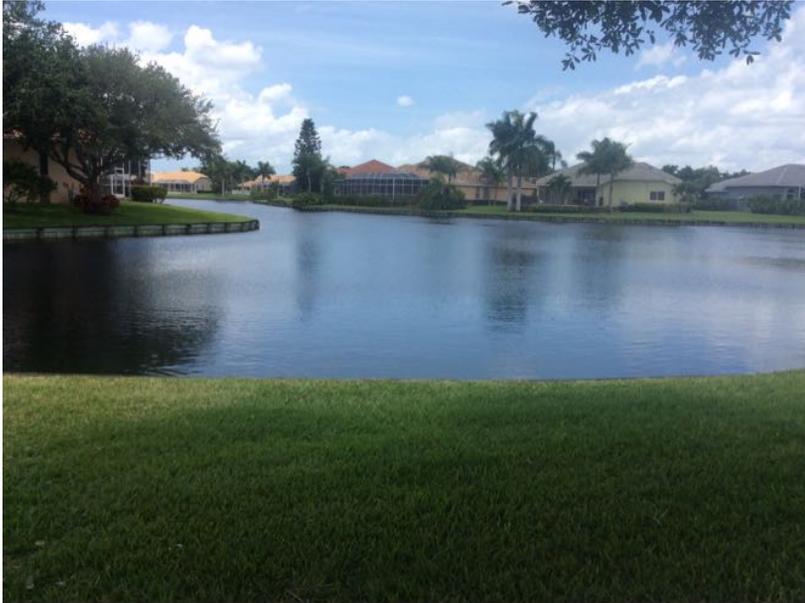
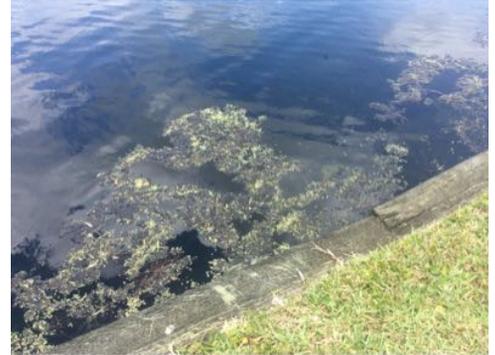
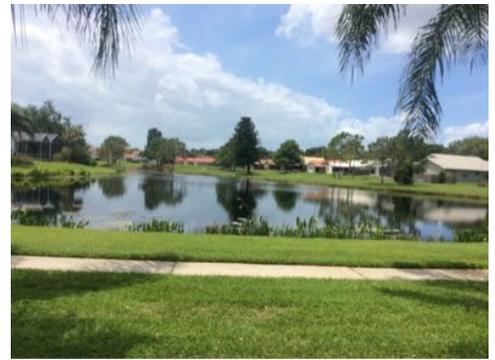
Site: 7

**Comments:** Normal growth observed

Overall condition is excellent. Trace algae and duckweed still present. Will continue to monitor for blooms.

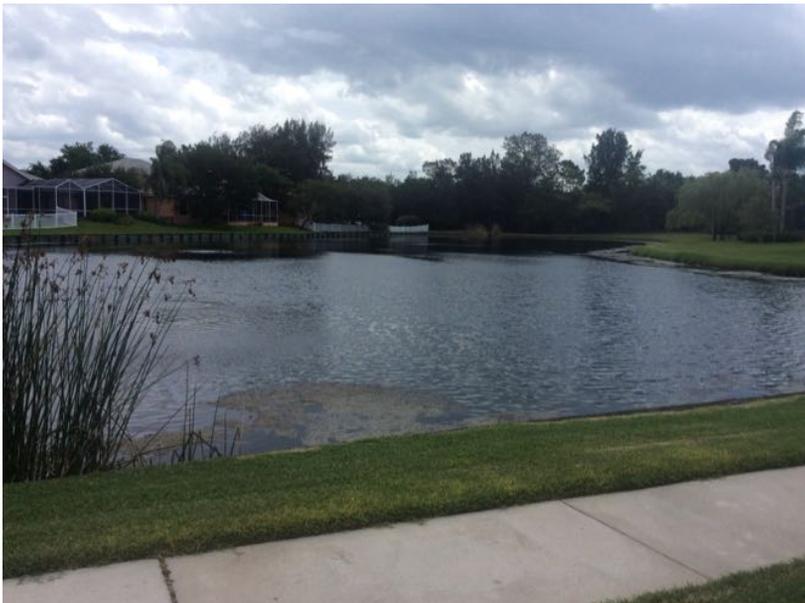
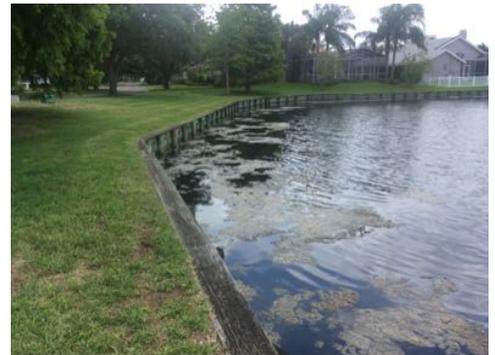
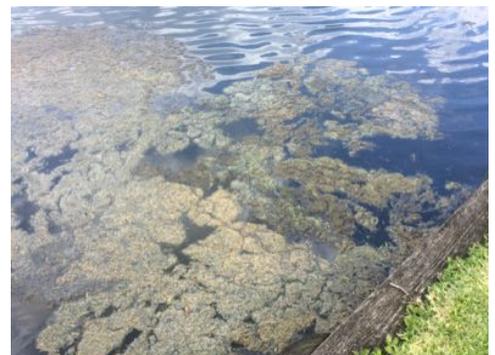
Site: 8

**Comments:** Normal growth observed

Site was treated the previous day with peroxide based algacide. Discoloration is indicative of an effective treatment. Results in 7-10 days.

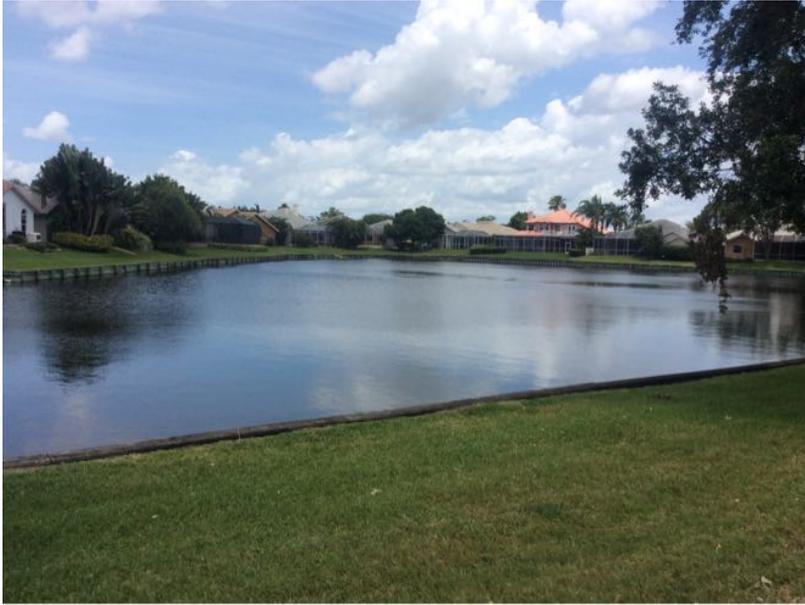
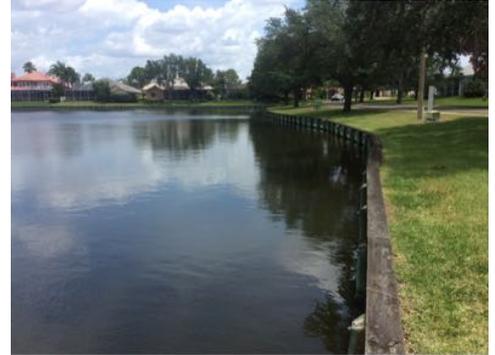
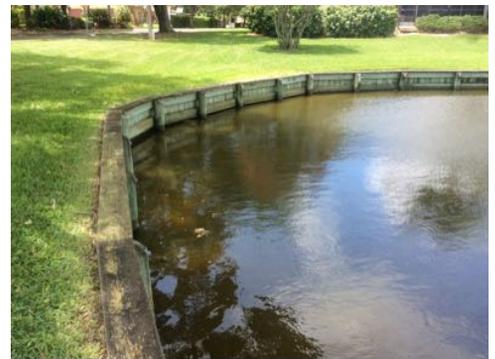
Site: 9

**Comments:** Site looks good

Alum treatment for sites #9 and #10 are being scheduled as soon as possible.

Salinity levels for all sites have been taken and are listed below for your records. Delivery of Alum for sites #9 and #10 is also being scheduled as soon as possible. At this point we are simply waiting on delivery confirmation from the delivery company.

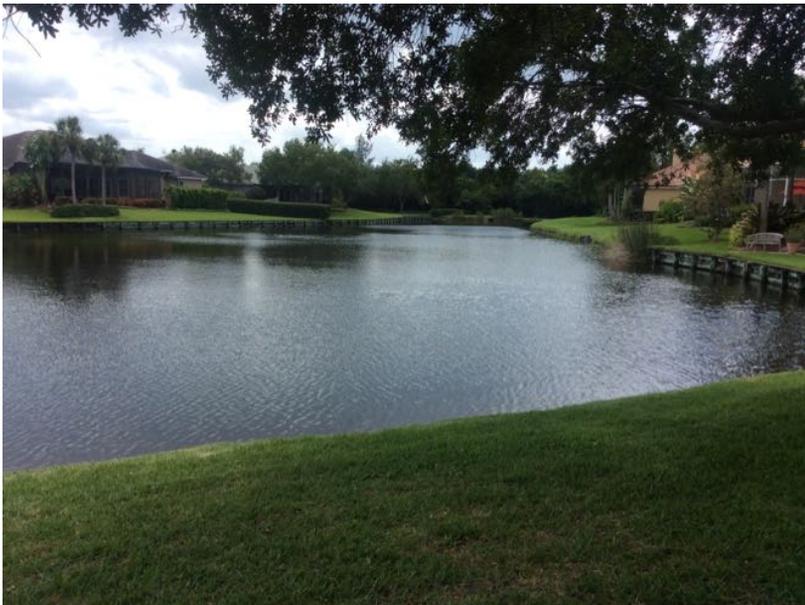
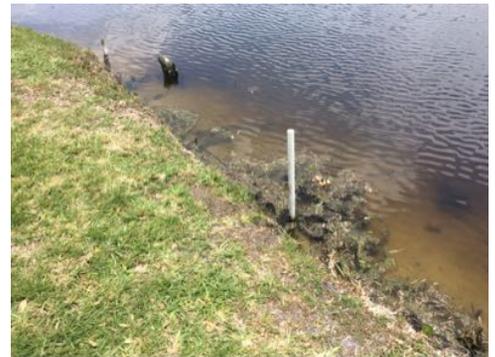
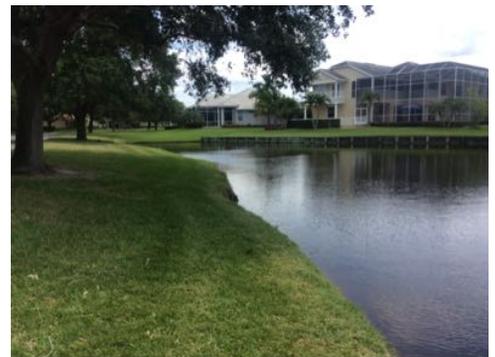
Site: 10

**Comments:** Site looks good

Higher salinity levels will require a more salt tolerant plant species for the replanting.
