Placido Bayou Community Association Waterway Inspection Report

Reason for Inspection: Routine Scheduled - Monthly

Inspection Date: 12/12/2016

Aquatic Systems, Inc. – St. Petersburg Field Office

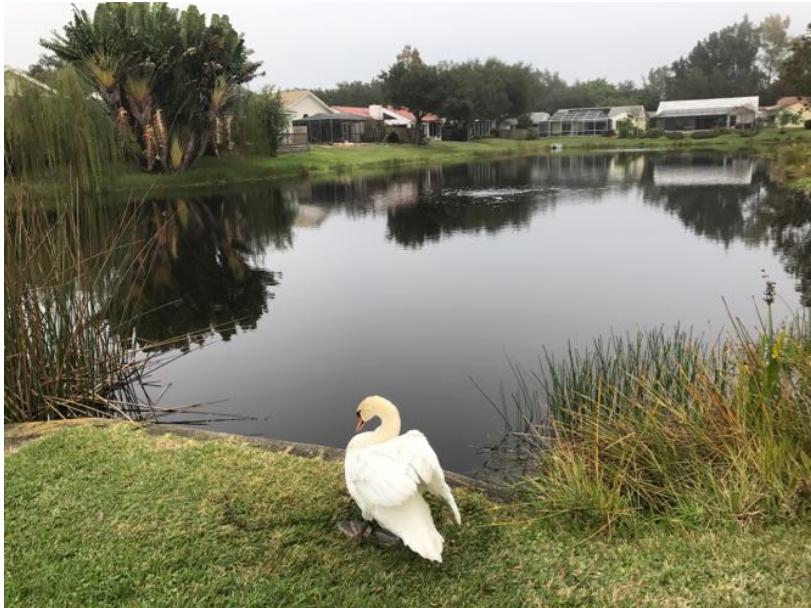
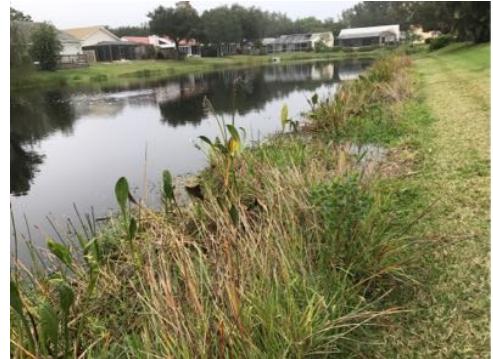
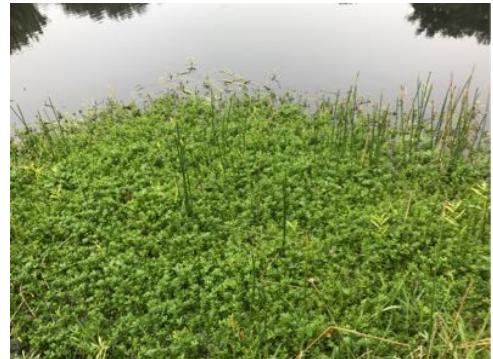
Site: 1

Site looks good
Beneficial native Bacopa on the bottom right is nicely filling in areas between planted Gulf Spikerush. Bacopa is especially important as it helps prevent invasive weeds such as Torpedograss from creeping in the lake.

1. Beneficial native Bacopa on the bottom right is nicely filling in areas between planted Gulf Spikerush. Bacopa is especially important as it helps prevent invasive weeds such as Torpedograss from creeping in the lake.

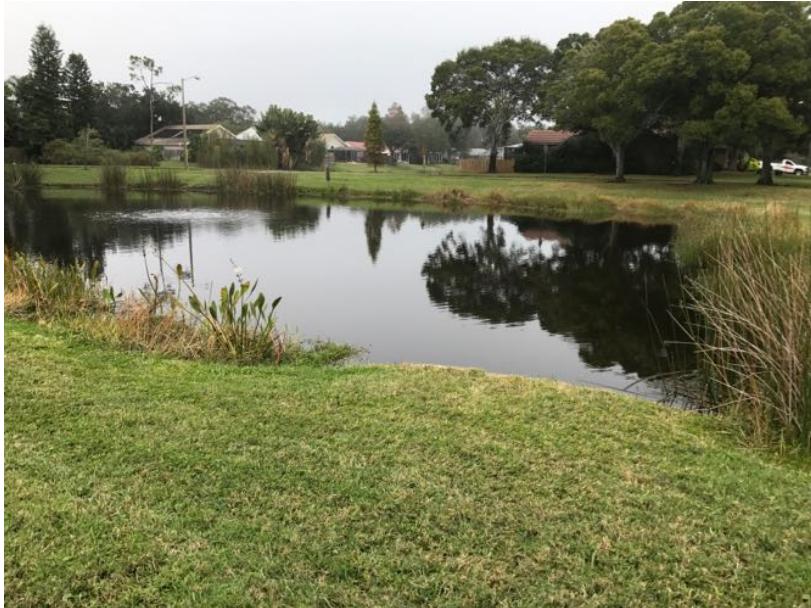
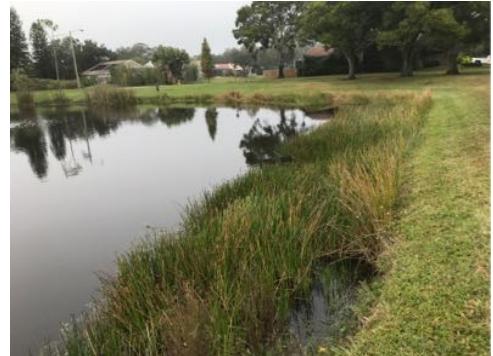
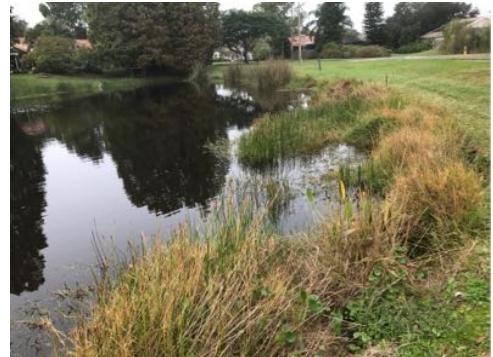
Site: 2

Site looks good
Hand removal of Torpedograss within the beneficial plants occurred in December. The areas of Gulf Spikerush are nicely filling in.

2. Hand removal of Torpedograss within the beneficial plants occurred in December. The areas of Gulf Spikerush are nicely filling in.
3. Water level has dropped in this pond and the cooler weather is helping efficiency of algaecides.

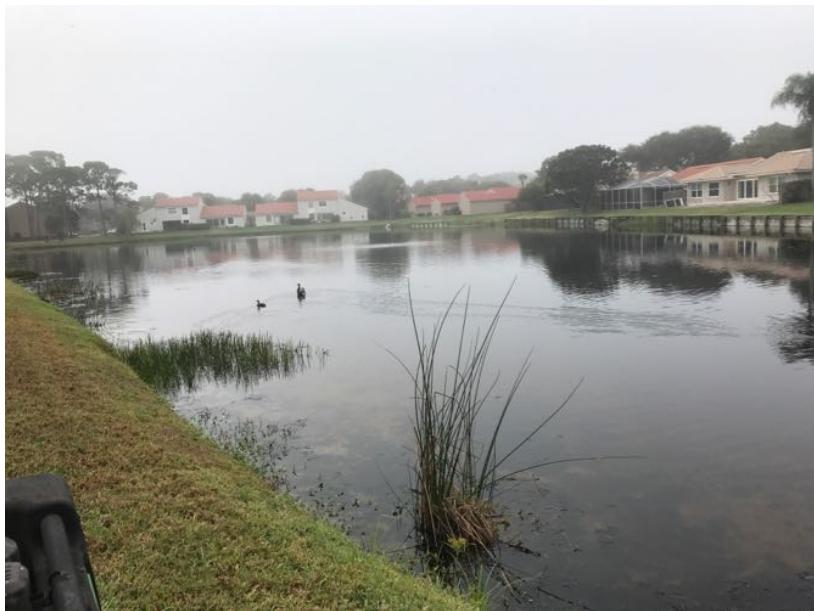
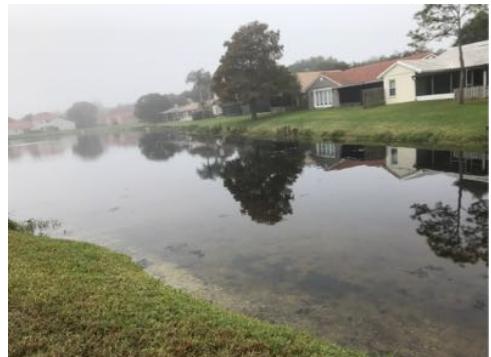
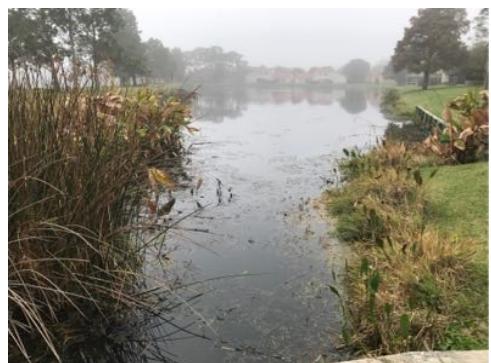
Site: 3

Site looks good
Water level has dropped in this pond and the cooler weather is helping efficiency of algaecides.

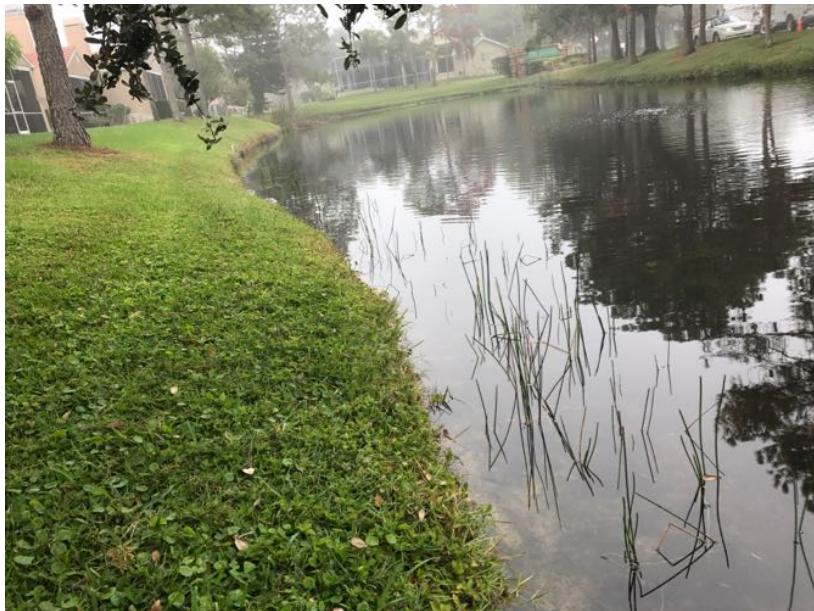
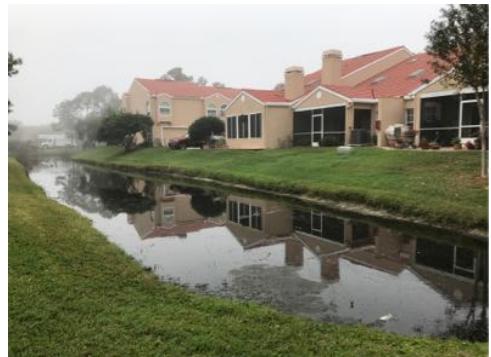
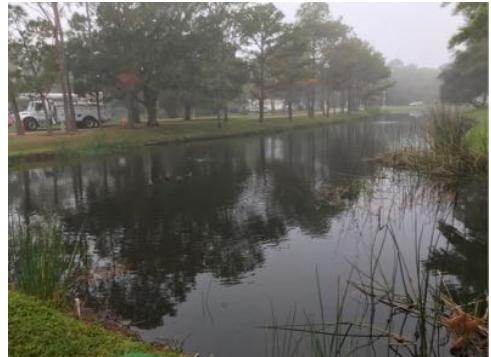
Site: 4

Site looks good
Gulf Spikerush is beginning to spread and fill in from recent planting. Areas of the finger are beginning to dry up as seen in top right.

4. Gulf Spikerush is beginning to spread and fill in from recent planting. Areas of the finger are beginning to dry up as seen in top right.
5. Water level is low and mud is beginning to expose. Tree limb in bottom right fell into the lake, but I believe this issue has been addressed.

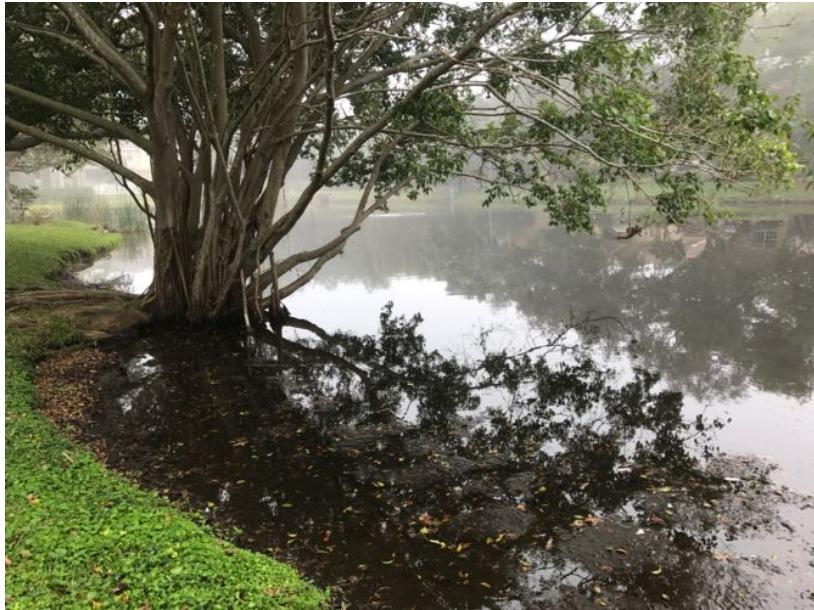
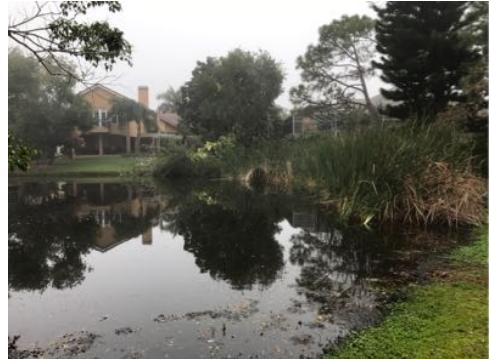
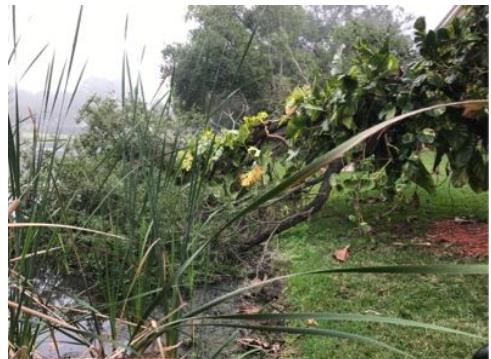
Site: 5

Site looks good
Water level is low and mud is beginning to expose. Tree limb in bottom right fell into the lake, but I believe this issue has been addressed.

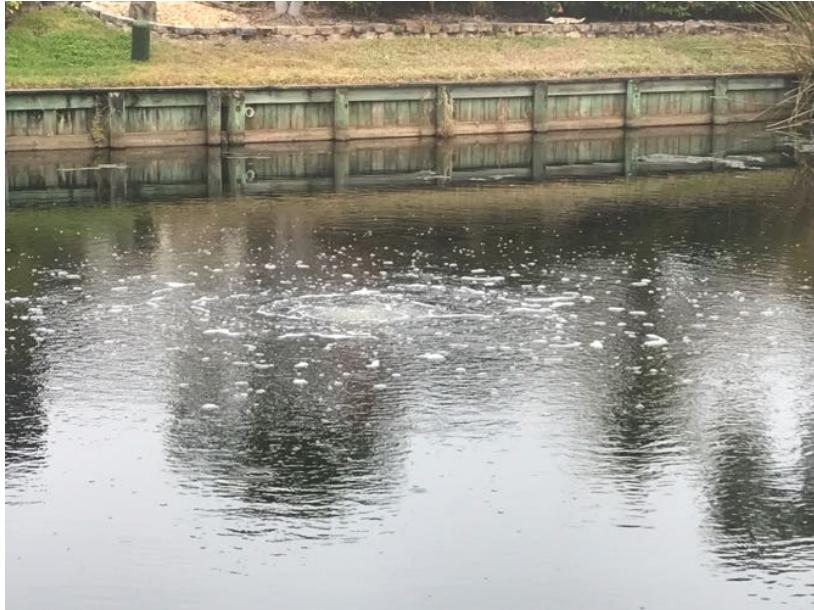
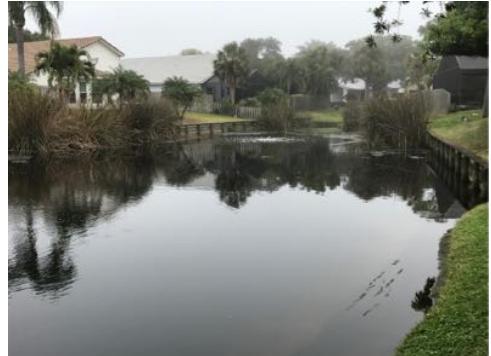
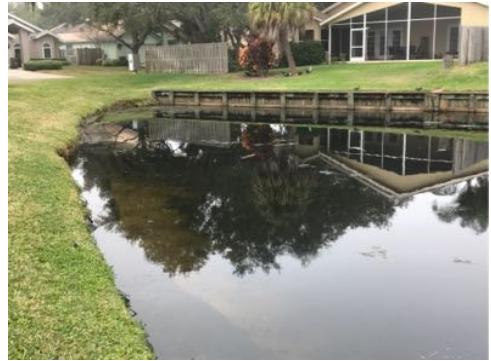
Site: 6

Site looks good
Waterway is looking great.

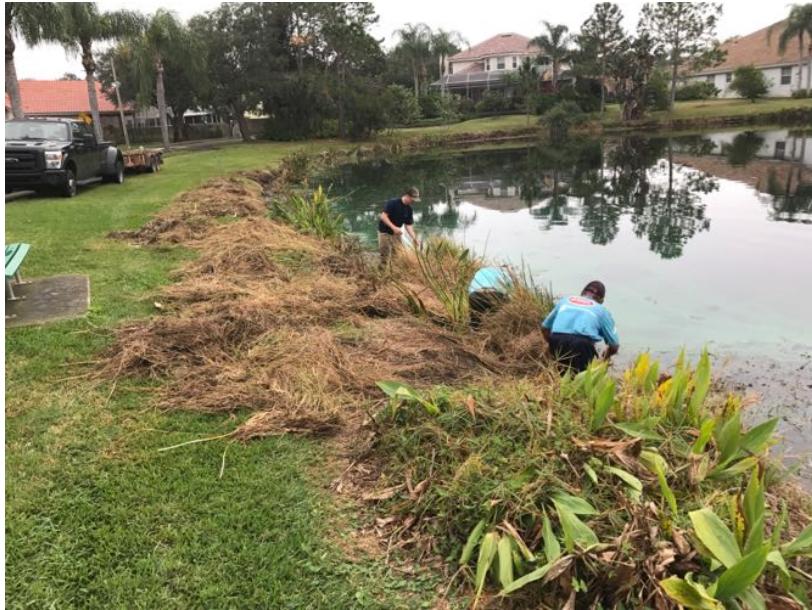
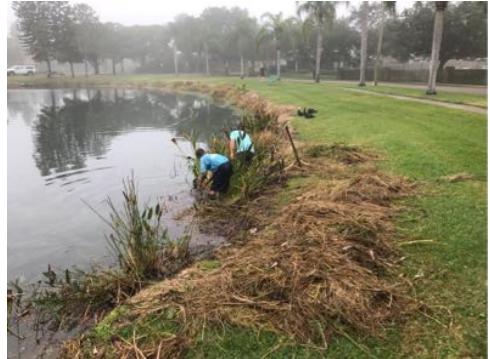
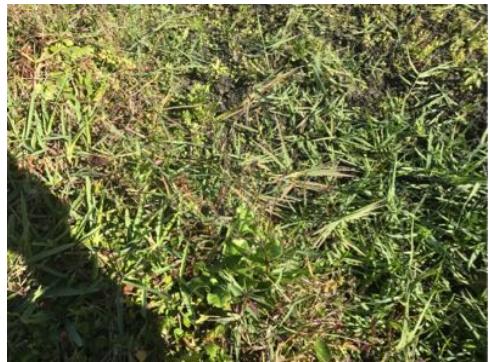
Site: 7

Site looks good

Physical removal of invasive weeds and creating a buffer line between aquatic and terrestrial plants will allow for reduced herbicide use and reduced physical removals. Bottom right shows how Torpedograss will spread to the lake without a buffer line.

6. Waterway is looking great.
7. Physical removal of invasive weeds and creating a buffer line between aquatic and terrestrial plants will allow for reduced herbicide use and reduced physical removals. Bottom right shows how Torpedograss will spread to the lake without a buffer line.

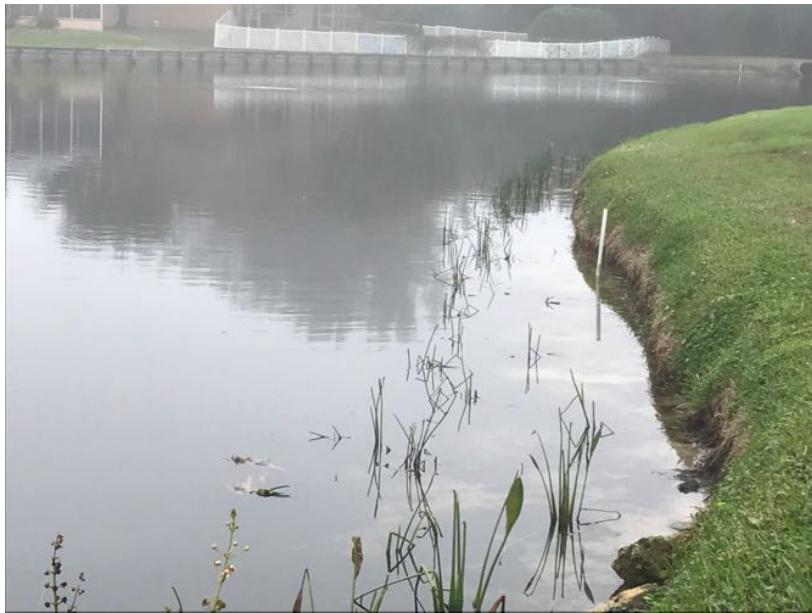
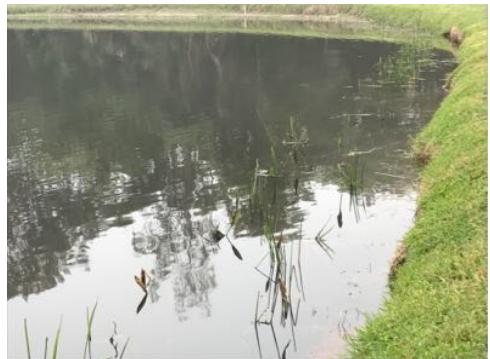
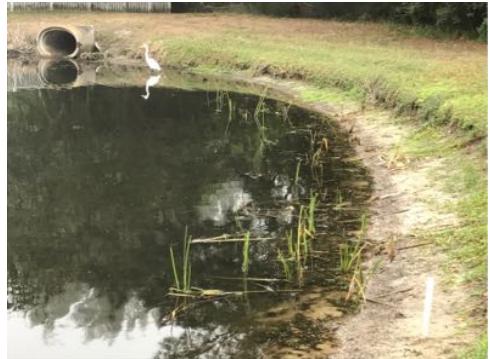
Site: 8

Site looks good

Water levels are dropping and the Duck Potato and Gulf Spikerush are spreading nicely. Note how the plants were properly planted minimum of 12 inches from the bank. This will allow for a nice buffer area to prevent Torpedograss and Saint Augustine from entering the lake.

8. Water levels are dropping and the Duck Potato and Gulf Spikerush are spreading nicely. Note how the plants were properly planted minimum of 12 inches from the bank. This will allow for a nice buffer area to prevent Torpedograss and Saint Augustine from entering the lake.

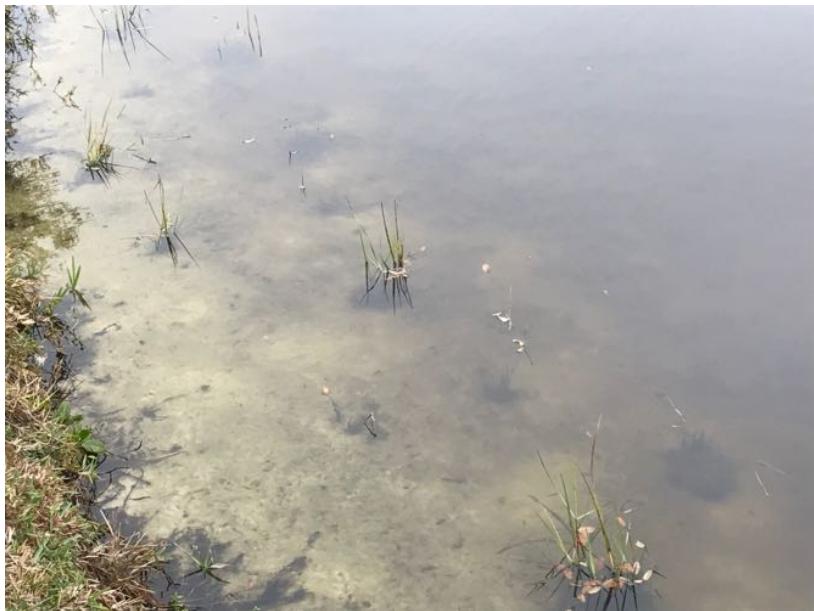
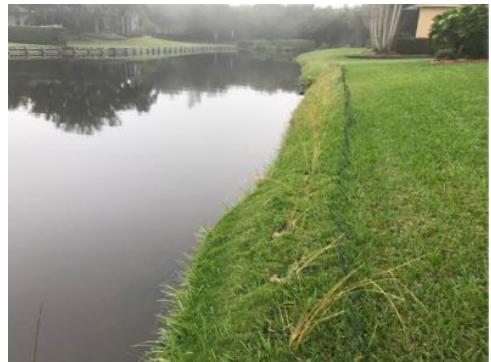
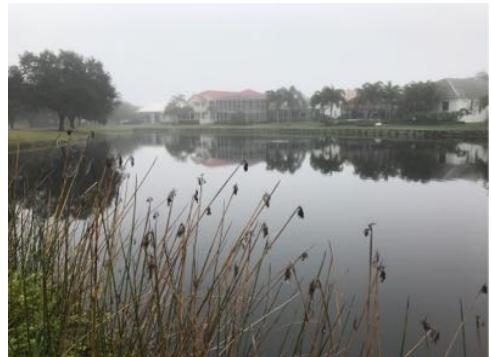
Site: 10

Site looks good

Smooth Cordgrass is showing a great survival rate. The Vetiver Grass is surviving and maintenance is to be provided by the homeowner as it is a terrestrial plant.

1. Monitor Gulf Spikerush planted in the bare areas in December at no cost to customer.
2. Monitor beneficial plants for invasive weed growth.
3. Monitor algae growth and invasive weeds growing near beneficial plants.
4. Monitor recent planting for success. Plants are looking good as of now. Continue probiotics.
5. No action required.
6. Continue probiotics.
7. Maintain buffer line created to reduce invasive weeds from entering the lake.
8. Monitor recent plantings for success. Plants are looking good as of now.
9. No action required.
10. Monitor recent planting for success. Recommend speaking with homeowner on how to properly maintain Vetiver Grass.

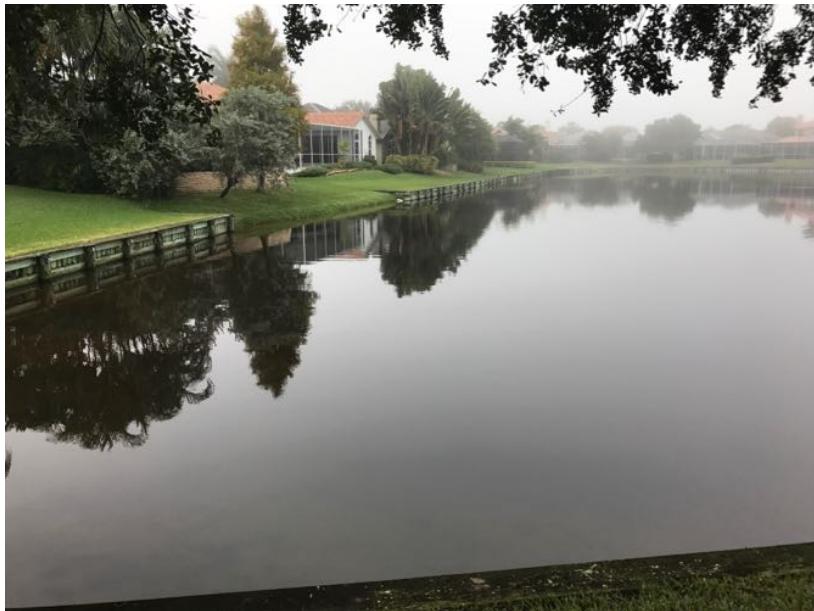
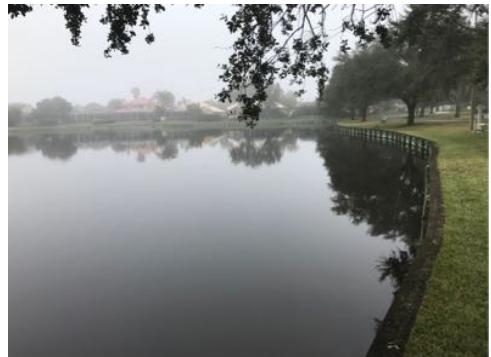
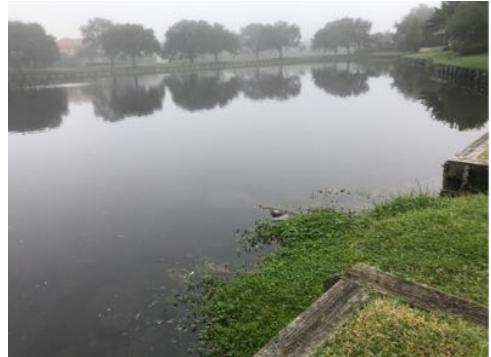
Site: 9

Site looks good

Bacopa has filled in the small area near the inflow where Cattails used to be.

9. Bacopa has filled in the small area near the inflow where Cattails used to be.
10. Smooth Cordgrass is showing a great survival rate. The Vetiver Grass is surviving and maintenance is to be provided by the homeowner as it is a terrestrial plant.
