Placido Bayou

Standard Lake Assessment

Sample date: 10/11/2017

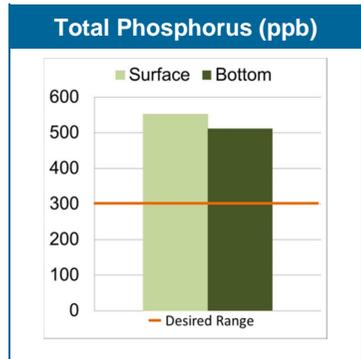
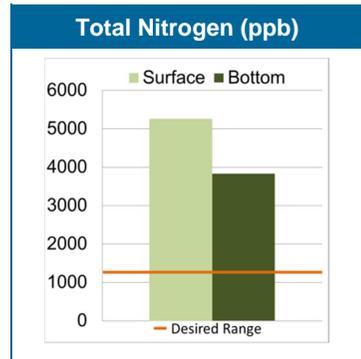
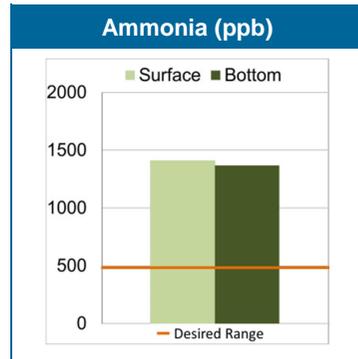
Test	Desired Range	Site 1		This lake is:
		Surface	Bottom	
Nutrients - Total Phosphorus	< 300 ppb	552	512	High
Nutrients - Total Nitrogen	400-1200 ppb	5260	3830	High
Nutrients - Ammonia	< 500 ppb	1410	1370	High
Water Clarity - Secchi Depth	≥ 4 Feet	3		Low

Water quality analysis suggests that Site 1 is experiencing elevated nutrient levels. Lakes with high nutrient concentrations are likely to experience algal blooms. Phosphorus, in particular, is often the limiting nutrient that fuels algal growth. Since algae use these nutrients for food, algae abundance is often correlated with nutrient availability.

- Recommendations for This Lake**
- Alum for Phosphorus Reduction
 - On-going water quality monitoring

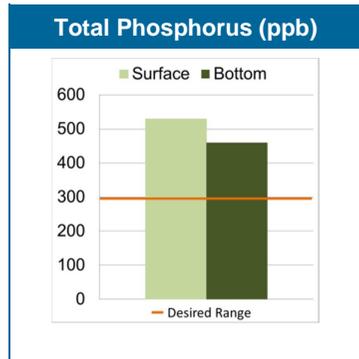
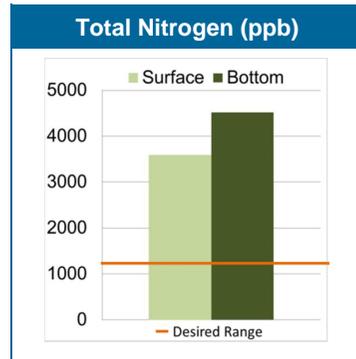
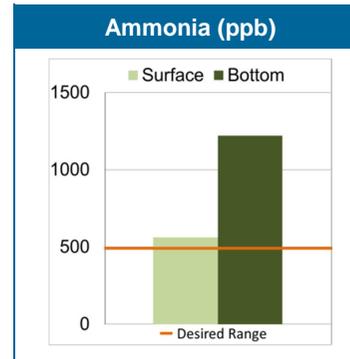
Test	Desired Range	Site 2		This lake is:
		Surface	Bottom	
Nutrients - Total Phosphorus	< 300 ppb	530	460	High
Nutrients - Total Nitrogen	400-1200 ppb	3585	4520	High
Nutrients - Ammonia	< 500 ppb	560	1220	High
Water Clarity - Secchi Depth	≥ 4 Feet	3		Low

Water quality analysis suggests that Site 2 is experiencing elevated nutrient levels. Lakes with high nutrient concentrations are likely to experience algal blooms. Phosphorus, in particular, is often the limiting nutrient that fuels algal growth. Since algae use these nutrients for food, algae abundance is often correlated with nutrient availability.

It is also important to note that Site 2 is at risk of oxygen stress. By installing aeration, oxygen levels could be restored for a healthy ecosystem.

- On-going water quality monitoring

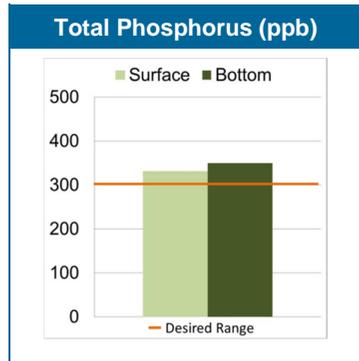
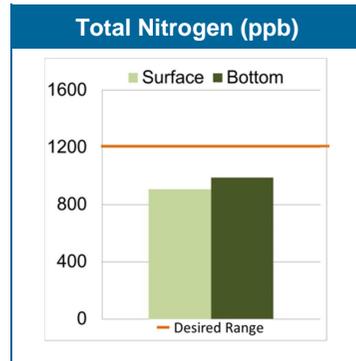
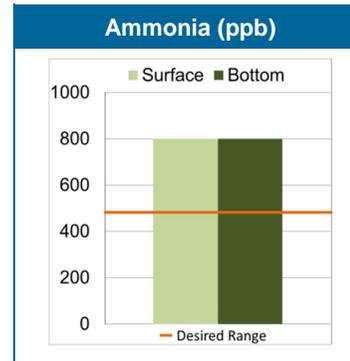
Test	Desired Range	Site 3		This lake is:
		Surface	Bottom	
Nutrients - Total Phosphorus	< 300 ppb	331	350	High
Nutrients - Total Nitrogen	400-1200 ppb	905	988	Normal
Nutrients - Ammonia	< 500 ppb	800	800	High
Water Clarity - Secchi Depth	≥ 4 Feet	3		Low

Observations
 Water quality analysis suggests that Site 3 is experiencing elevated nutrient levels. Lakes with high nutrient concentrations are likely to experience algal blooms. Phosphorus, in particular, is often the limiting nutrient that fuels algal growth. Since algae use these nutrients for food, algae abundance is often correlated with nutrient availability.

- On-going water quality monitoring

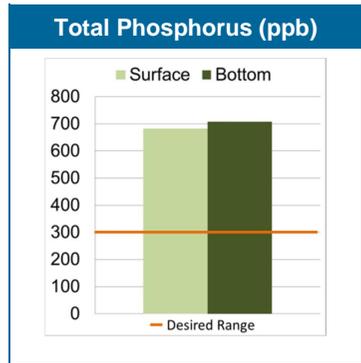
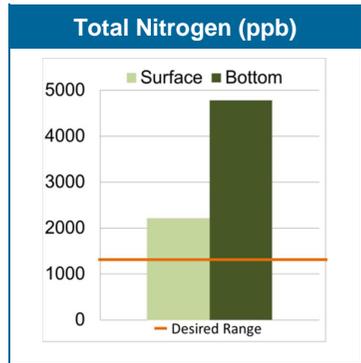
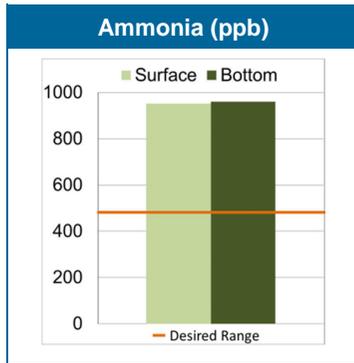
Test	Desired Range	Site 4		This lake is:
		Surface	Bottom	
Nutrients - Total Phosphorus	< 300 ppb	682	708	High
Nutrients - Total Nitrogen	400-1200 ppb	2210	4780	High
Nutrients - Ammonia	< 500 ppb	950	960	High
Water Clarity - Secchi Depth	≥ 4 Feet	3		Low

Water quality analysis suggests that Site 4 is experiencing elevated nutrient levels. Lakes with high nutrient concentrations are likely to experience algal blooms. Phosphorus, in particular, is often the limiting nutrient that fuels algal growth. Since algae use these nutrients for food, algae abundance is often correlated with nutrient availability.

It is also important to note that Site 4 is at risk of oxygen stress. By installing aeration, oxygen levels could be restored for a healthy ecosystem.

- Recommendations for This Lake**
- Alum titrations and treatment for Phosphorus Reduction
 - On-going water quality monitoring

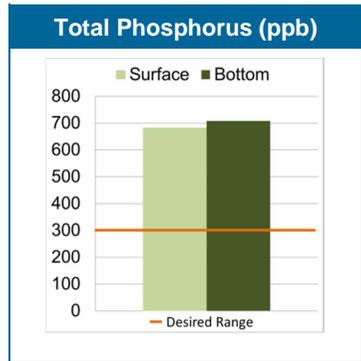
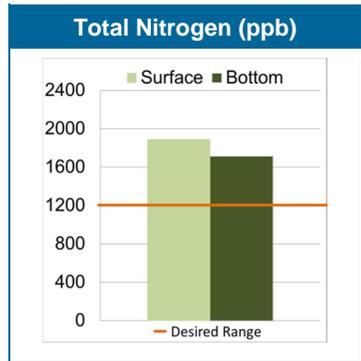
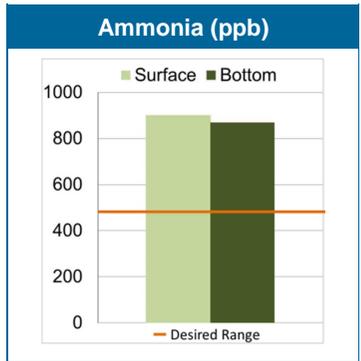
Test	Desired Range	Site 5		This lake is:
		Surface	Bottom	
Nutrients - Total Phosphorus	< 300 ppb	783	775	High
Nutrients - Total Nitrogen	400-1200 ppb	1890	1710	High
Nutrients - Ammonia	< 500 ppb	900	870	High
Water Clarity - Secchi Depth	≥ 4 Feet	3		Low

Observations
 Water quality analysis suggests that Site 5 is experiencing elevated nutrient levels. Lakes with high nutrient concentrations are likely to experience algal blooms. Phosphorus, in particular, is often the limiting nutrient that fuels algal growth. Since algae use these nutrients for food, algae abundance is often correlated with nutrient availability.
 It is also important to note that Site 5 is at risk of oxygen stress. By installing aeration, oxygen levels could be restored for a healthy ecosystem.

- Recommendations for This Lake**
- Alum titrations and treatment for Phosphorus Reduction
 - On-going water quality monitoring

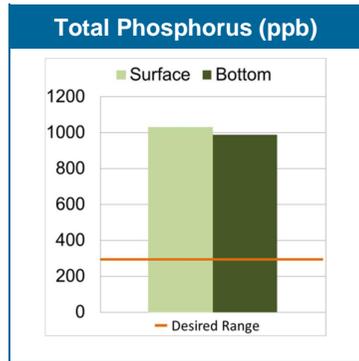
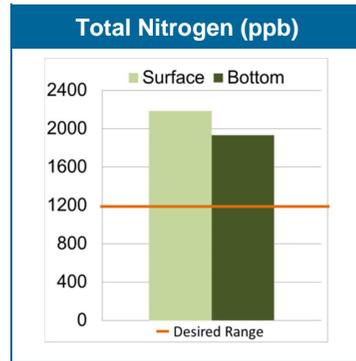
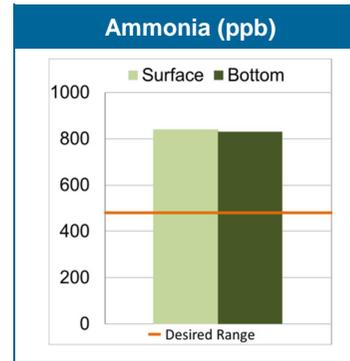
Site Readings				
Test	Desired Range	Site 6		This lake is:
		Surface	Bottom	
Nutrients - Total Phosphorus	< 300 ppb	1030	989	High
Nutrients - Total Nitrogen	400-1200 ppb	2180	1930	High
Nutrients - Ammonia	< 500 ppb	840	830	High
Water Clarity - Secchi Depth	≥ 4 Feet	1.5		Low

Water quality analysis suggests that Site 6 is experiencing elevated nutrient levels. Lakes with high nutrient concentrations are likely to experience algal blooms. Phosphorus, in particular, is often the limiting nutrient that fuels algal growth. Since algae use these nutrients for food, algae abundance is often correlated with nutrient availability.

It is recommended to install aeration in order to fully mix the water column at Site 6. When oxygen levels are low at the bottom of the water column, phosphorus may leach out of bottom sediments and ammonia may accumulate to toxic levels.

- Alum titrations and treatment for Phosphorus Reduction
- On-going water quality monitoring

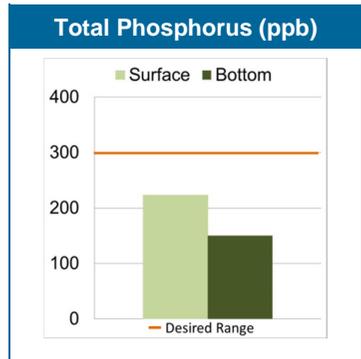
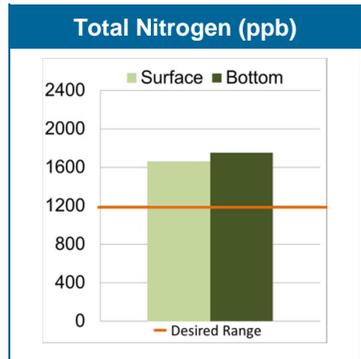
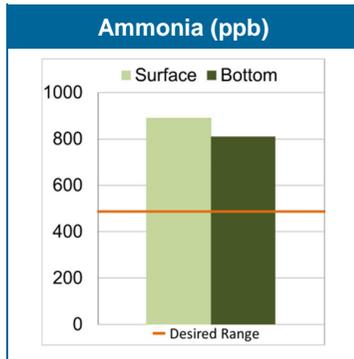
Test	Desired Range	Site 7		This lake is:
		Surface	Bottom	
Nutrients - Total Phosphorus	< 300 ppb	223	150	Borderline
Nutrients - Total Nitrogen	400-1200 ppb	2660	1750	High
Nutrients - Ammonia	< 500 ppb	890	810	High
Water Clarity - Secchi Depth	≥ 4 Feet	0.5		Low

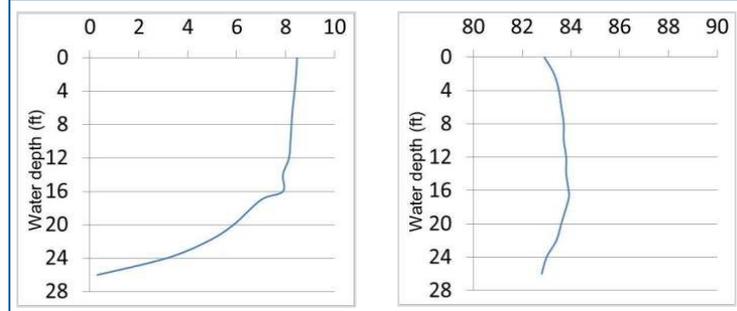
Dissolved Oxygen: DO (ppm) + Temperature (°F) - Indicates that this lake is:

Water quality testing suggests that Site 7 is experiencing oxygen stratification. When oxygen levels are low on the bottom of the water column, phosphorus may leach out of the bottom sediments and ammonia may accumulate to toxic levels.

Field observation suggests that Site 7 is experiencing foul odors and a heavy plankton algae bloom. The odors are likely a result of hydrogen sulfide production in the anoxic bottom waters. It is also possible that phosphorus levels are even higher than measured if the algae have sequestered the nutrients within their cells.

The dissolved oxygen and temperature profile shows the water column is stratified into separate water temperature layers resulting in reduced oxygen concentrations at lower depths often leading to fish kills, algae blooms, muck accumulation and foul odors.

- Bathymetric Mapping to determine comprehensive bottom contour and total volume of water within pond
- Aeration for de-stratification
- On-going water quality monitoring

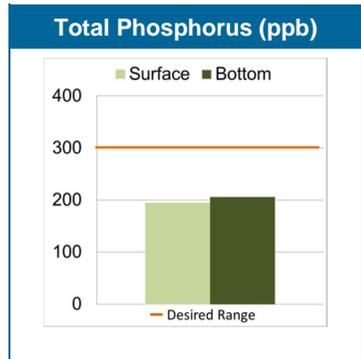
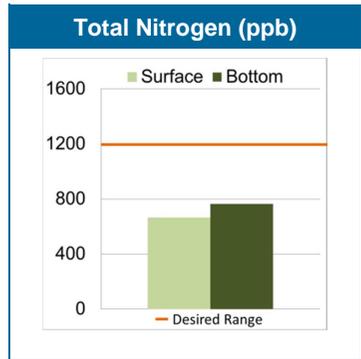
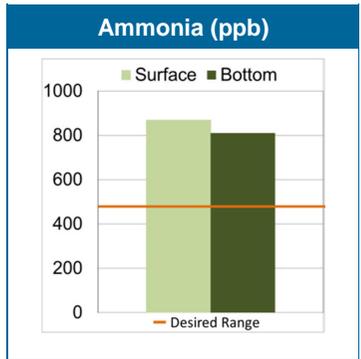
Test	Desired Range	Site 8		This lake is:
		Surface	Bottom	
Nutrients - Total Phosphorus	< 300 ppb	195	206	Borderline
Nutrients - Total Nitrogen	400-1200 ppb	663	763	Normal
Nutrients - Ammonia	< 500 ppb	870	810	High
Water Clarity - Secchi Depth	≥ 4 Feet	1		Low

Water quality analysis suggests that Site 8 is experiencing oxygen super-saturation. Field observations confirm that Site 8 is experiencing a plankton algae bloom, which is likely the cause of such elevated oxygen levels.

It is also evident that Site 8 is experiencing elevated ammonia levels. It is recommended to install aeration in order to stabilize oxygen levels and reduce ammonia from the water column.

- Recommendations for This Lake**
- Additional aeration for stable oxygen levels and ammonia reduction
 - Additional Alum treatments for nutrient reduction
 - On-going water quality monitoring

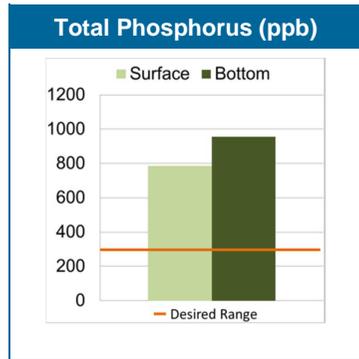
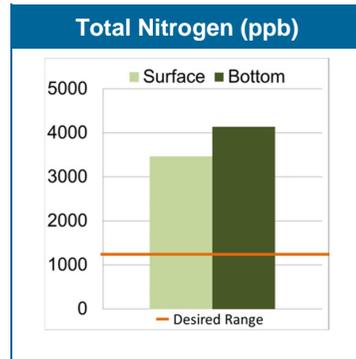
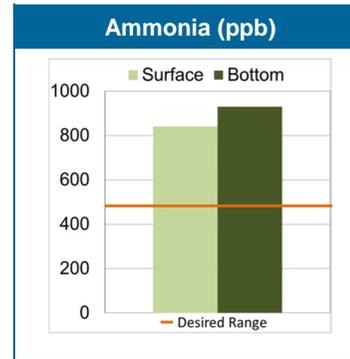
Site Readings				
Test	Desired Range	Site 9		This lake is:
		Surface	Bottom	
Nutrients - Total Phosphorus	< 300 ppb	785	955	High
Nutrients - Total Nitrogen	400-1200 ppb	3460	4140	High
Nutrients - Ammonia	< 500 ppb	840	930	High
Water Clarity - Secchi Depth	≥ 4 Feet	3		Low

Water quality analysis suggests that Site 9 is experiencing elevated nutrient levels. Lakes with high nutrient concentrations are likely to experience algal blooms. Phosphorus, in particular, is often the limiting nutrient that fuels algal growth. Since algae use these nutrients for food, algae abundance is often correlated with nutrient availability.

It is also important to note that Site 9 is experiencing oxygen stratification. This is often the source of various in-lake issues, including elevated nutrients, fish kills and foul odors.

- Recommendations for This Lake**
- Additional aeration for de-stratification
 - Additional Alum for Phosphorus Reduction
 - On-going water quality monitoring

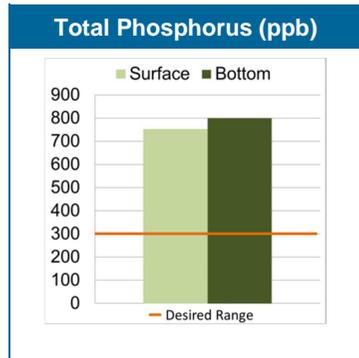
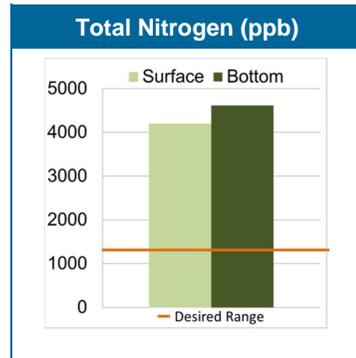
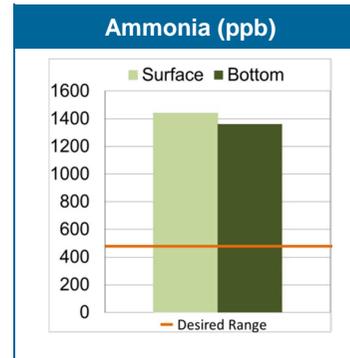
Site Readings				
Test	Desired Range	Site 10		This lake is:
		Surface	Bottom	
Nutrients - Total Phosphorus	< 300 ppb	752	800	High
Nutrients - Total Nitrogen	400-1200 ppb	4195	4615	High
Nutrients - Ammonia	< 500 ppb	1440	1360	High
Water Clarity - Secchi Depth	≥ 4 Feet	3		Low

Water quality analysis suggests that Site 10 is experiencing elevated nutrient levels. Lakes with high nutrient concentrations are likely to experience algal blooms. Phosphorus, in particular, is often the limiting nutrient that fuels algal growth. Since algae use these nutrients for food, algae abundance is often correlated with nutrient availability.

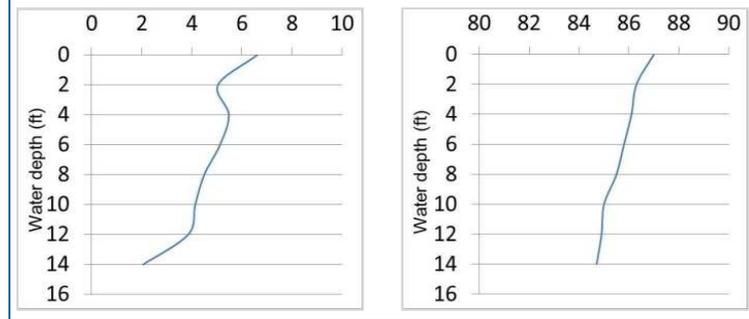
Dissolved Oxygen: DO (ppm) + Temperature (°F) - Indicates that this lake is:

The dissolved oxygen and temperature profile shows the water column is stratified into separate water temperature layers resulting in reduced oxygen concentrations at lower depths often leading to fish kills, algae blooms, muck accumulation and foul odors.

It is also important to note that Site 10 is experiencing oxygen stratification. This is often the source of various in-lake issues, including elevated nutrients, fish kills and foul odors.

- Additional aeration for de-stratification
- Additional Alum for Phosphorus Reduction
- On-going water quality monitoring
