Placido Bayou Community Association Waterway Inspection Report

Reason for Inspection: Routine Scheduled - Monthly

Inspection Date: 9/15/2017

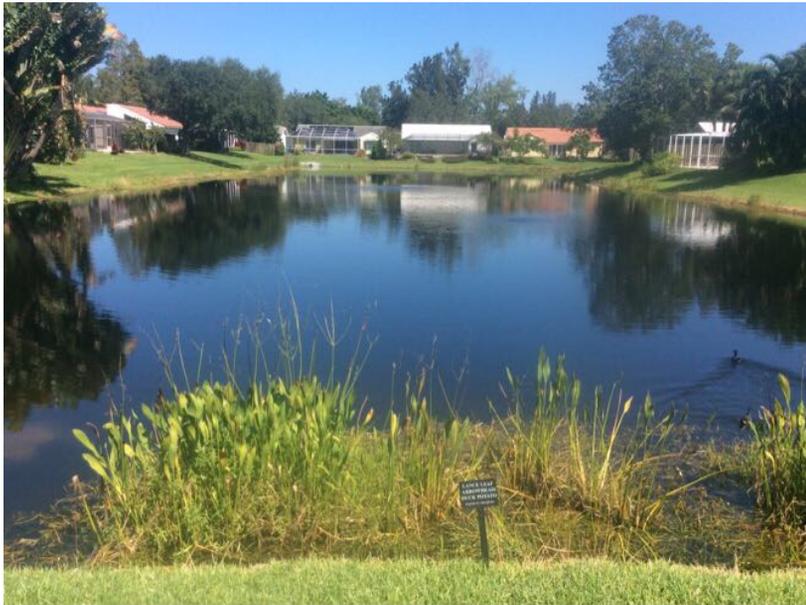
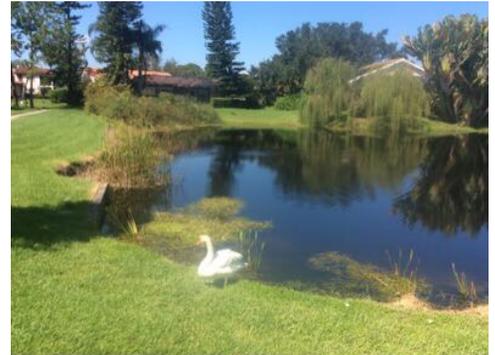
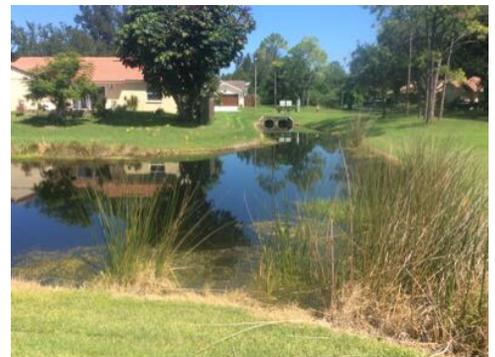
Site: 1

Comments: Normal growth observed

Regrowth of Alligator Weed was observed growing outwards from the bank at site #1. This will be targeted during an upcoming scheduled visit.

- Perform a grass treatment on the Alligator Weed within site #1.
- Monitor site #2 for regrowth of shoreline vegetation and algae, performing additional treatments as necessary.

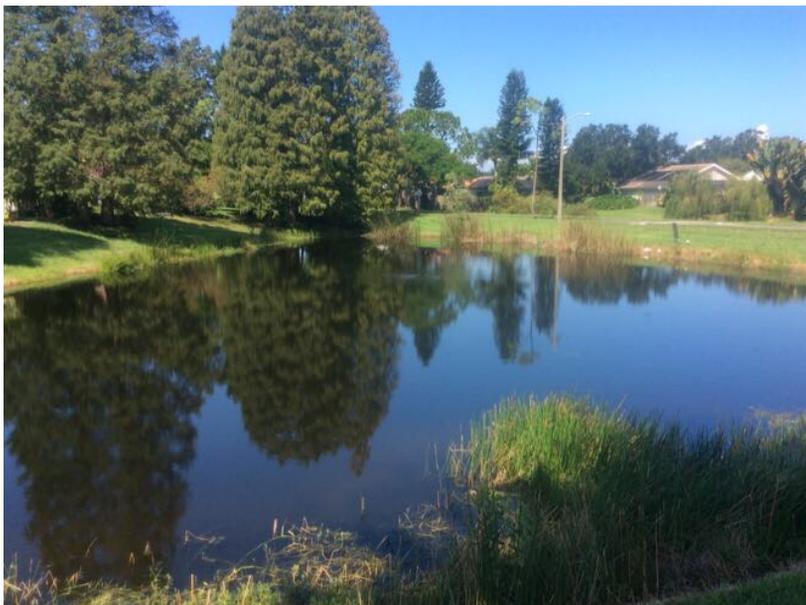
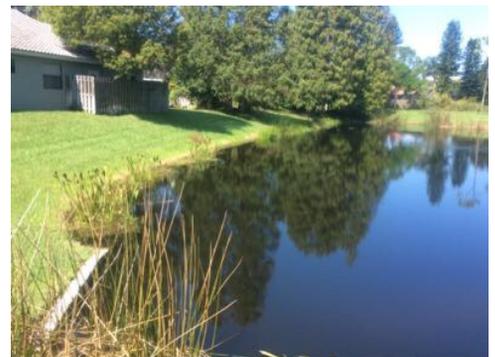
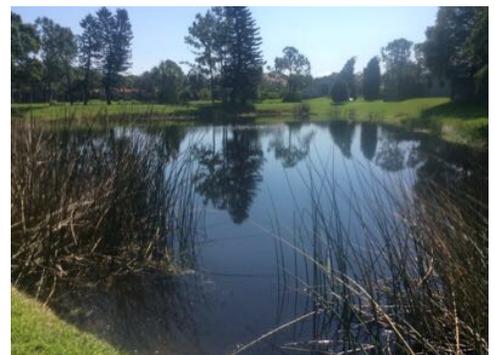
Site: 2

Comments: Site looks good

Site #2 was in good condition during this inspection. Evidence of successful grass treatments could be observed along the perimeter of the site.

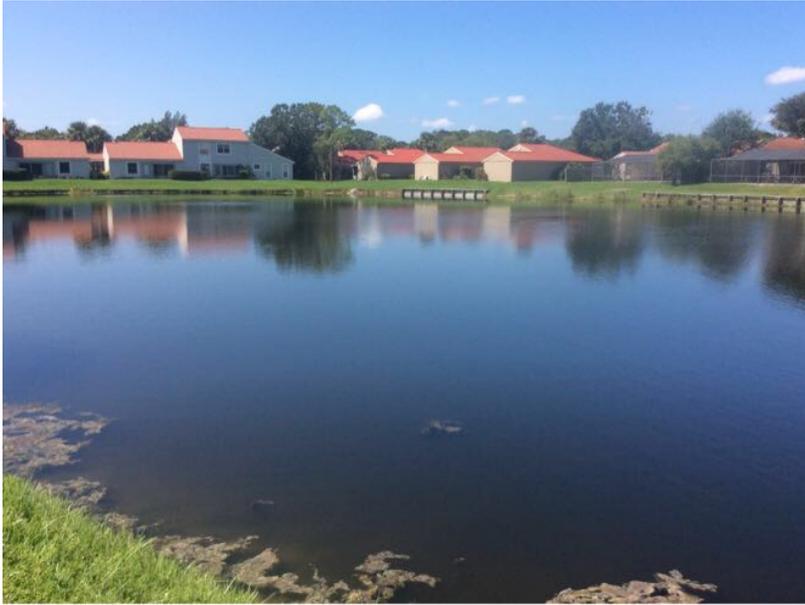
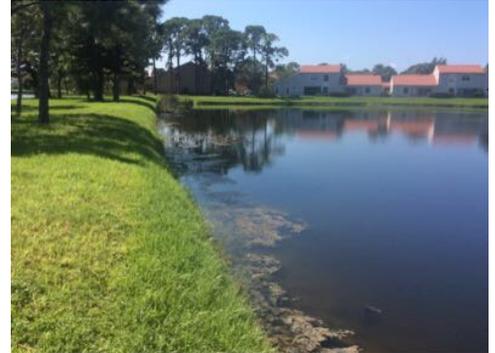
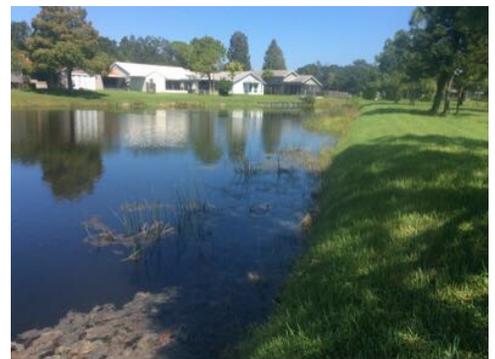
Site: 3

Comments: Normal growth observed

Site #3 was experiencing filamentous algae growth at a 2-3 foot band around the perimeter of the lake. This will be targeted during an upcoming scheduled visit.

- Target the filamentous algae growth within site #3.
- Apply an algae treatment for the filamentous and planktonic algae at site #4.
- Target the filamentous algae along the perimeter of site #5.

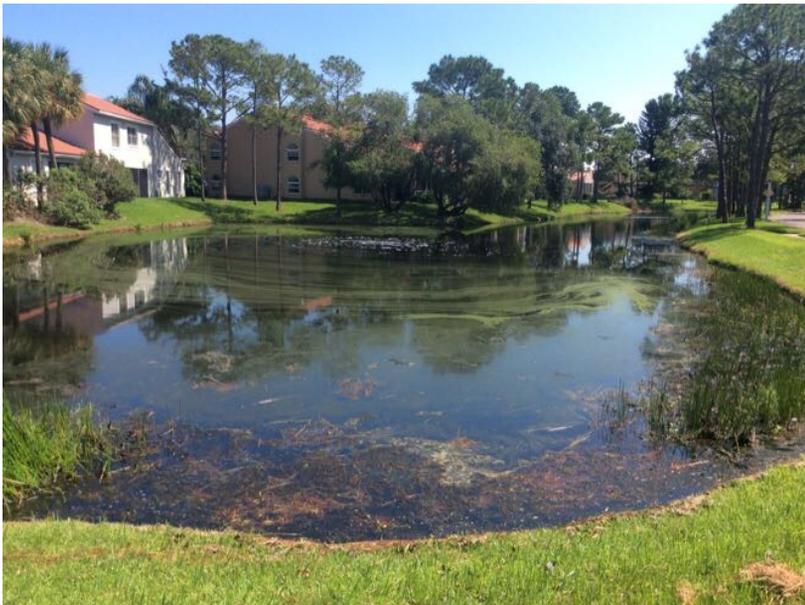
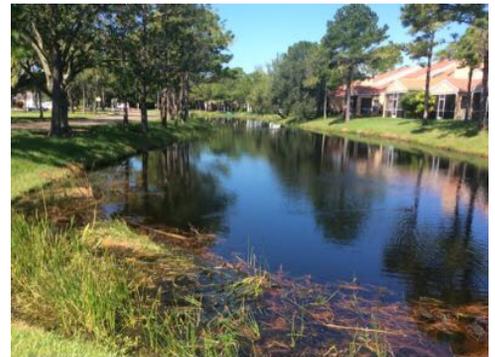
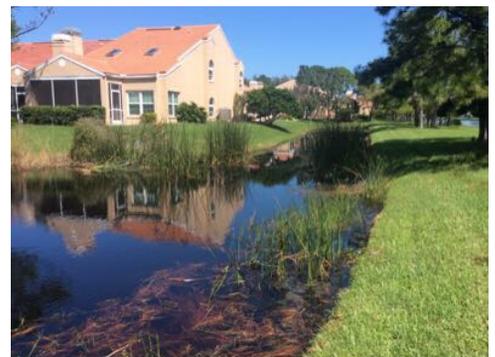
Site: 4

Comments: Normal growth observed

A planktonic algae bloom was occurring on site #4, with filamentous algae around the perimeter of the site. An algae treatment will be applied during an upcoming scheduled visit.

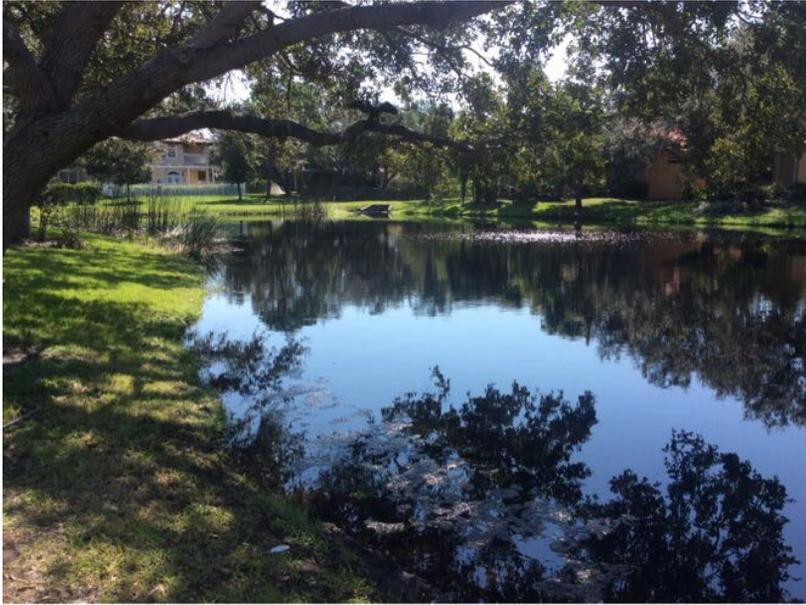
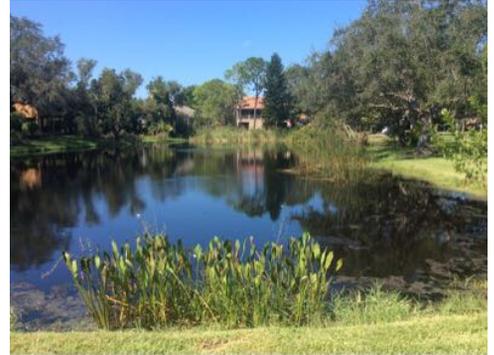
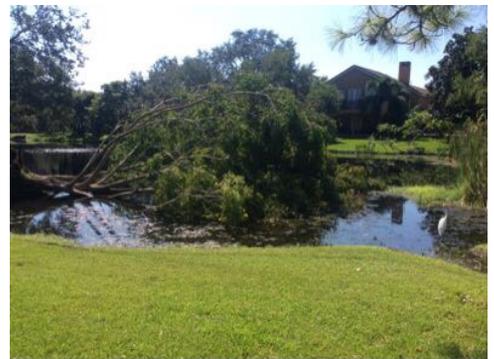
Site: 5

Comments: Normal growth observed

Filamentous algae growth was observed at 1-3 feet along the shoreline of site #5, and will be treated during an upcoming scheduled visit.

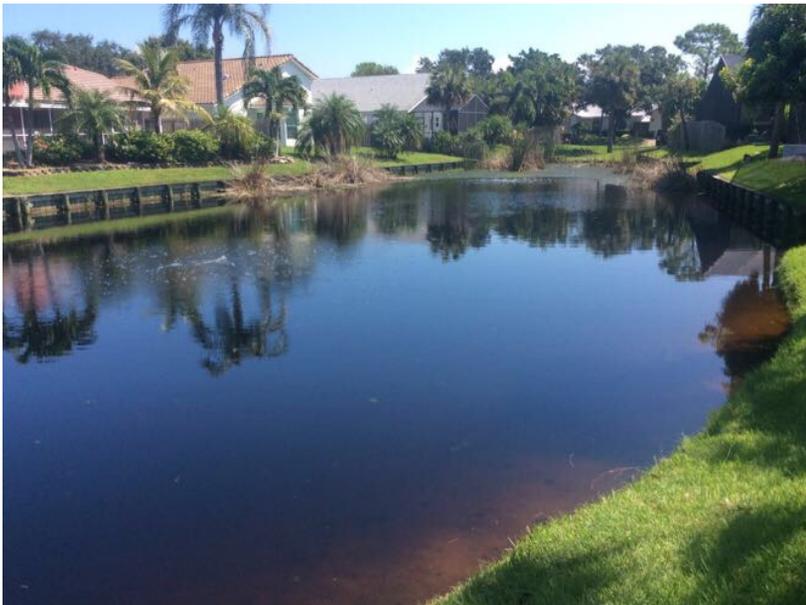
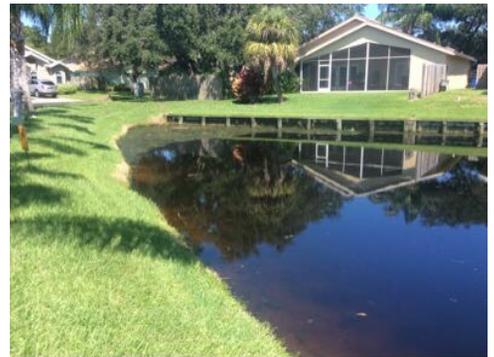
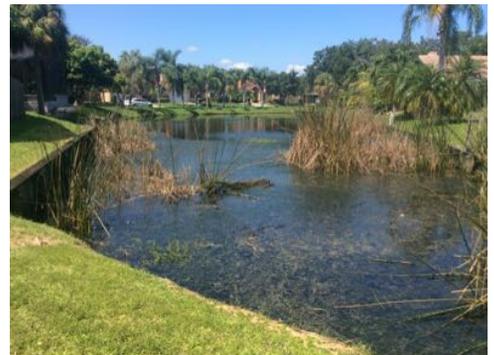
Site: 6

Comments: Requires attention

A filamentous algal bloom was present at site #6. This will be targeted during the next scheduled visit.

- Apply an aggressive algae treatment for the algae bloom within site #6.
- Perform an aggressive algae treatment for the planktonic and filamentous algae within site #7. A follow up treatment to occur on the following visit to ensure desired results are achieved.

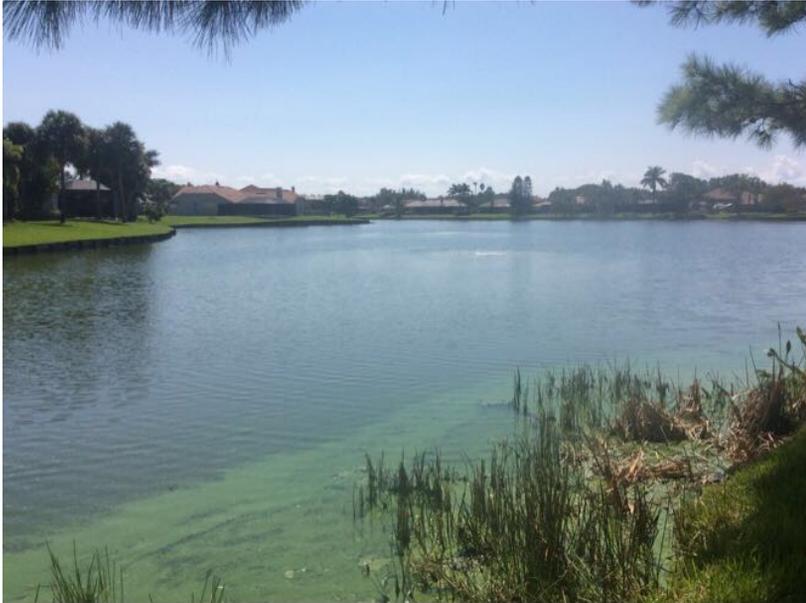
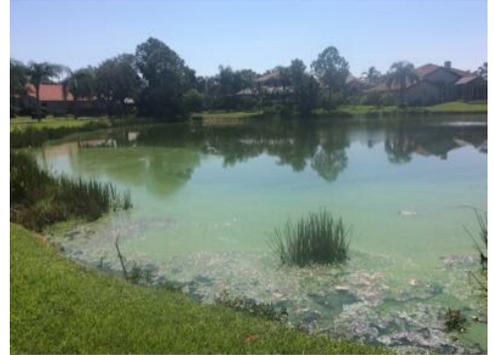
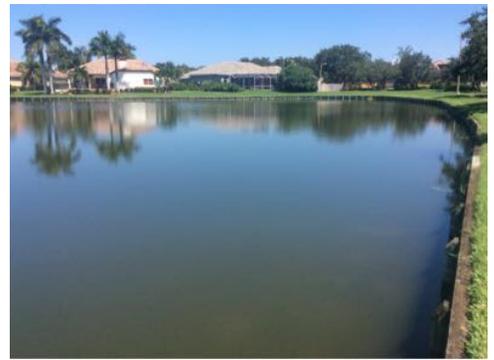
Site: 7

Comments: Requires attention

Planktonic and filamentous algae blooms were observed within site #7. This will be aggressively treated during the next scheduled visit, with a follow up treatment to occur on the following visit to ensure desired results are achieved.

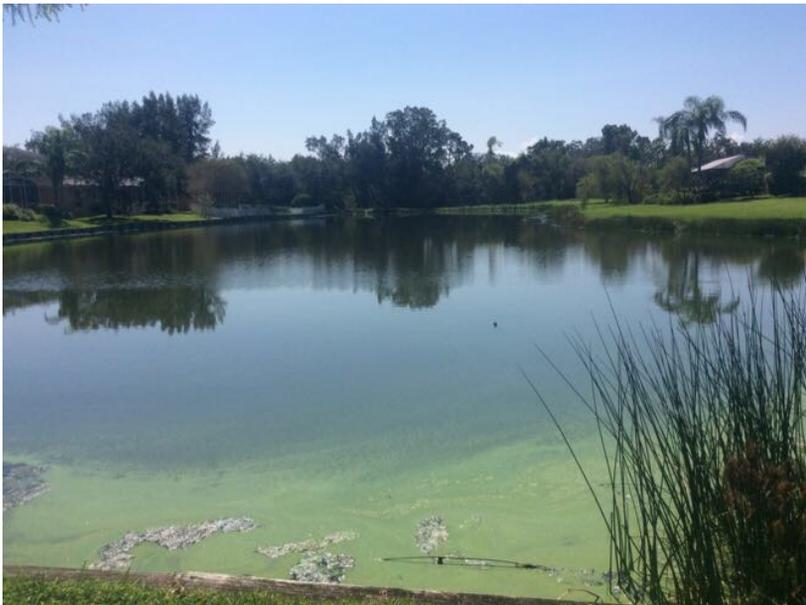
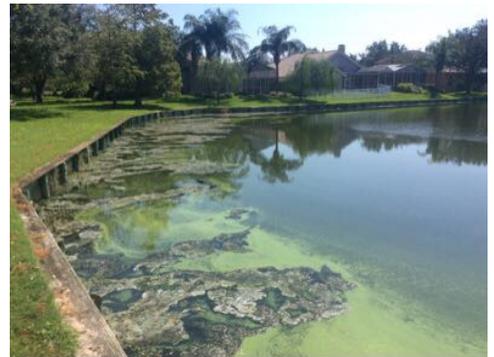
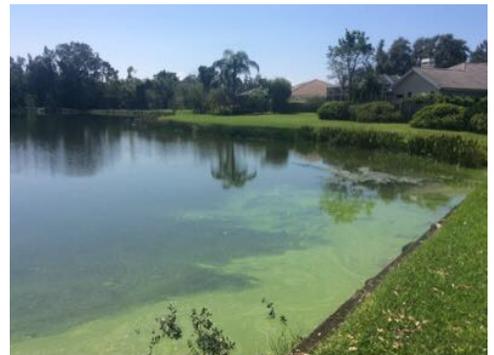
Site: 8

Comments: Requires attention

Site #8 was experiencing planktonic and filamentous algae blooms during this inspection. This will be treated during the next scheduled visit.

- Apply an algae treatment to target the filamentous and planktonic algae blooms within site #8.
- Monitor site #9 for regrowth of undesired vegetation and algae, performing additional treatments as required.

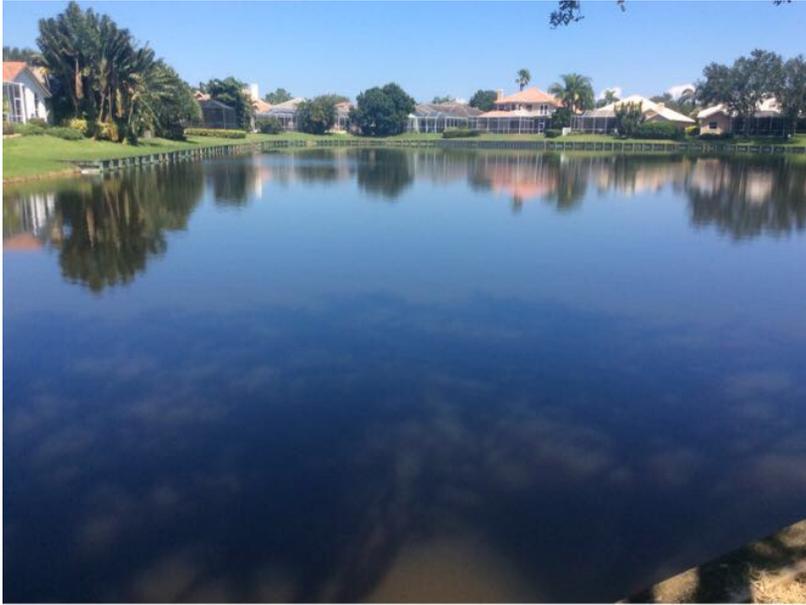
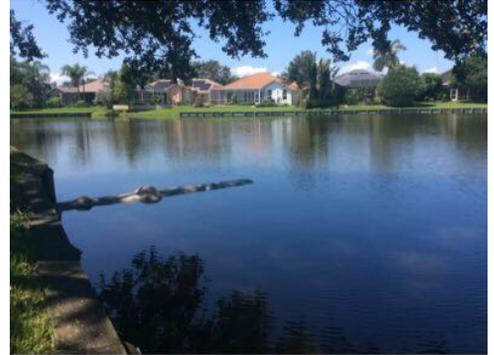
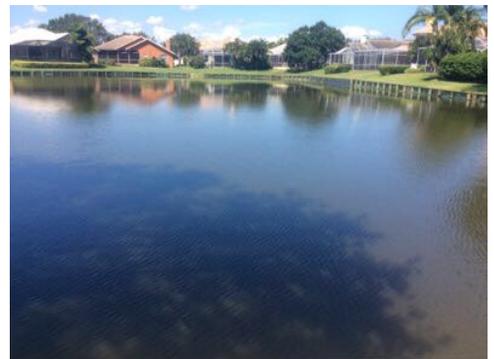
Site: 9

Comments: Site looks good

Site #9 was in great condition, with no algae or undesired vegetation present.

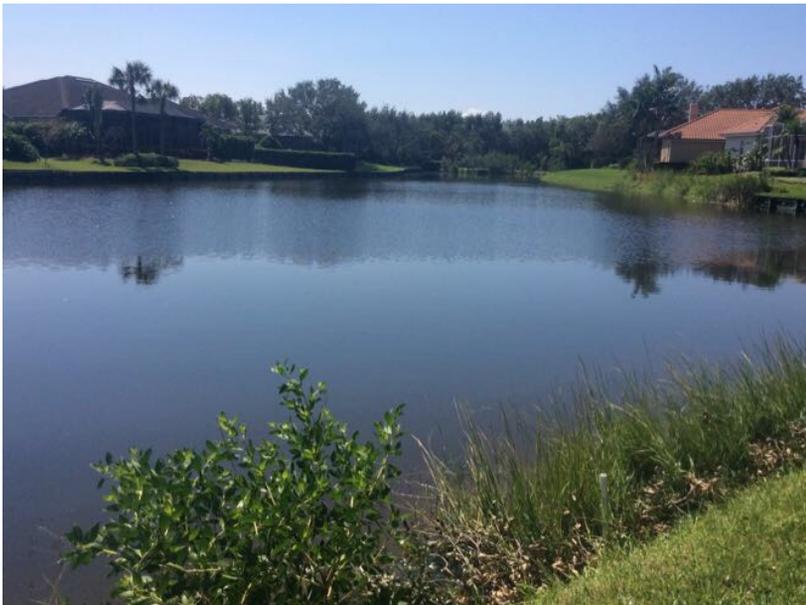
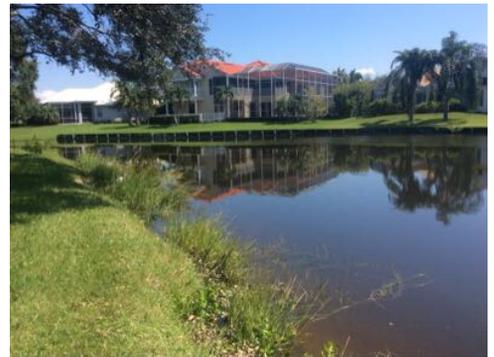
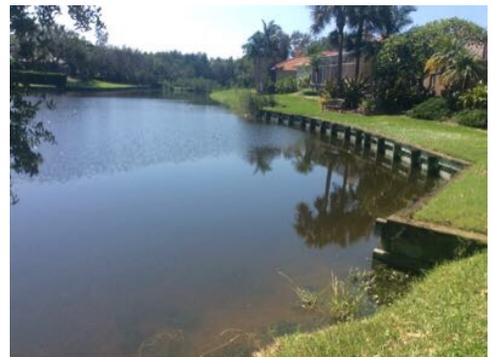
Site: 10

Comments: Site looks good

Site #10 was in excellent condition, and was kept free of all algae and undesired shoreline grasses.

- Monitor site #10 for new growth of algae and undesired shoreline vegetation, treating as necessary.
