Placido Bayou Community Association Waterway Inspection Report

Reason for Inspection:

Monthly Contract

10/22/2021

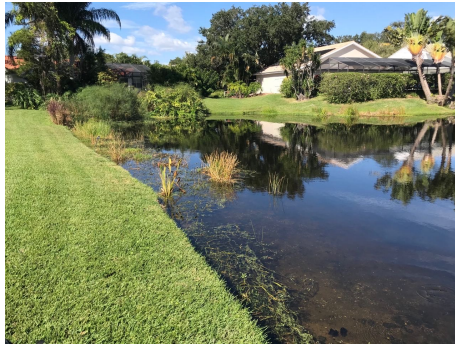
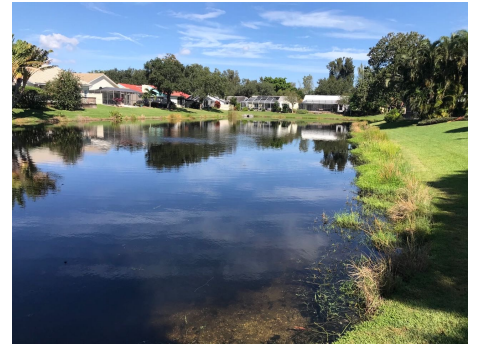
Pond 1

Normal Growth Observed

Backpack was used around the entire perimeter to spot treat invasive weeds. Trace amounts of Duckweed was observed.

1. Backpack was used around the entire perimeter to spot treat invasive weeds. Trace amounts of Duckweed.
2. Spot spray treatments between Gulf Spikerush and Bulrush will continue on a monthly basis.

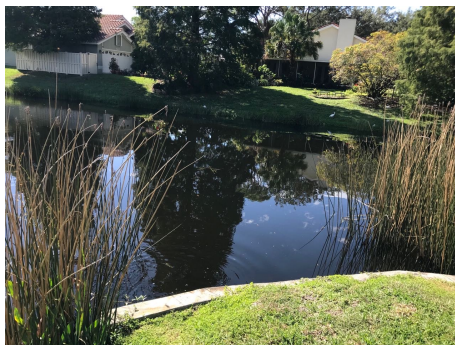
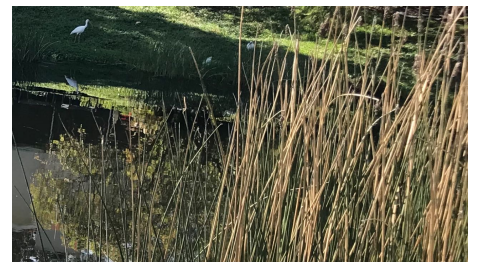
Pond 2

Normal Growth Observed

Spot spray treatments between Gulf Spikerush and Bulrush will continue on a monthly basis.

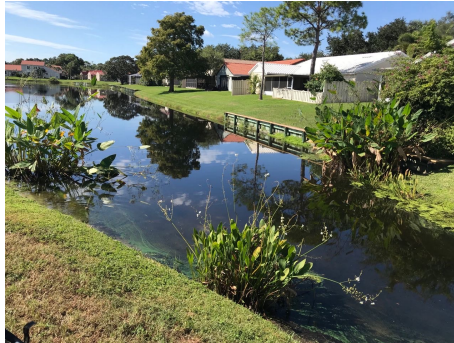
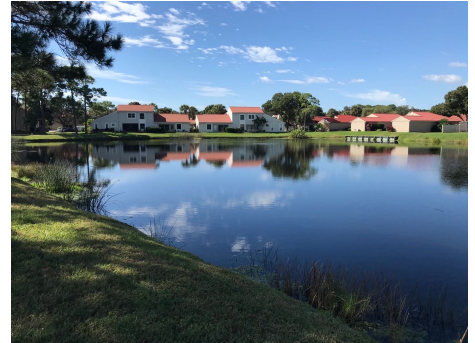
Pond 3

Normal Growth Observed

Trace amounts of Phytoplankton was observed windblown in the corner of the pond. Overall, the pond has much improved.

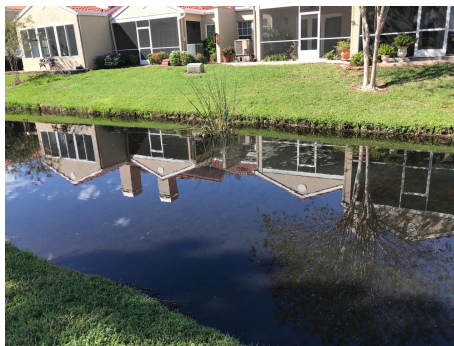
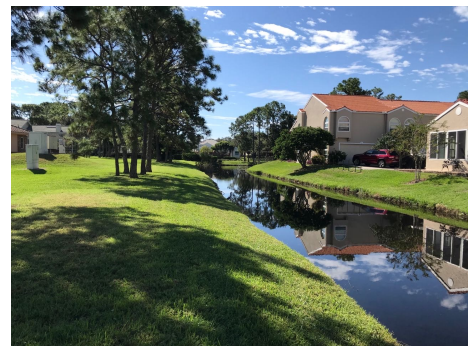
Pond 4

Normal Growth Observed

Probiotics are used monthly inside this pond. Sewper Rx is the name of the sludge reduction technology that we typically use. Probiotics can help reduce nutrients and muck. Over time, it can help reduce algae blooms.

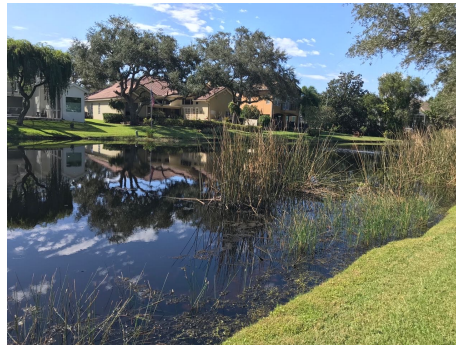
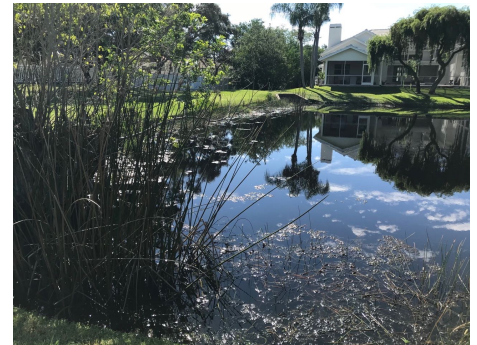
Pond 5

Treatment In Progress

Filamentous algae was observed approximately 5 feet out around the perimeter. Algicide was applied.

5. Filamentous algae was observed approximately 5 feet out around the perimeter. Algicide was applied.
6. In November, we will be physically removing decomposing Alligatorweed.

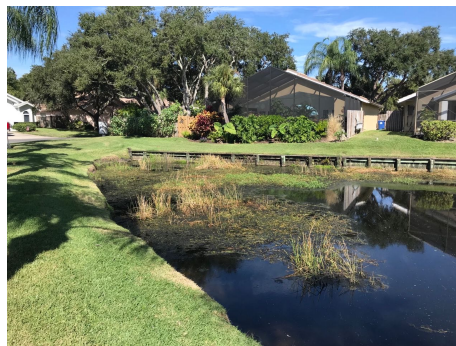
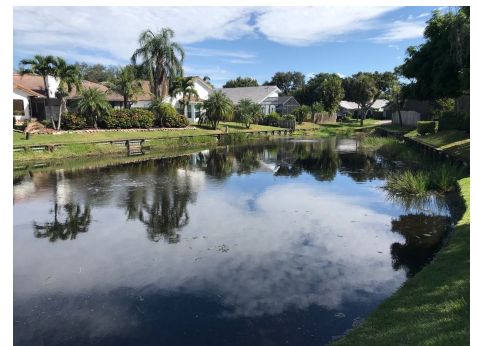
Normal Growth Observed

Probiotics are used monthly inside this pond. Sewper Rx is the name of the sludge reduction technology that we typically use. Probiotics can help reduce nutrients and muck. Over time, it can help reduce algae blooms.

In November, we will be physically removing decomposing Alligatorweed.

Pond 6 had considerable amounts of decomposing Alligatorweed growing inside the native aquatic plants. We will be physically removing the Alligatorweed to help the progress along. We are also recommending adding additional plants to this area in the Spring.

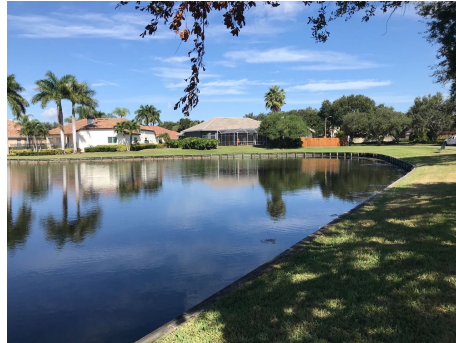
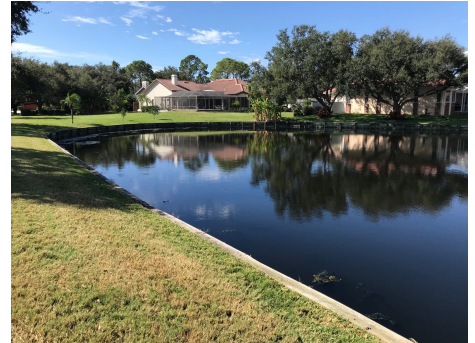
Pond 7

Treatment In Progress

We have been seeing the higher than usual levels of algae in this pond. Each month we try to utilize both the ATV and boat. Each has it's own advantage, however the boat can reach areas the ATV cannot in this particular pond.

7. We have been seeing the higher than usual levels of algae in this pond. Each month we try to utilize both the ATV and boat. Each has it's own advantage.

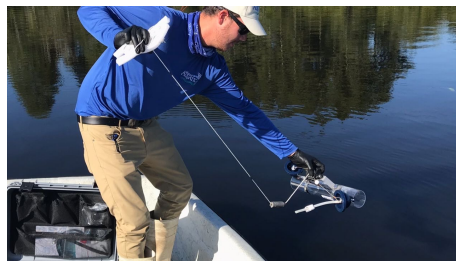
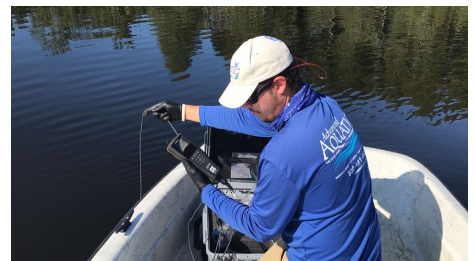
Pond 8

Site Looks Good

No action required. All 10 ponds at PBCA received a water quality analysis. Left shows a picture of our bottom water sampler. Right shows a picture of our YSI. We send our water samples with a chain of custody to a state certified lab to ensure accurate data. We'll provide a report for each pond in November.

In November, we will be providing the results of each water quality analysis for each pond. Based upon the results, we will make scientifically guided recommendations for Placido Bayou's water bodies.

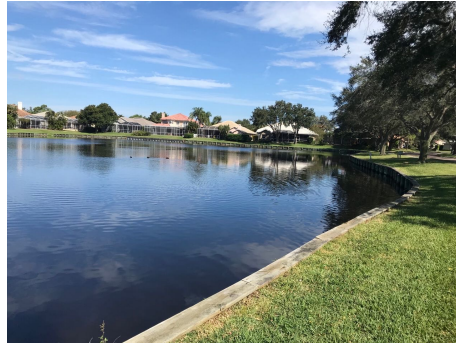
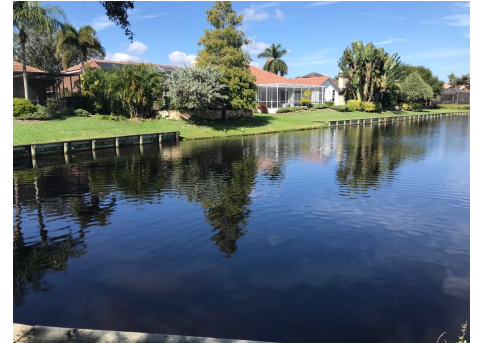
Pond 9

Treatment In Progress

Seawalls were treated for weeds.

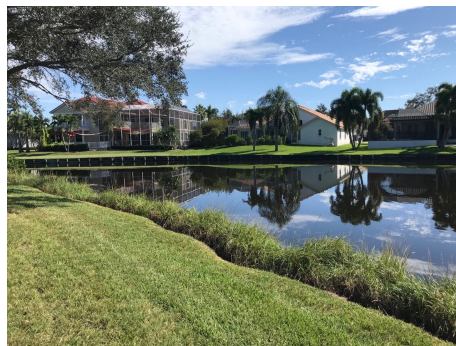
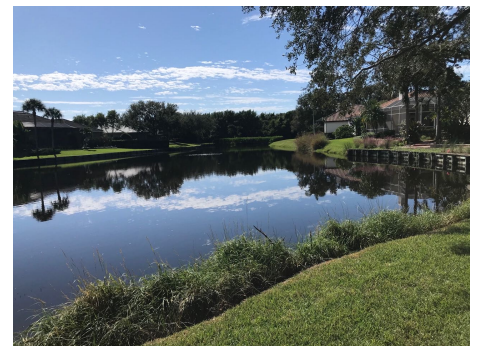
Pond 10

Treatment In Progress

Seawalls were treated for weeds.
