Placido Bayou Community Association Waterway Inspection Report

Reason for Inspection:
Monthly Quality Assurance

Inspection Date:
12/14/2021

Prepared for:
Placido Bayou Community Association

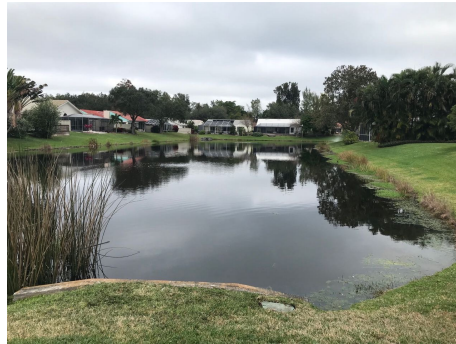
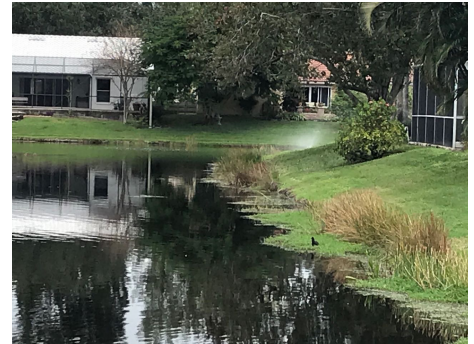
Pond 1

Normal Growth Observed

Trace amounts of filamentous algae were treated. Picture of the right shows sprinklers. They have turned on while I go around this pond the last couple of treatments.

1. Trace amounts of filamentous algae were treated. Picture of the right shows sprinklers. They have turned on while I go around this pond the last couple of treatments.

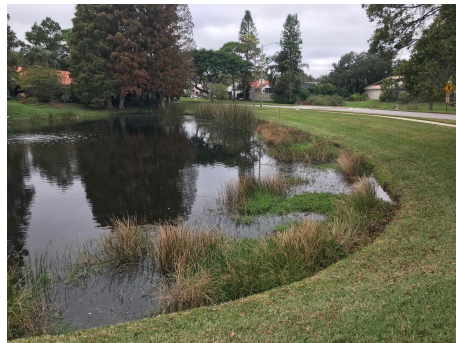
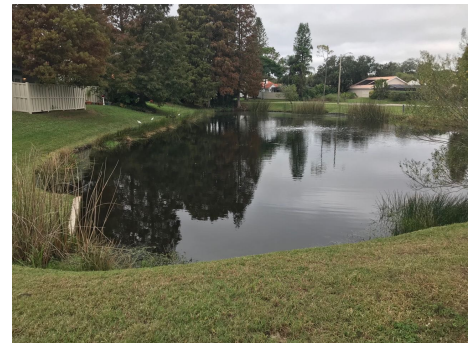
Pond 2

Normal Growth Observed

Trace amounts of grasses treated in pond.

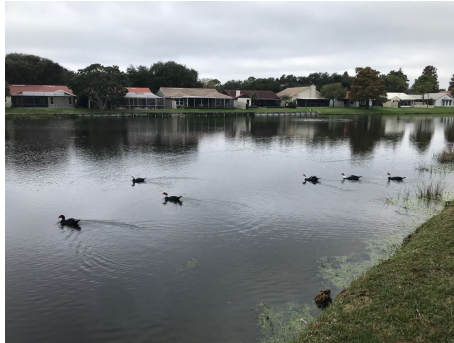
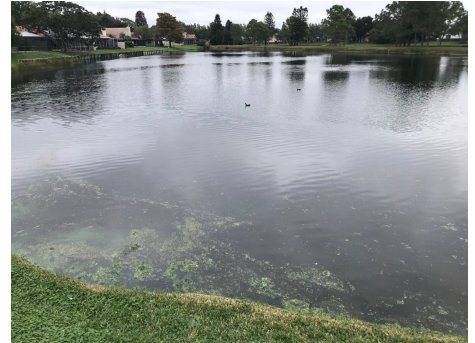
Pond 3

Treatment In Progress

Filamentous algae, Duckweed and Bluegreen algae were targeted on last scheduled treatment.

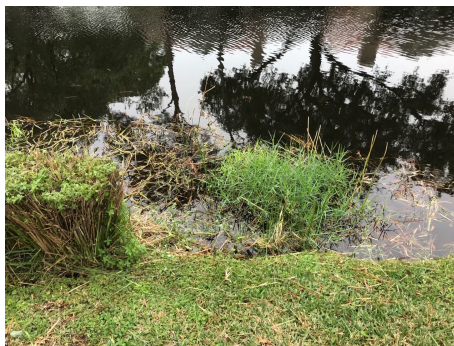
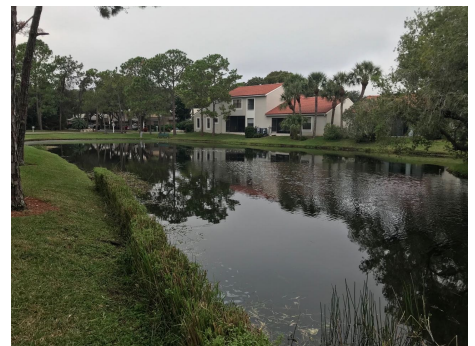
Pond 4

Treatment In Progress

Algae treatment from earlier in the month worked. Left, shows Torpedograss that was targeted on this treatment.

- Selectively spot spray invasive Alligatorweed and Torpedograss within beneficial plants.

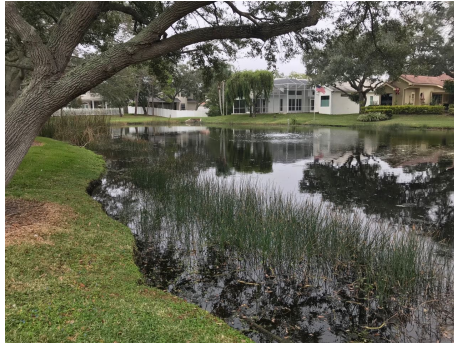
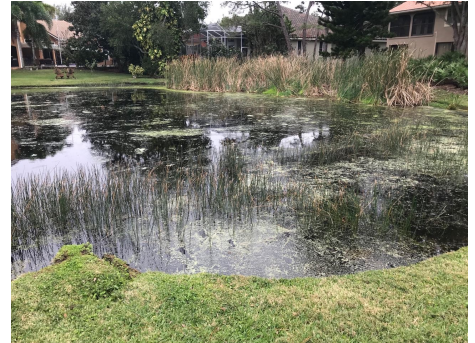
Pond 5

Treatment In Progress

Green algae bloom was beginning to grow across the lake. Algicide was applied.

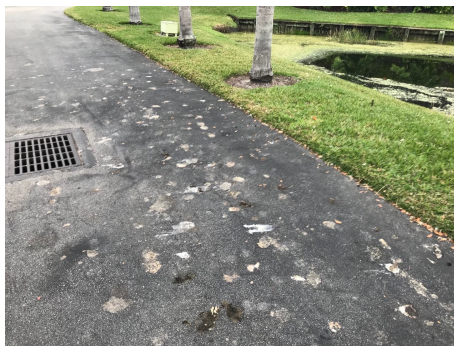
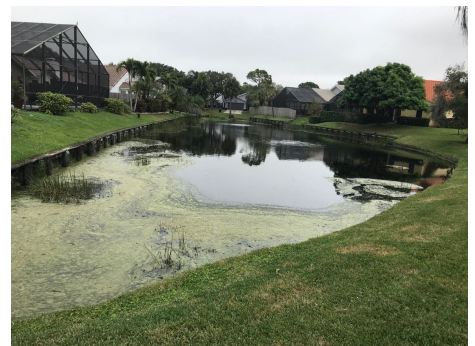
Pond 6

Treatment In Progress

Algicide was applied to the algae wind blown in the corner. This pond is very small and has the highest levels of Total Phosphorous within the community. Please do not feed the birds. The droppings (picture on the left) will wash down storm drains and enter the lake. The droppings are high in nutrients and cause algae.

- Please do not feed water fowl or fish. In nature, these animals will take from the lake and will cycle their was back into the system. In the case of feeding fish and birds, outside sources of nutrients are entering the waterbody. Native fish and waterfowl are signs of productive habitats. However, too much of anything can cause problems.
- Please confirm that we are doing our part with irrigation. Our irrigation is reclaimed water, which we tested and is off the chart in Total Phosphorous, the limiting nutrient in fresh water systems. Any water that lands on impervious surfaces such as streets, sidewalks and driveways can ultimately flow into storm drain and then the lake.

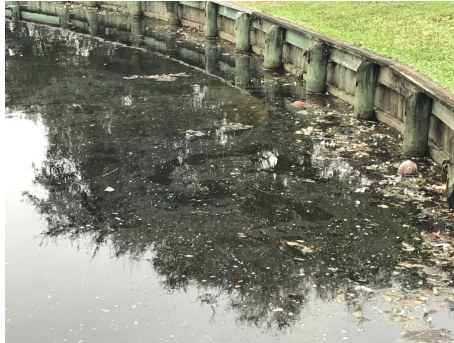
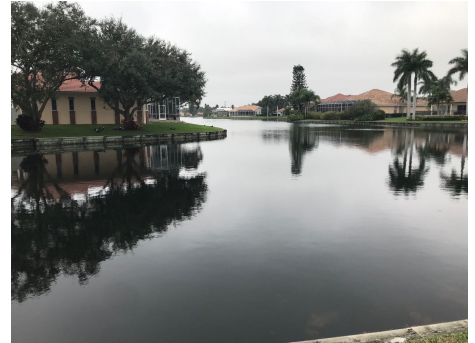
Pond 7

Normal Growth Observed

Picture in the left shows floating organics that have windblown across the lake. There is pollen, coconuts, leaves and feathers. These pose no serious concerns for the lake and typically only gather in a few wind blown areas of the lake.

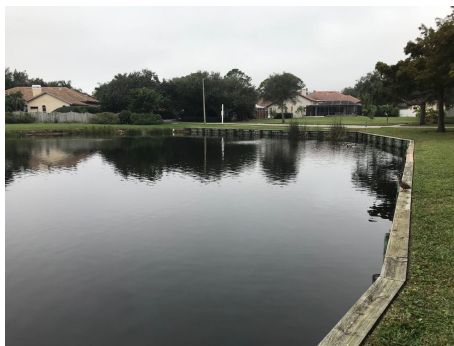
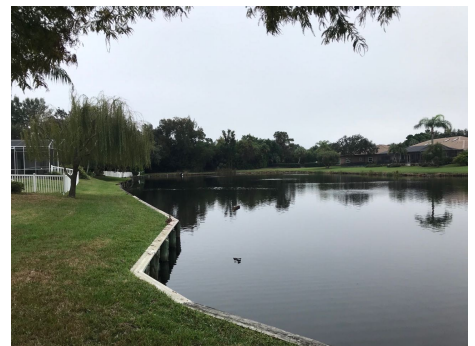
Pond 8

Site Looks Good

No action required.

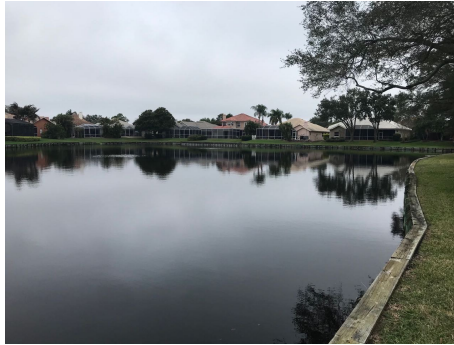
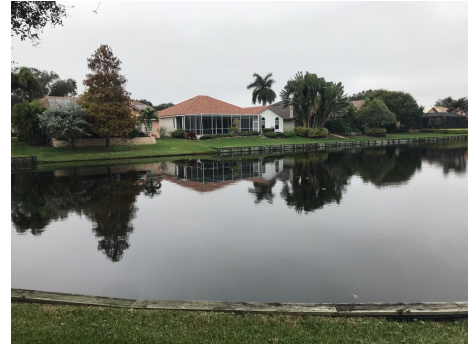
Pond 9

Site Looks Good

No action required.

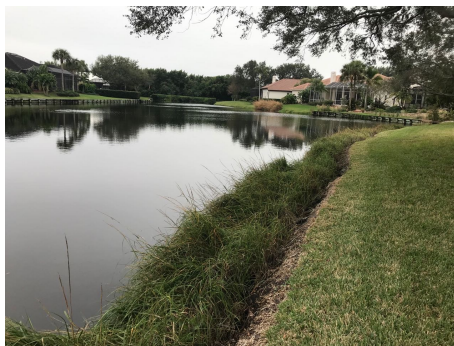
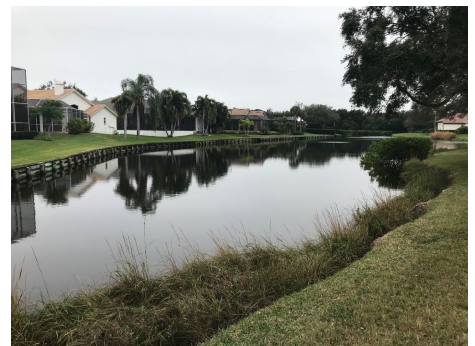
Pond 10

Site Looks Good

No action required.
