Placido Bayou Community Association Waterway Inspection Report

Reason for Inspection:
Quality Assurance

Inspection Date:
8/19/2022

Prepared by:
Doug Agnew, Senior Environmental Consultant

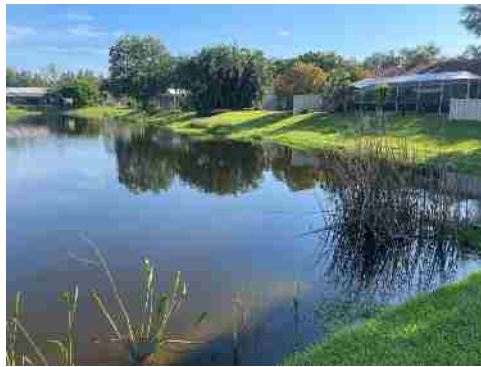
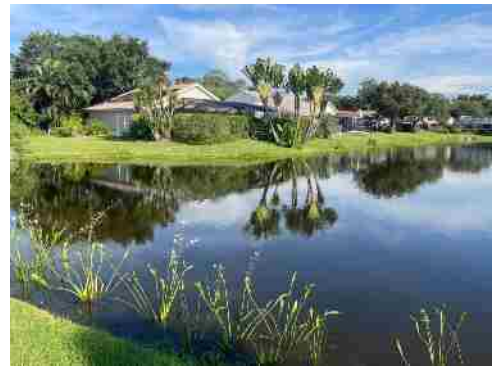
Pond 1

Site Looks Good

Invasive alligator weed sprayed on home side with backpack. Beneficial native plant, Bacopa, growing from shoreline.

- 1- Trace amounts of Alligator weed treated. Native Bacopa & Arrowhead growing nicely.
- 2- Invasive shoreline growth treated. Native Bacopa, Arrowhead & Bullrush growing nicely .

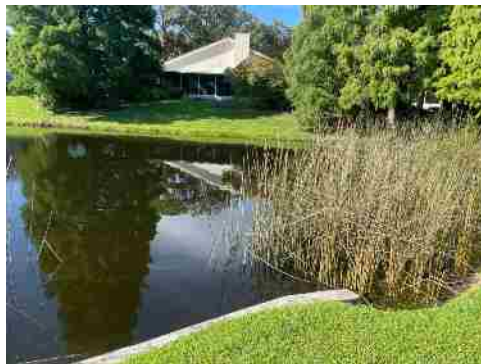
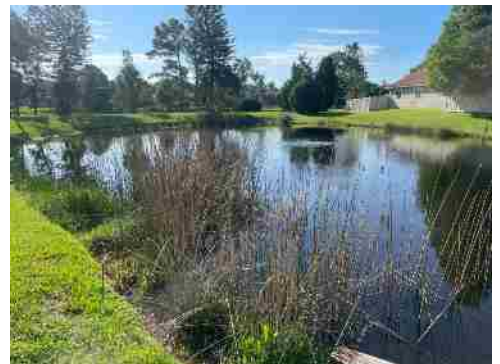
Pond 2

Site Looks Good

Beneficial natives growing around pond: Bacopa, Gulf Spikerush, and Bullrush.

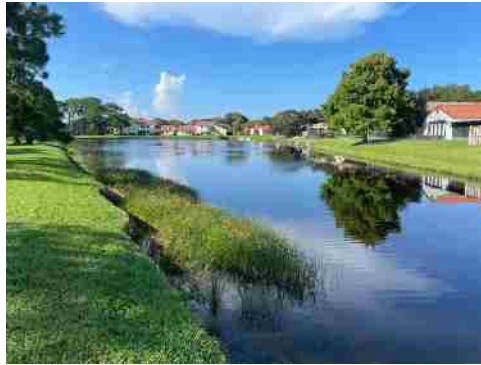
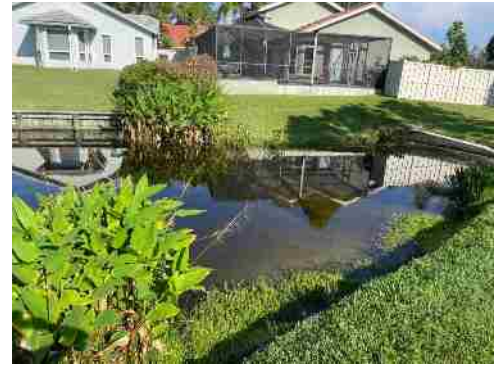
Pond 3

Site Looks Good

Used boat to treat Invasive grasses and aquatic weeds growing on home side of pond. Excellent water clarity.

- 3- Planktonic and Filamentous algae treated. Boat treatment of invasive grasses and aquatic weeds.
- 4- Filamentous algae carefully treated. Native plants developing nicely.

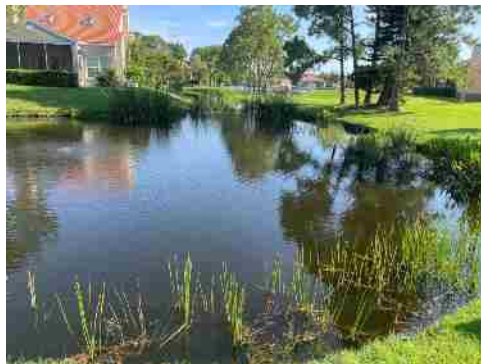
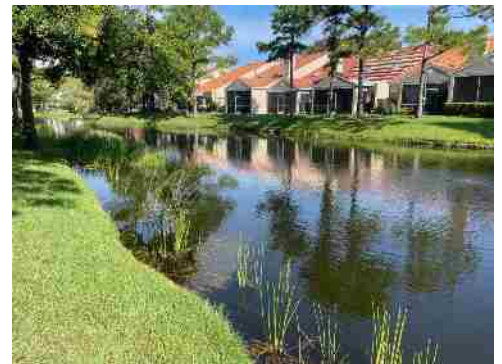
Pond 4

Treatment In Progress

Continuing applications to stay ahead of algae growth.

Native beneficial plant species growing nicely.

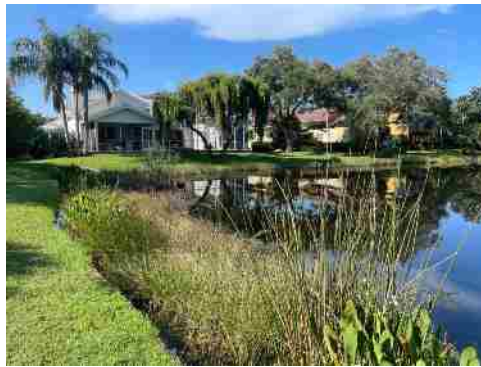
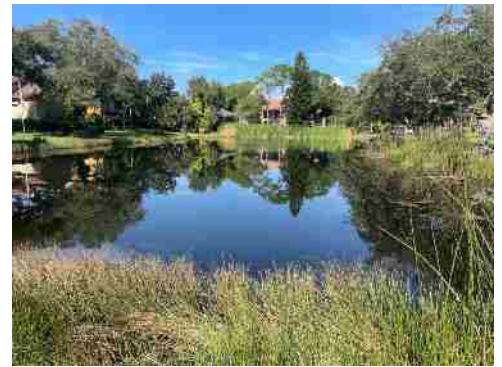
Pond 5

Treatment In Progress

Continuing multiple treatments for algae control.

Also, performing applications to reduce advancement of Cattail growth.

Treating Torpedograss with TIGR that is growing within native planted areas.

- 5- Filamentous algae carefully treated. TIGR used to treat Torpedograss within native planted areas.
- 6- Treatment of trace amounts of Alligatorweed performed. Native plants continuing to develop.

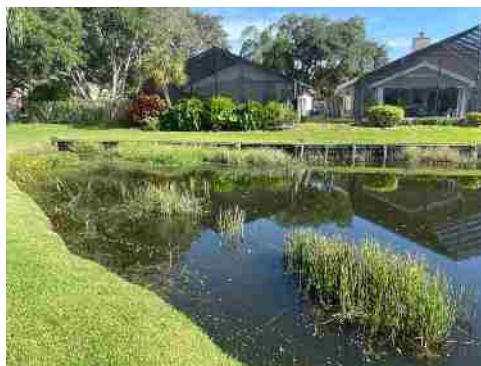
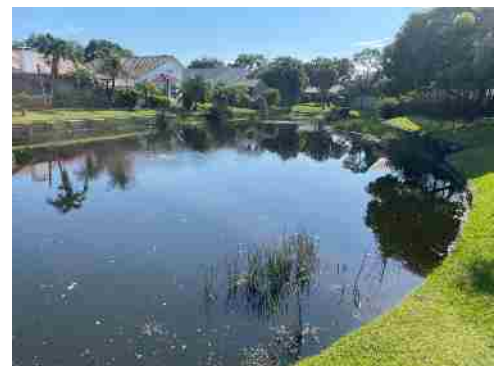
Pond 6

Treatment In Progress

Algae present and scheduled for continued treatments.

Sprayed alligator weed on home side with backpack.

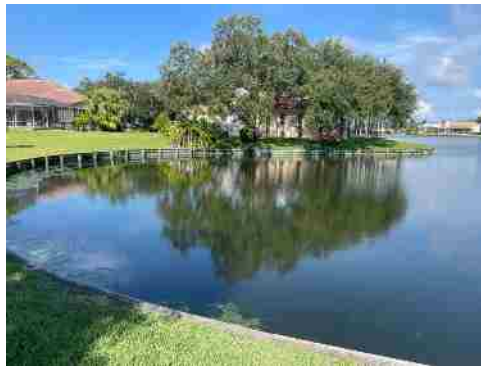
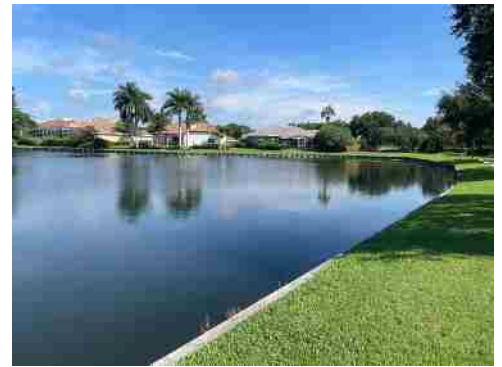
Pond 7

Requires Attention

Planktonic Algae is an ongoing problem.

Multiple Copper based applications performed to keep reasonable control of algae, both filamentous and planktonic.

EutroSORB treatment scheduled for Sept. 1st! This will lower the Phosphorus levels within this pond, which will reduce the food source of the algae and improve the ecosystem.

- 7- Significant copper based treatments of Planktonic & Filamentous algae performed via boat and ATV. EutroSORB application (a Phosphorus reduction strategy) scheduled for Sept. 1st.

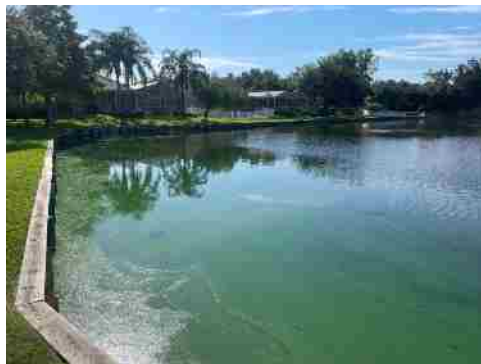
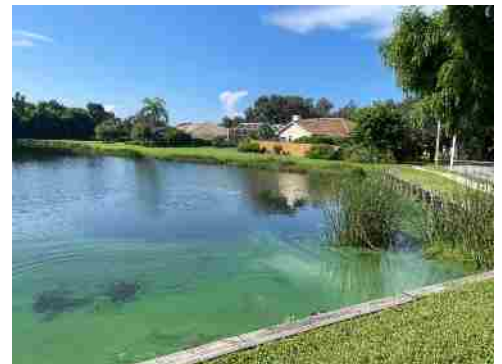
Pond 8

Requires Attention

Planktonic Algae spreading in pond.

Treatments performed to reduce this algae. We will carefully follow up to gauge results.

- 8- Treatment of Planktonic Algae performed. Follow up treatment scheduled for 2 weeks later.
- 9- Successful treatment of wooden retaining wall growth performed.

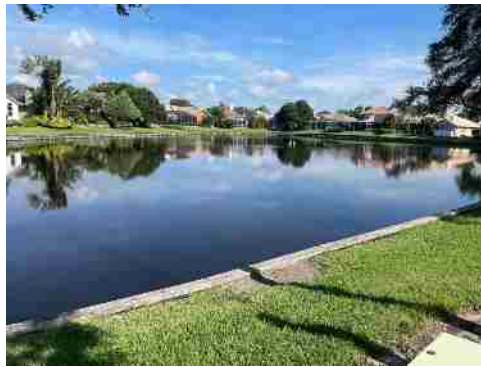
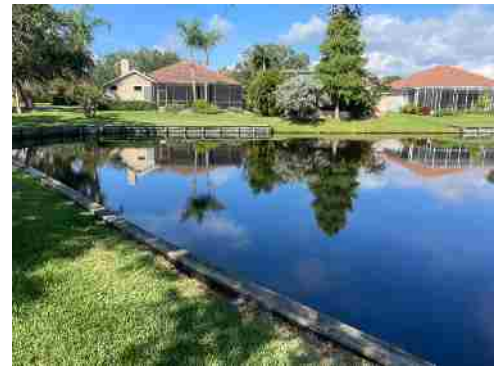
Pond 9

Site Looks Good

Excellent water clarity and growth in wooden retaining walls has been successfully treated.

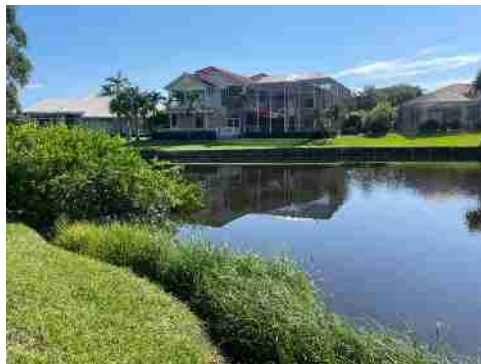
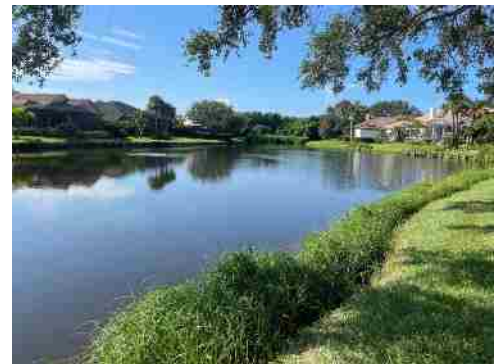
Pond 10

Site Looks Good

Excellent water clarity and growth in wooden retaining walls has been successfully treated.

Beneficial Marsh Grass growing quite nicely!

- 10- Successful treatment of wooden retaining wall growth. Also, Planktonic algae treatment performed.
