# Placido Bayou Community Association Waterway Inspection Report

**Reason for Inspection:** Customer Request

**Inspection Date:** 5/9/2014

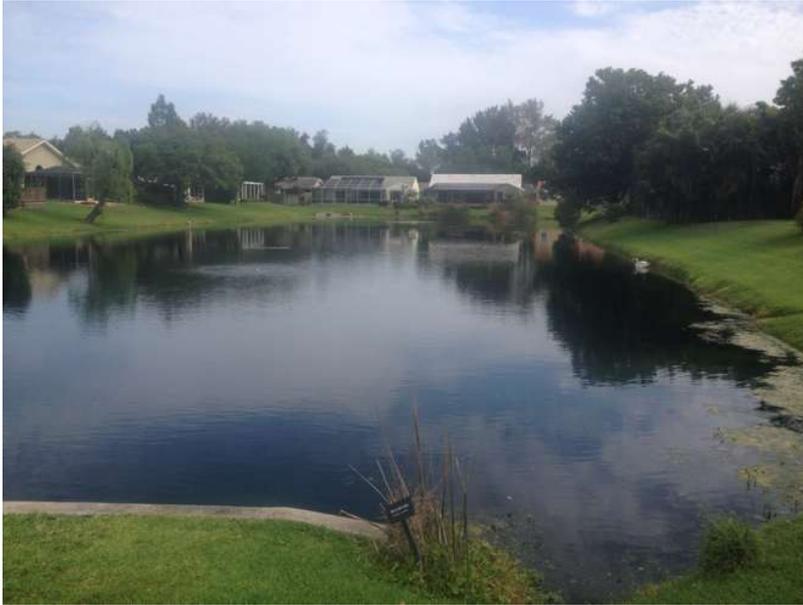
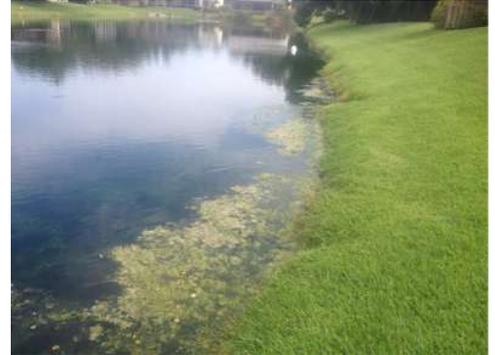
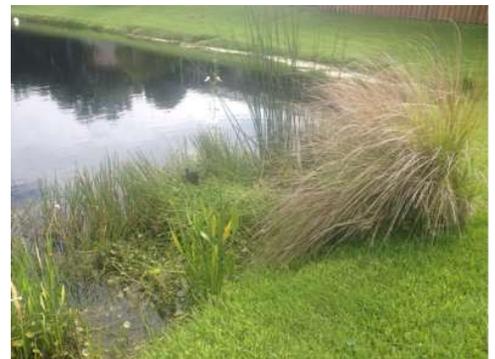
Site: 1

**Comments:** Normal growth observed

Site recently treated with peroxide based algaecide. Results should be evident in several days.

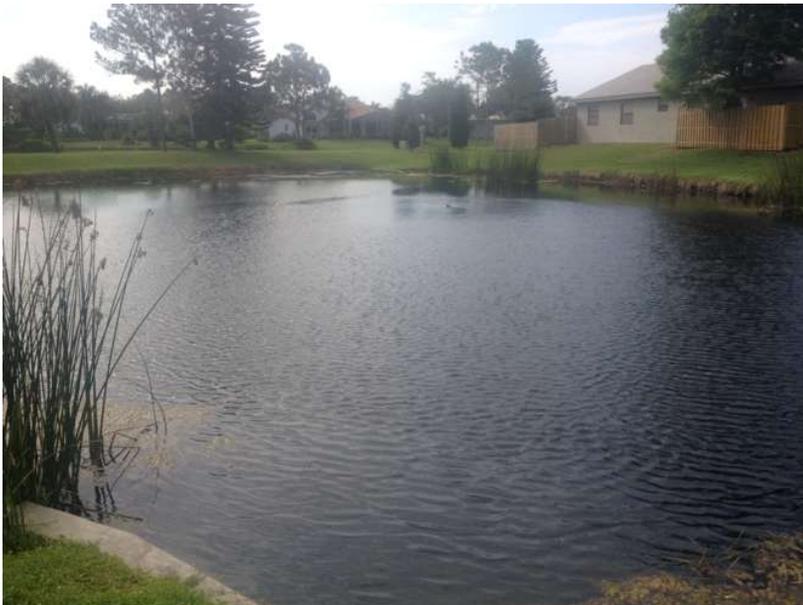
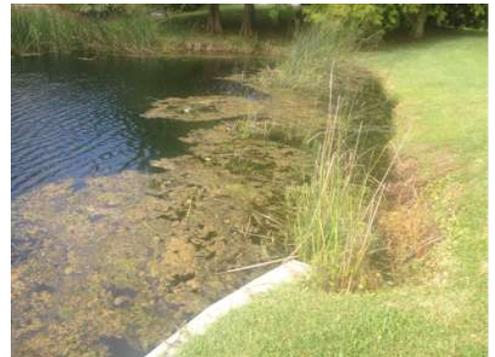
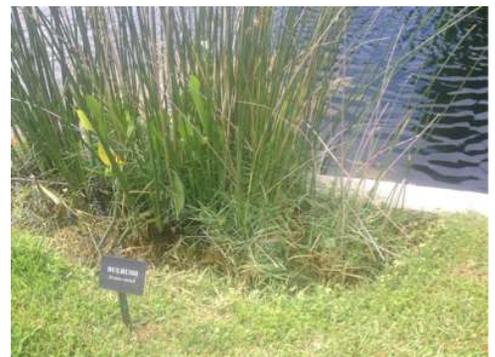
Site: 2

**Comments:** Requires attention

Technician will address algae growth and grasses observed amongst beneficial's during next visit.

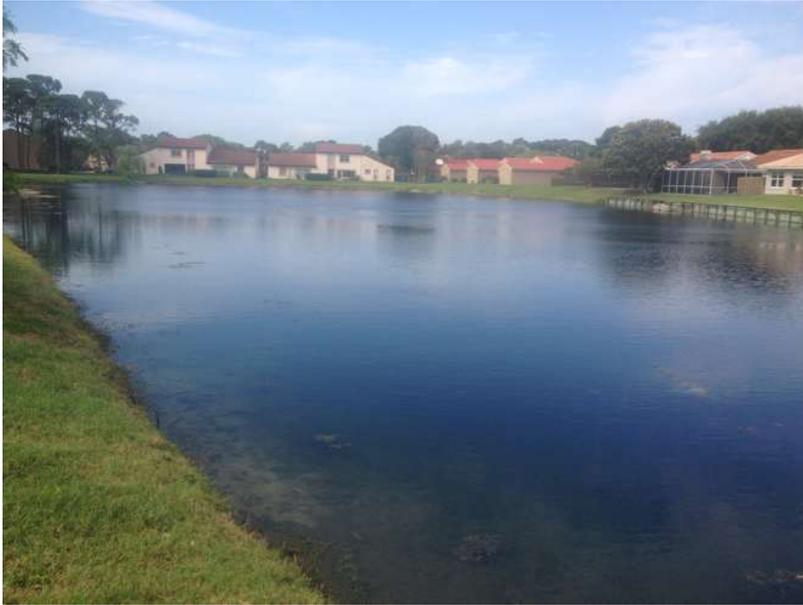
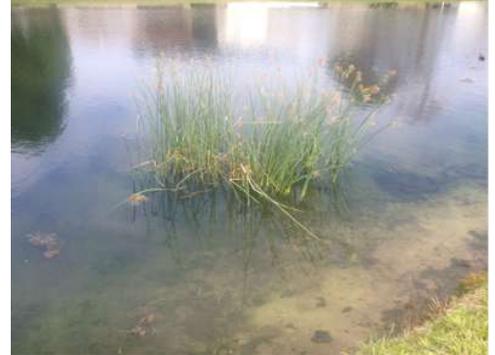
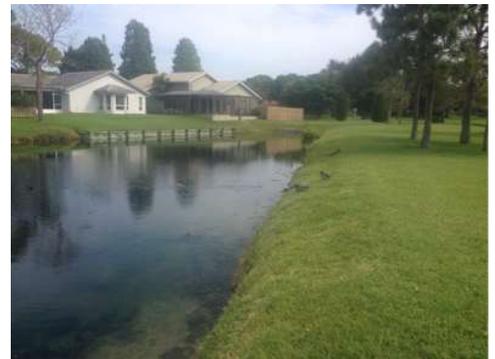
Site: 3

**Comments:** Site looks good

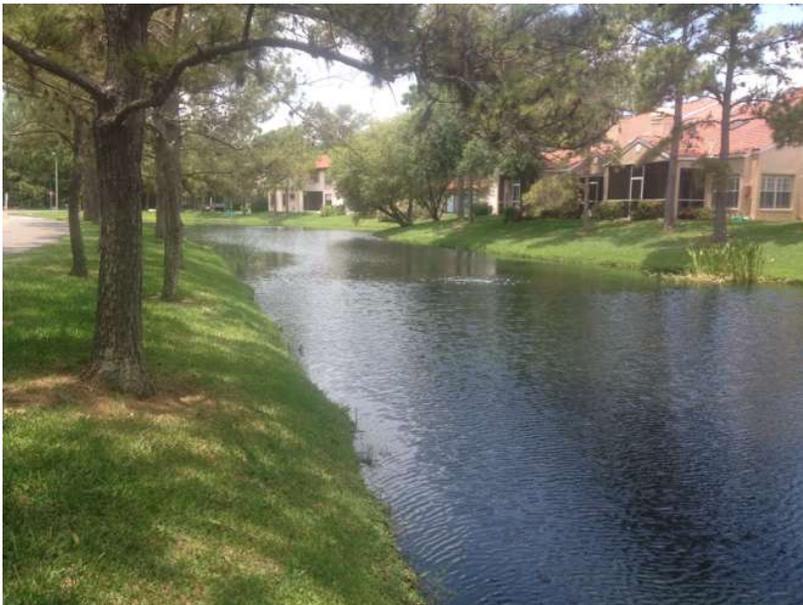
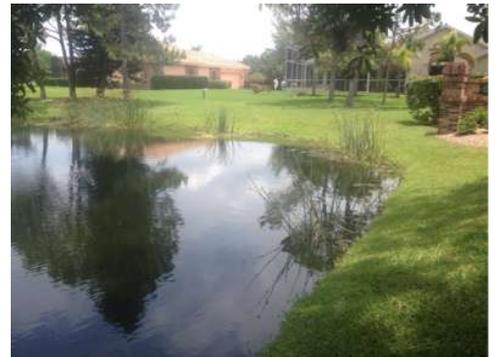
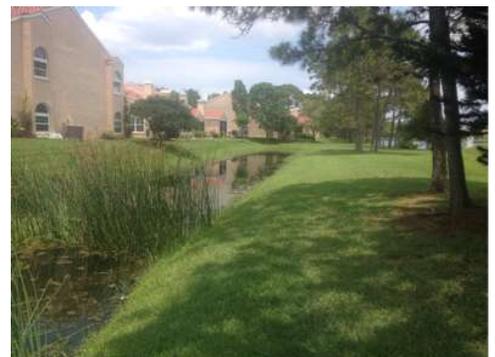
Site: 4

**Comments:** Normal growth observed

Address grasses amongst beneficial's on the inside corner during next visit.

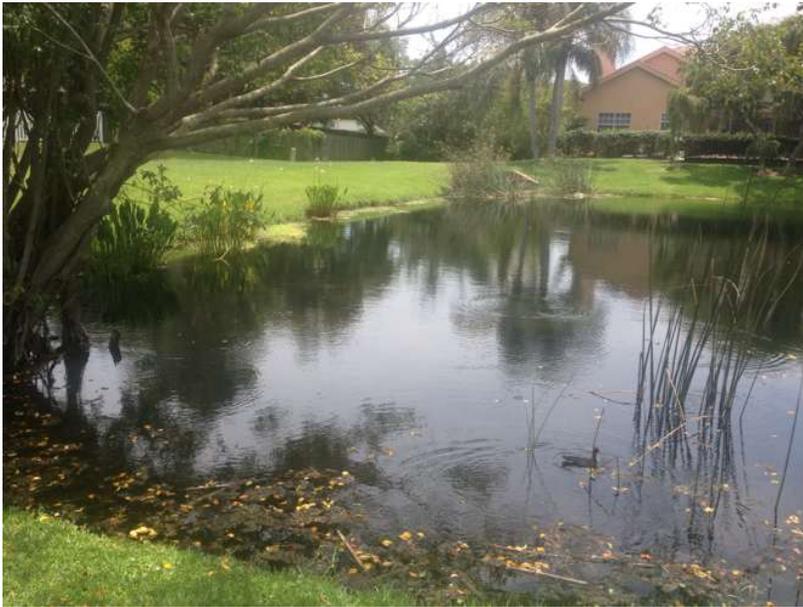
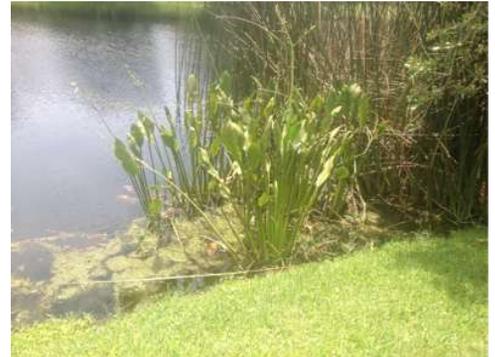
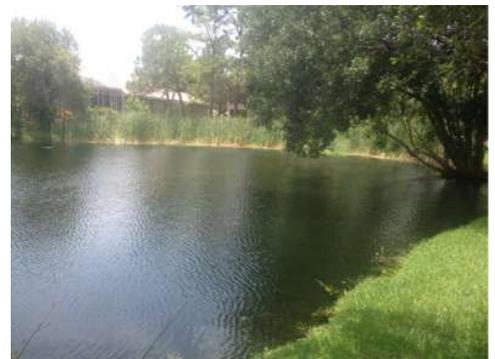
Site: 5

**Comments:** Normal growth observed  
Algae and Duckweed observed. Launch boat during next visit.

The removal of Cattails on pond #9 was performed this month and we will continue to monitor and treat the area for regrowth as it occurs. The Cattails on pond #5 will be trimmed back over the next several visits to the degree we discussed.

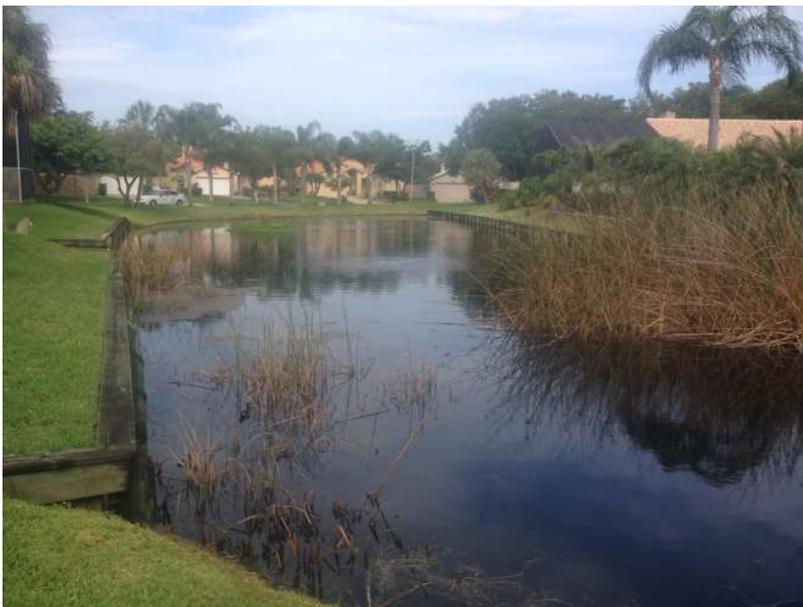
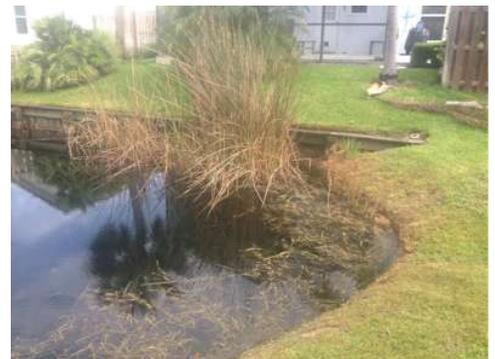
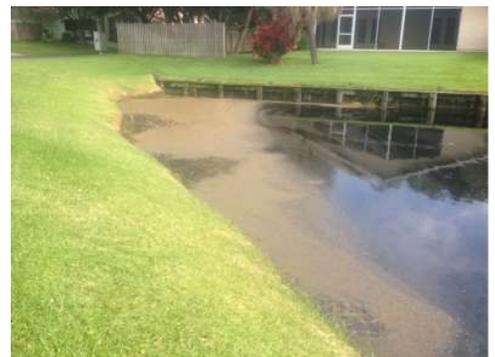
Site: 6

**Comments:** Site looks good  
Evidence of decomposing Duckweed present.

We have also strongly recommended instituting buffer zones around many troublesome ponds such as #6 to help limit nutrients as well.

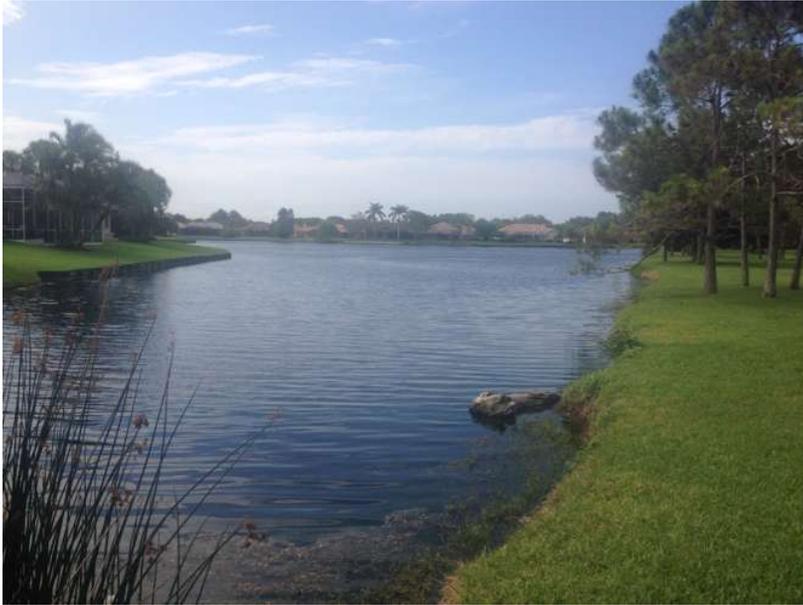
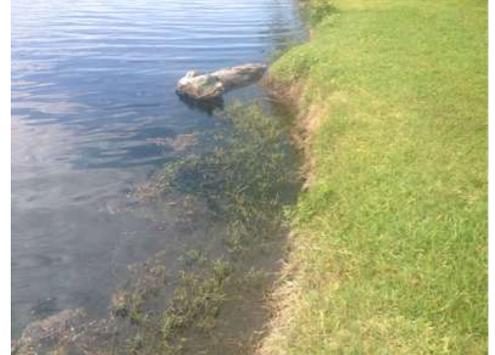
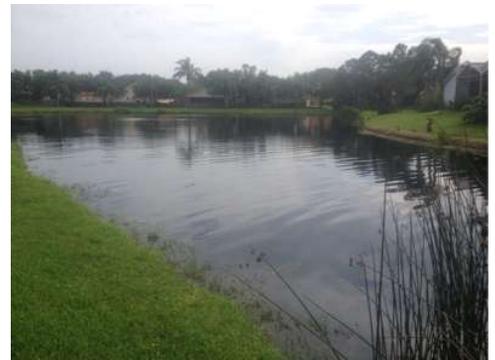
Site: 7

**Comments:** Requires attention

Shoreline grasses and submersed weeds to be treated during next visit.

The main focus for the next visit will be to eliminate any submersed vegetation remaining on pond #7 and to treat for all remaining Torpedograss so that issues will be minimal while the plants become established.

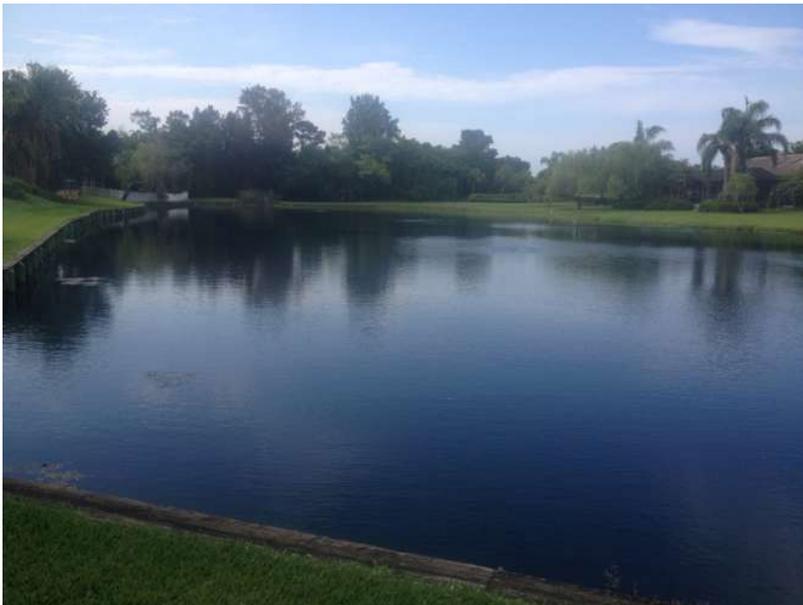
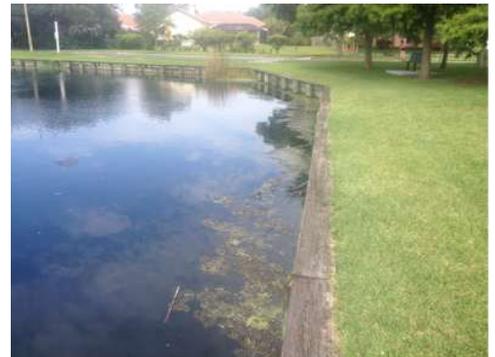
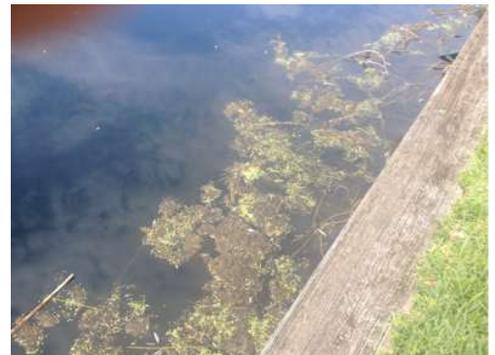
Site:

**Comments:** Normal growth observed

Trace Algae and Duckweed observed. Will treat on next visit.

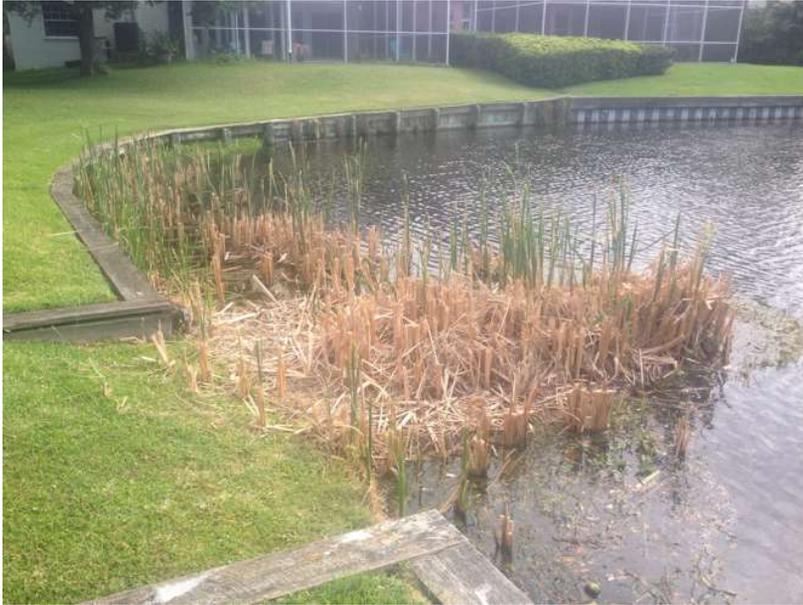
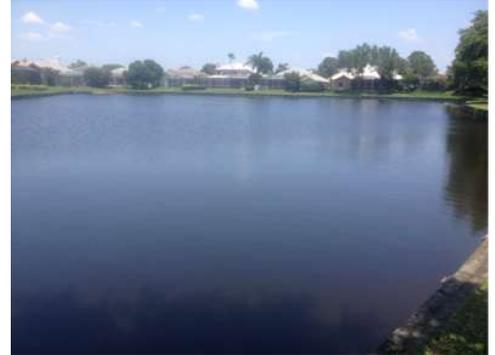
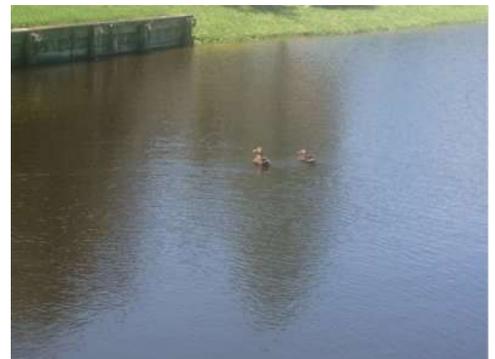
Site: 9

**Comments:** Site looks good

Removal of Cattails successful. Retreat new growth during next visit.

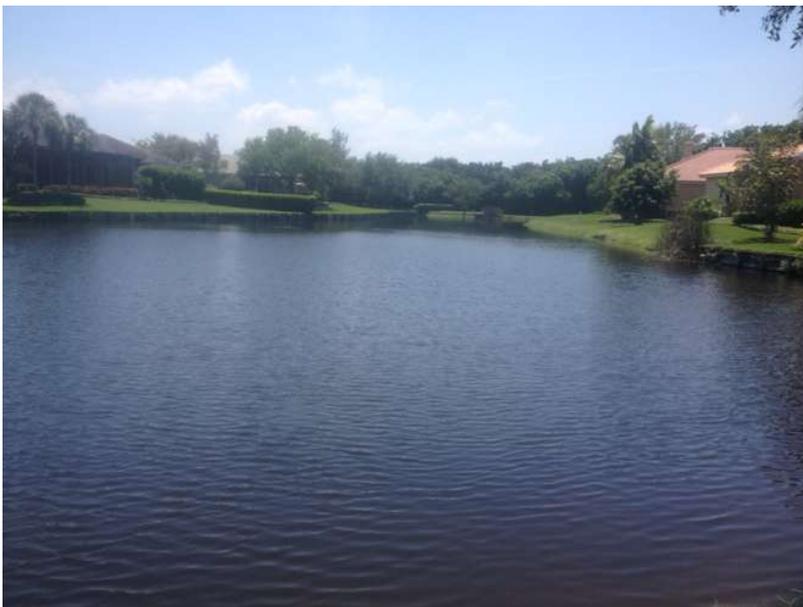
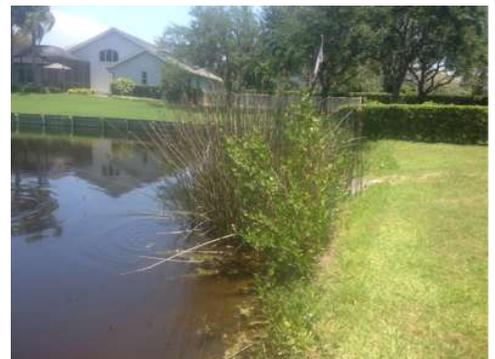
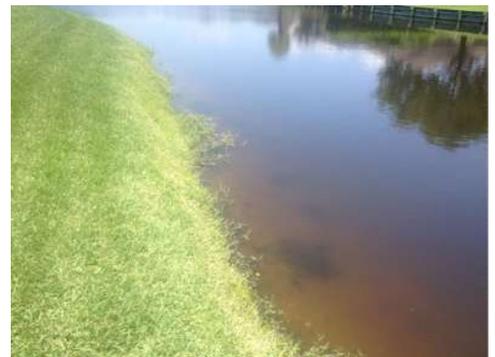
Site: 10

**Comments:** Site looks good

Trace grasses observed to be treated on next visit.
