Placido Bayou Community Association Waterway Inspection Report

Reason for Inspection: Customer Request

Inspection Date: 4/1/2015

Aquatic Systems, Inc. – St. Petersburg Field Office

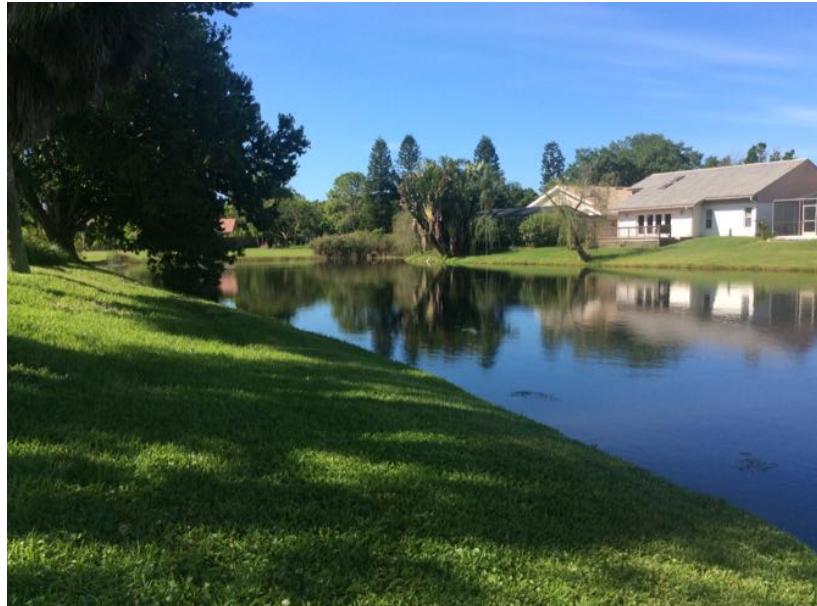
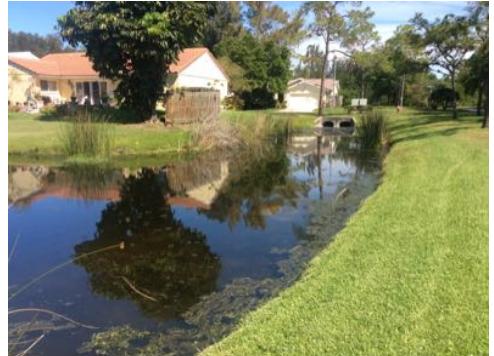
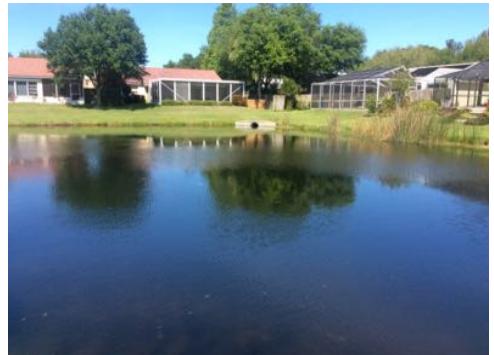
Site: 1

Normal growth observed

Inflow now clear of Bacopa. Duckweed and surface algae observed developing in trace amounts. Technician will focus his efforts to minimize the spread of these species utilizing algaecide and herbicide ASAP in April.

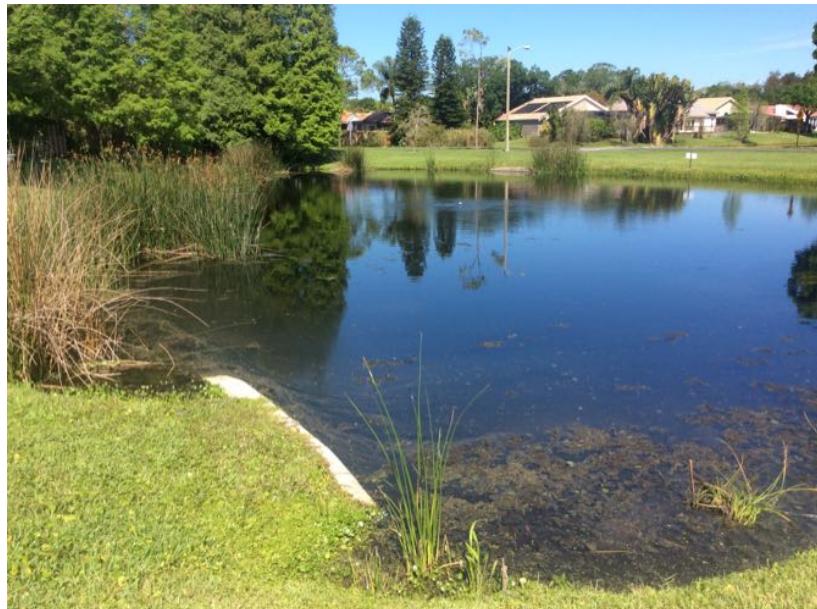
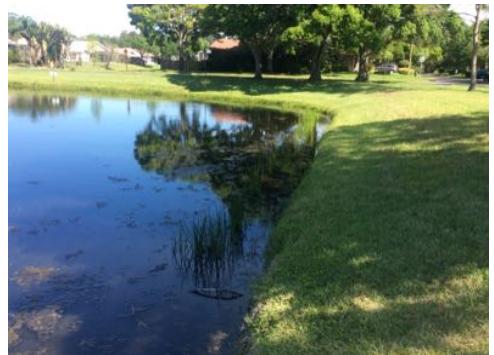
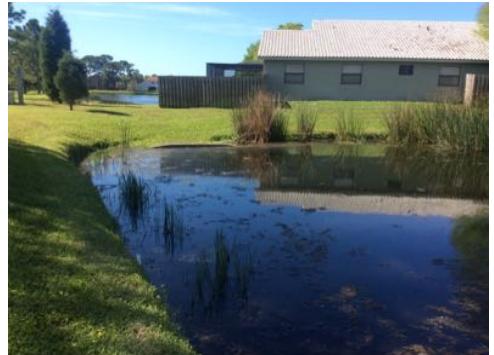
Site: 2

Normal growth observed

Trace algae observed likely due to extremely shallow nature of perimeter. Likely also the reason for the high success rate of plantings in this site. Algae will be treated during next visit.

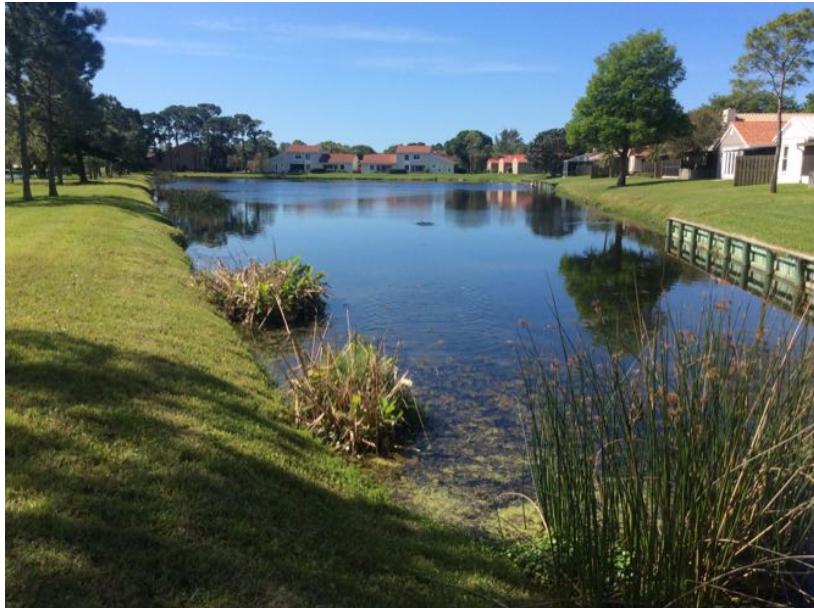
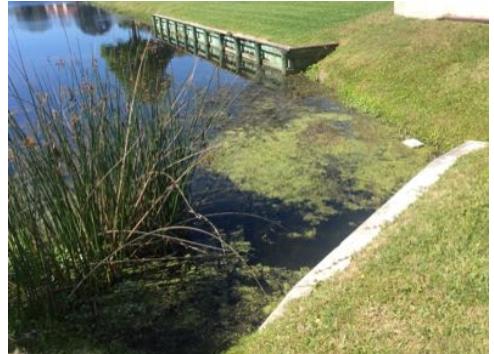
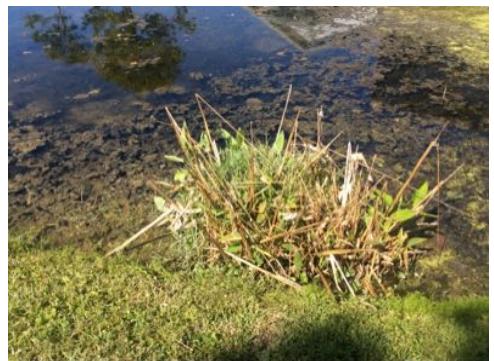
Site: 3

Requires attention
Trace amounts of algae and Duckweed also observed near culvert connecting sites #2 and #3.
Planned excavation of this area should help reduce this growth significantly. Treatment will occur at next scheduled visit.

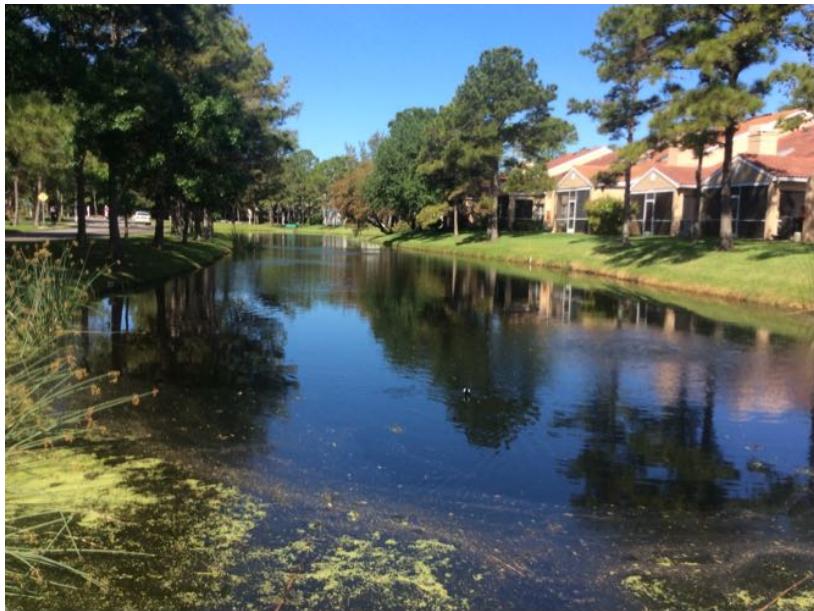
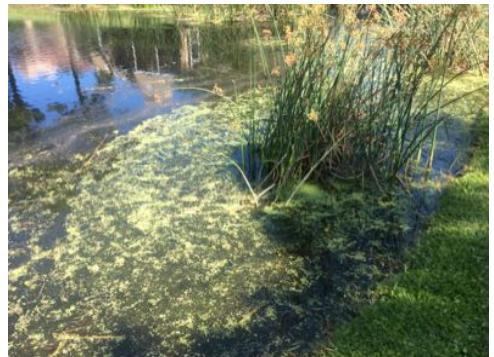
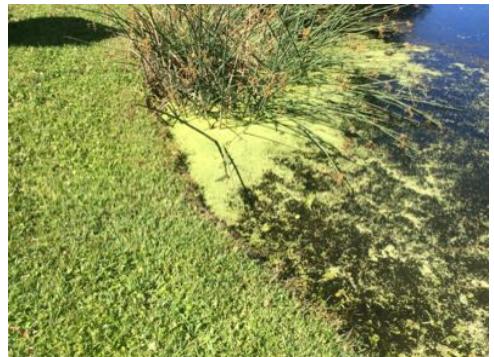
Site: 4

Requires attention
Duckweed is blooming rapidly in site #4 as seen here. Treatment is scheduled ASAP.

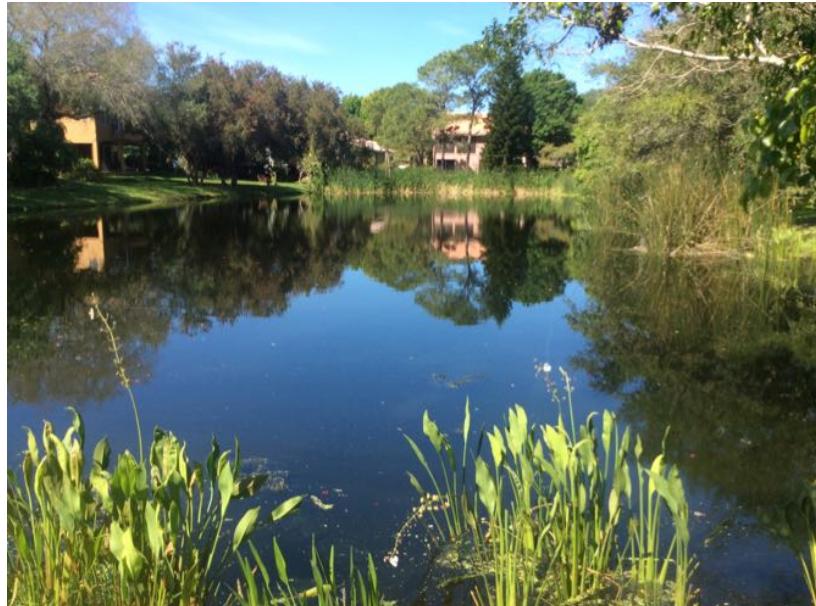
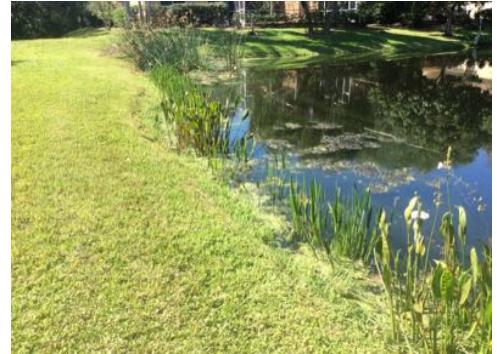
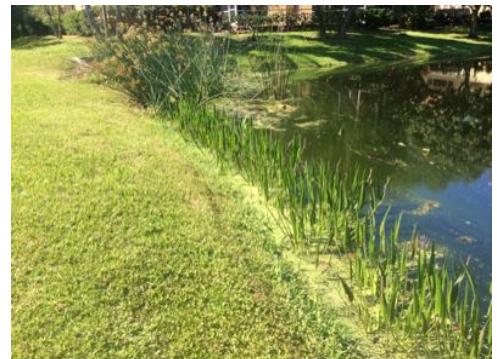
Site: 5

Requires attention
Trace Duckweed observed here as well. Will be treated ASAP. Beneficial's doing very well.

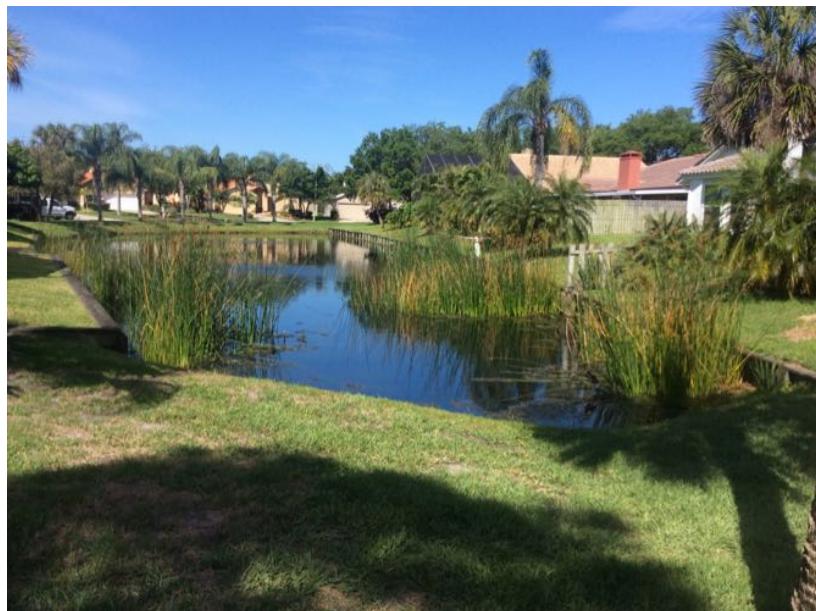
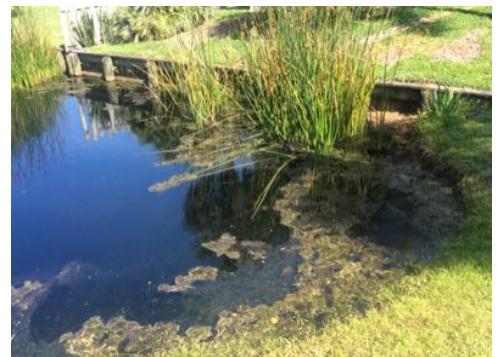
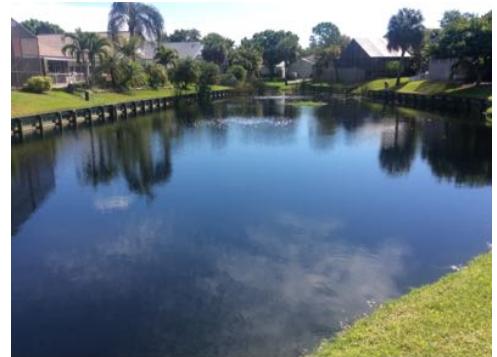
Site: 6

Normal growth observed
Trace algae and Duckweed observed at very small amounts in site #6. Treatment requirement should be minimal at this time.

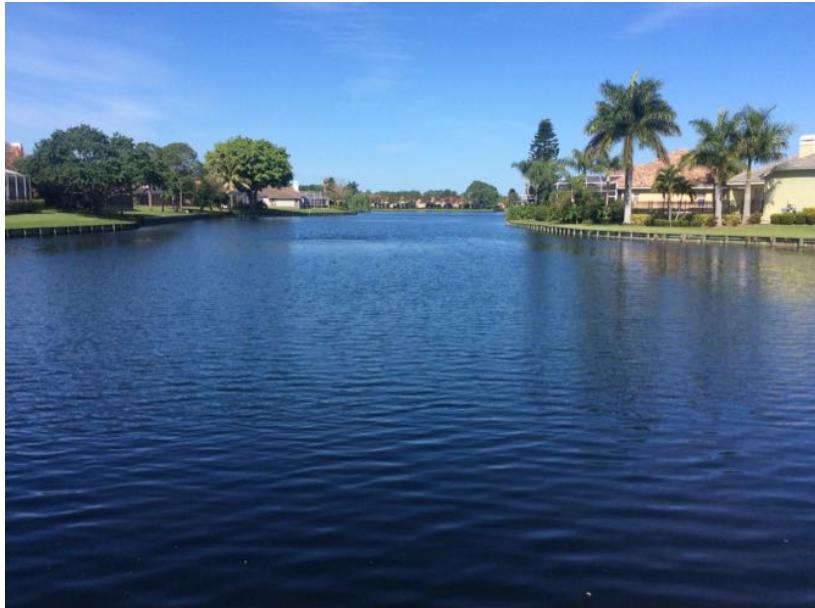
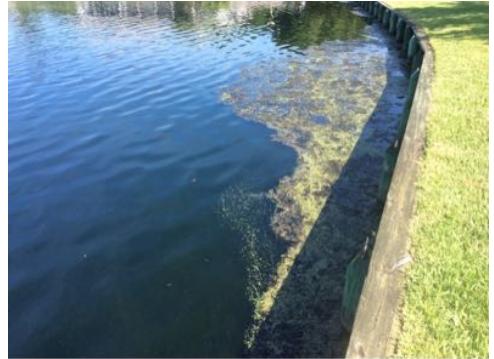
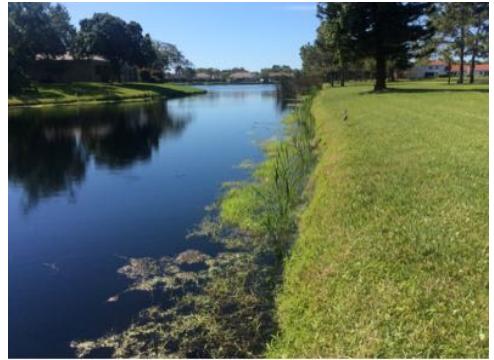
Site: 7

Requires attention
Grass clippings observed top right. Also present are Duckweed and algae. Bottom right is Torpedograss growing in area of new plantings. Careful application of systemic herbicide should bring this under control without collateral damage now that beneficial plants are established.

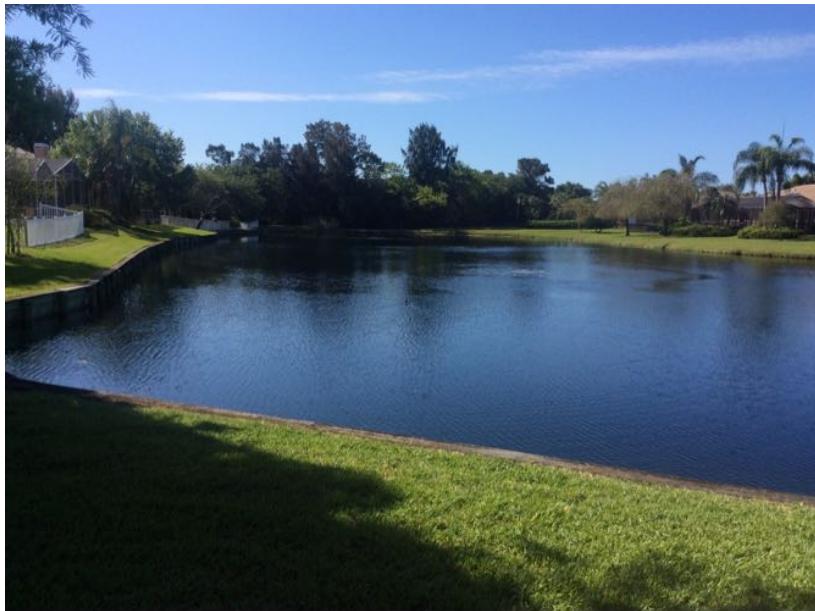
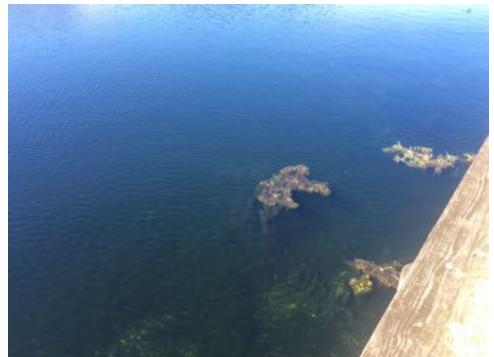
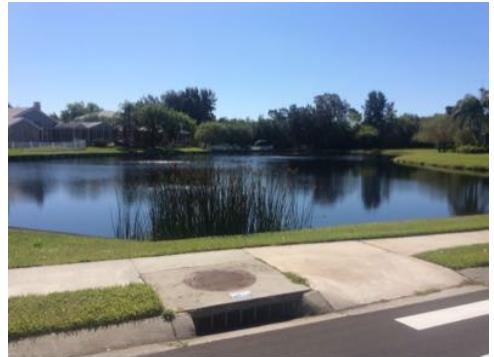
Site: 8

Site looks good
Trace bottom to surface algae observed. Overall site is in excellent condition at this time.

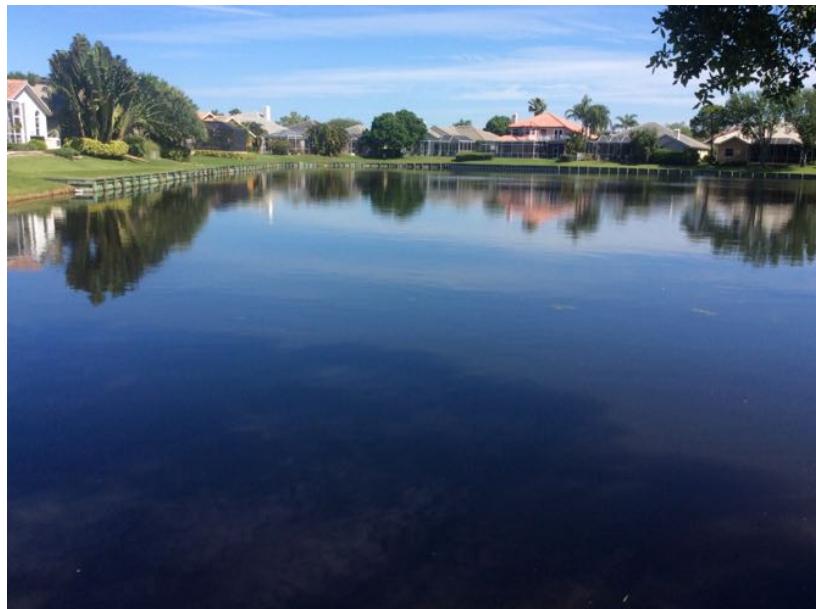
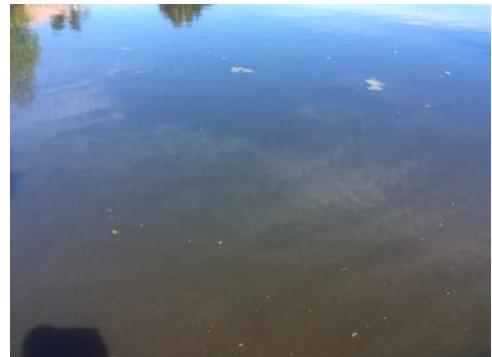
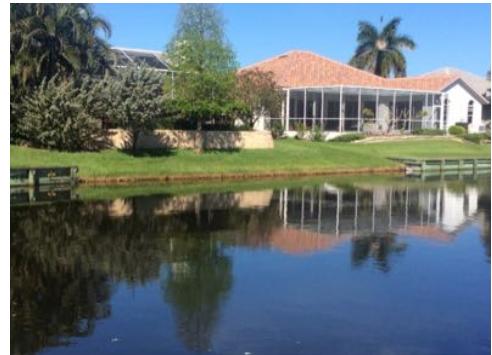
Site: 9

Normal growth observed

Planktonic growth still observed although in far lower density. Recommend for priority in aeration evaluation and alum application. Pond shading will be applied for now.

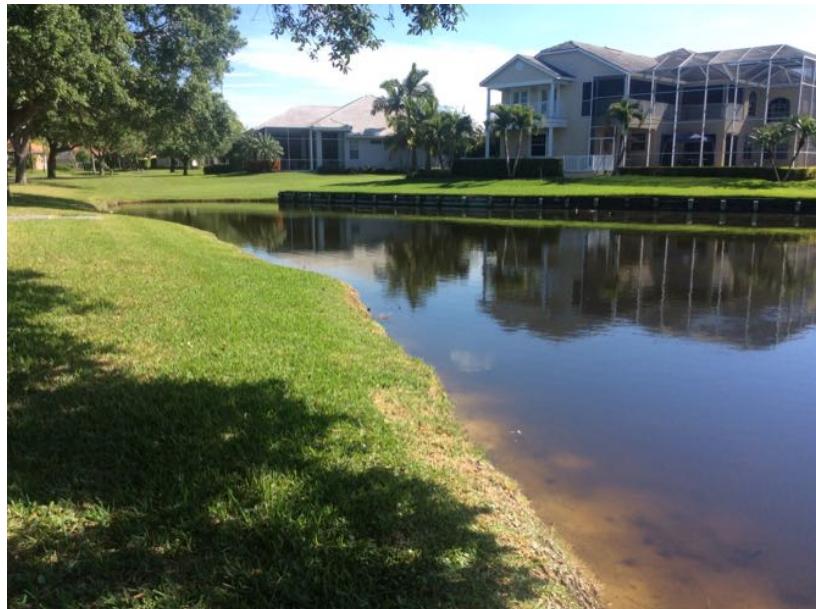
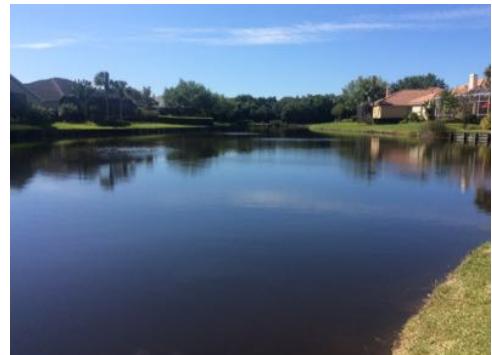
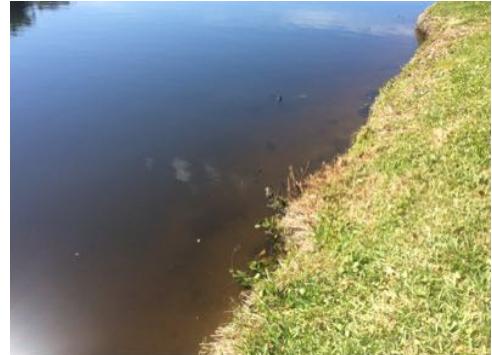
Site: 10

Site looks good

Shoreline mangroves no longer present. They would appear to be victim of a weed whacker. Otherwise site is in excellent condition.
