# Placido Bayou Community Association Waterway Inspection Report

**Reason for Inspection:** Customer Request

**Inspection Date:** 10/16/2015

James Roehm, Service Manager  
Aquatic Systems, Inc. – St. Petersburg Field Office  
Corporate Headquarters  
2100 N.W. 33<sup>rd</sup> Street, Pompano Beach, FL 33069  
1-800-432-4302

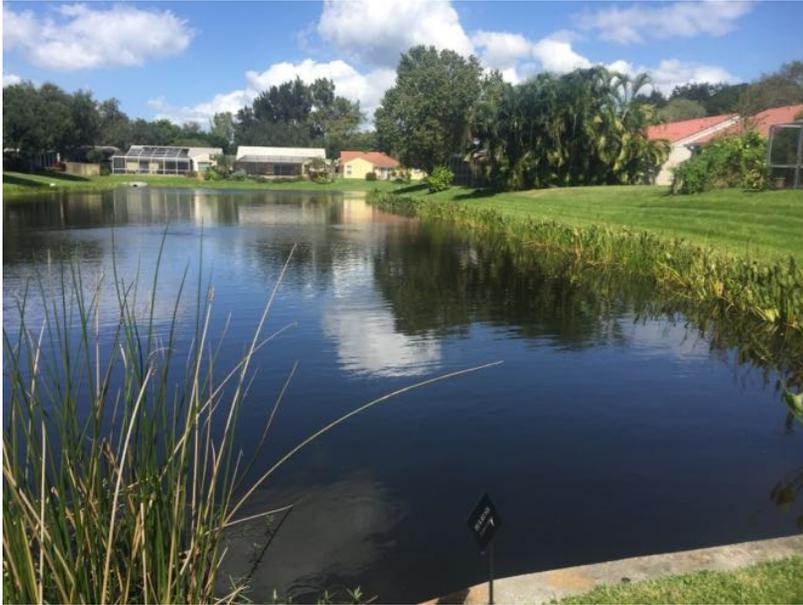
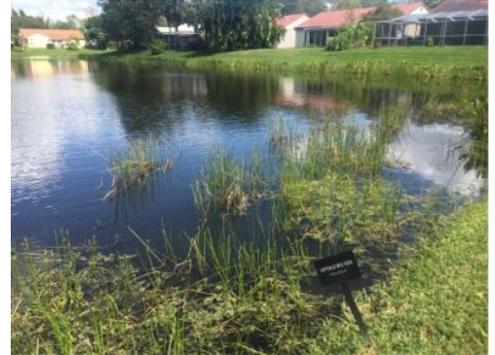
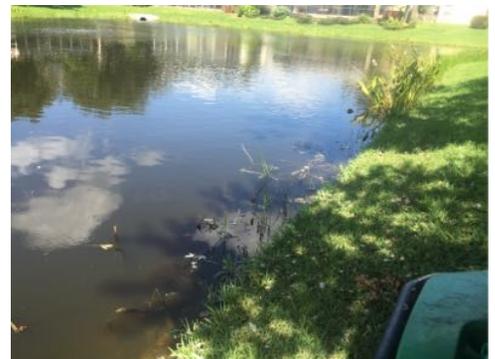
Site: 1

**Comments:** Site looks good

Gulf Spikerush (beneficial) is growing in area where Alligatorweed and Torpedograss was physically removed. 150 Duck Potato were planted along perimeter in areas that required extra plants.

1. Gulf Spikerush (beneficial) is growing in area where Alligatorweed and Torpedograss was physically removed. 150 Duck Potato were planted along perimeter in areas that required extra plants.

1. Restrict herbicide around young plants and spot spray invasives around beneficials.
2. Spot spray invasives around beneficials and monitor algae/duckweed growth.

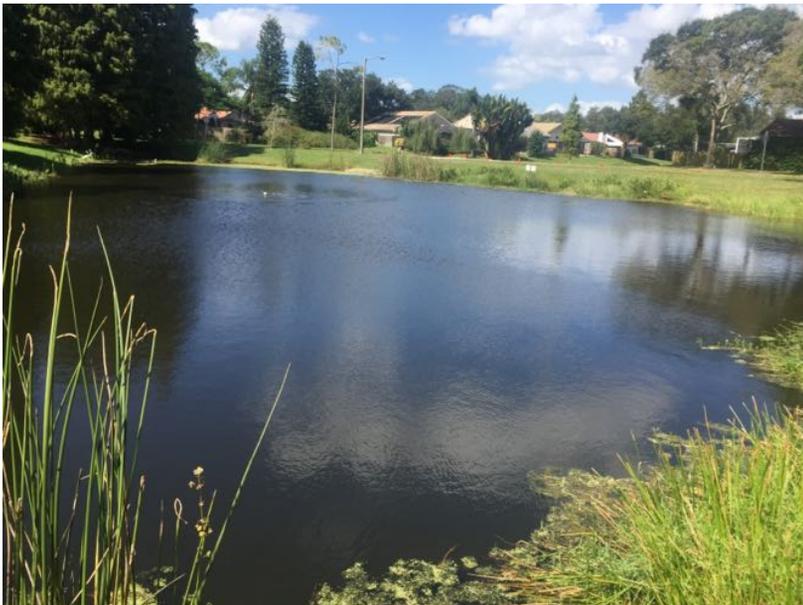
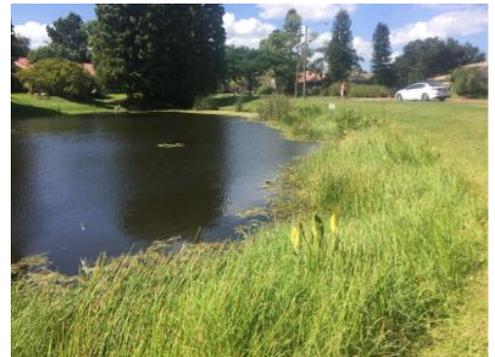
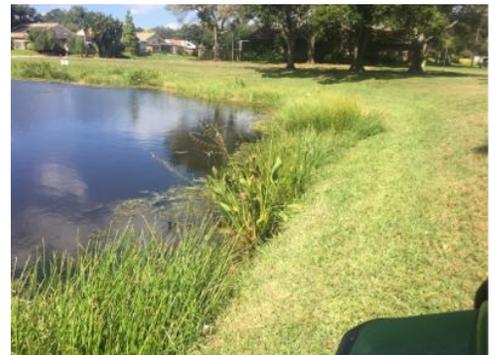
Site: 2

**Comments:** Site looks good

Alligatorweed was physically removed that was floating in the middle of pond. The beneficial plants are filling in well here. We will monitor for future algae growth.

2. Alligatorweed was physically removed that was floating in the middle of pond. The beneficial plants are filling in well here. We will monitor for future algae growth.

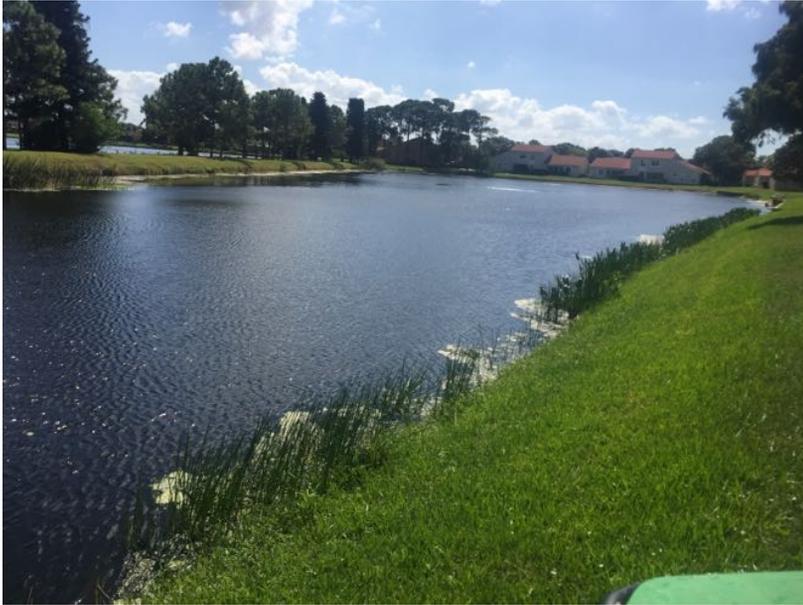
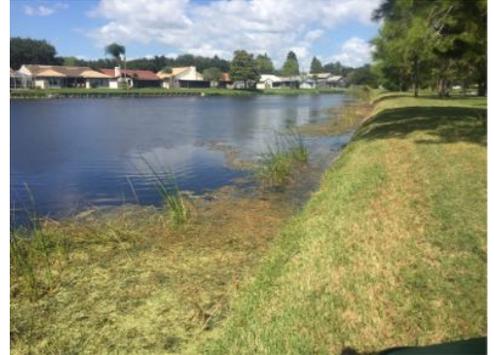
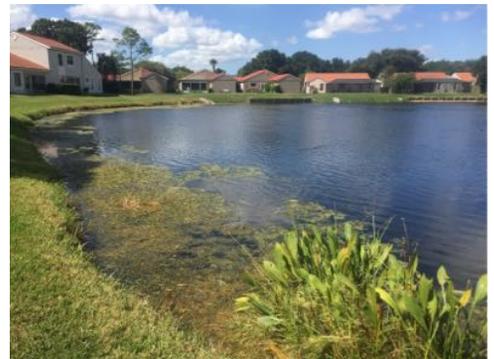
Site: 3

**Comments:** Site looks good

Observed a successful herbicide spot treatment along the perimeter. The Alligatorweed and Torpedograss will continue to decompose next month. Beneficial Bulrush will now begin to establish this perimeter. 30 bare-root Gulf Spikerush were planted in this pond.

3. Observed a successful herbicide spot treatment along the perimeter. The Alligatorweed and Torpedograss will continue to decompose next month. Beneficial Bulrush will now begin to establish this perimeter. 30 bare-root Gulf Spikerush were planted in this pond.

3. Restrict herbicide use around young growth. Allow grasses to decompose from previous treatment and focus on allowing beneficial Bulrush to grow along perimeter.

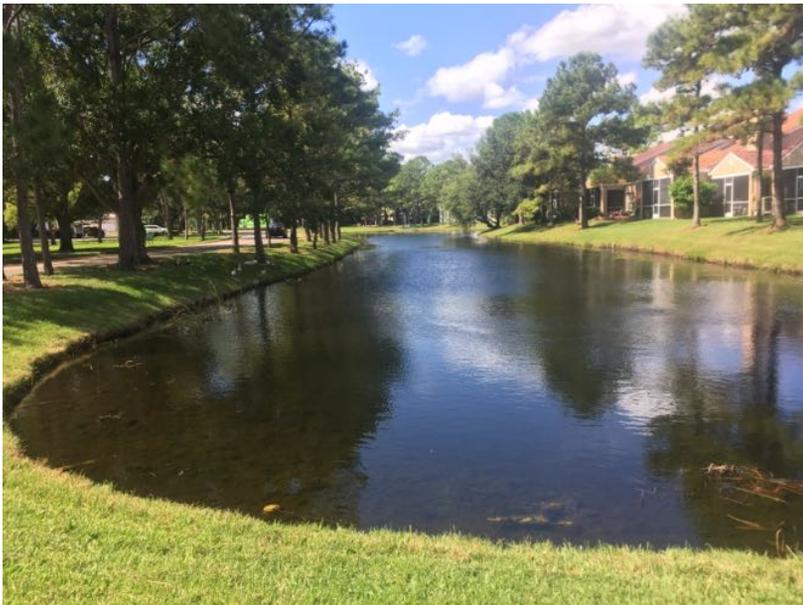
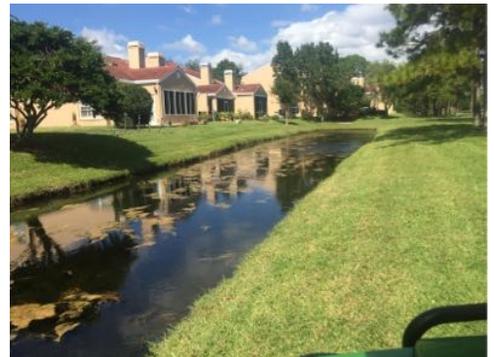
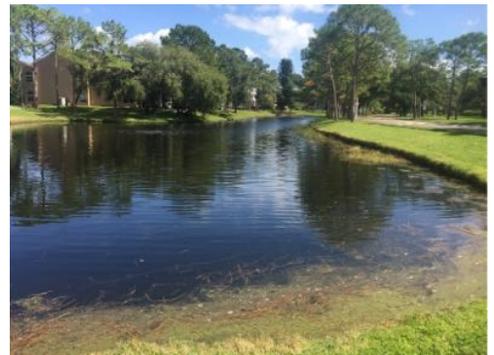
Site: 4

**Comments:** Normal growth observed

Algae from previous treatment appears to be decomposing. Algae will be continuously targeted in this pond.

4. Algae from previous treatment appears to be decomposing. Algae will be continuously targeted in this pond.
5. Cattails and Torpedograss continue to decompose from previous treatment. Cattails along inflow area were physically removed. We will continue to treat Cattail regrowth in this area. Algae appears to be dying from previous treatment.

4. Continue scheduled algaecide treatments.
5. Monitor regrowth of Cattails along perimeter and Treat any reoccurring algae and Torpedograss.
6. Apply and algaecide with a nutrient reducing agent to help establish longer term control. We will physically remove Primrose on the floating mat and treat the Alligatorweed with herbicide. Dye should be added to the pond.

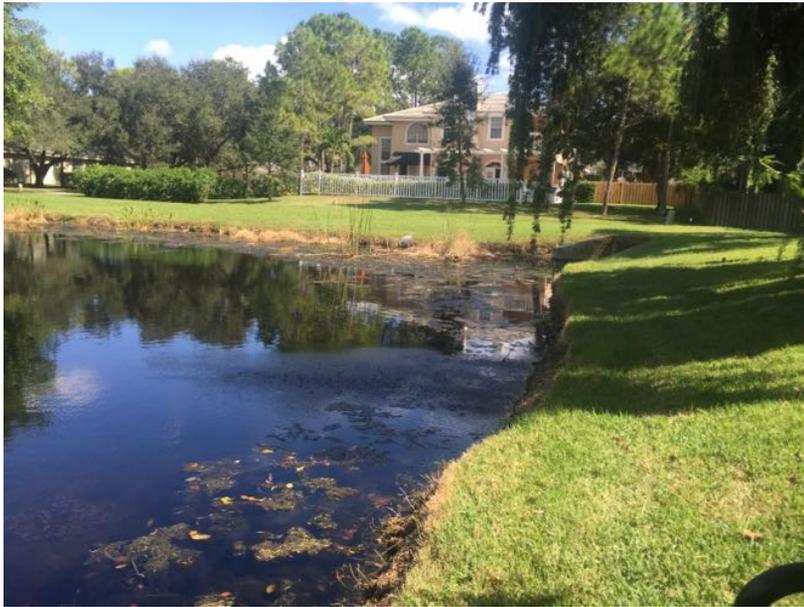
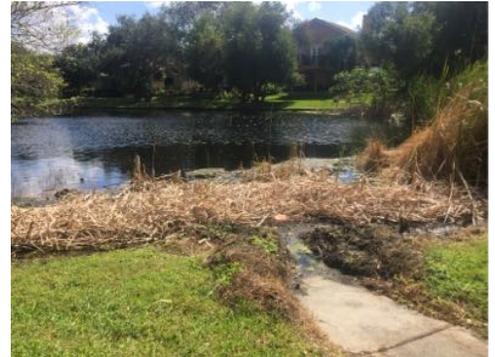
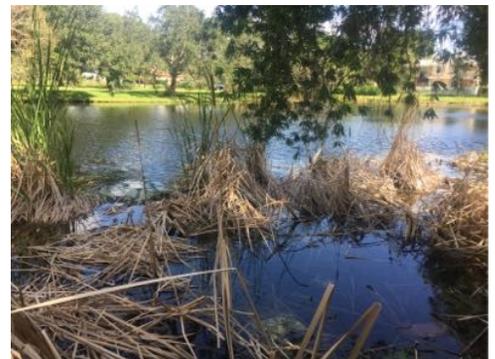
Site: 5

**Comments:** Normal growth observed

Cattails and Torpedograss continue to decompose from previous treatment. Cattails along inflow area were physically removed. We will continue to treat Cattail regrowth in this area. Algae appears to be dying from previous treatment.

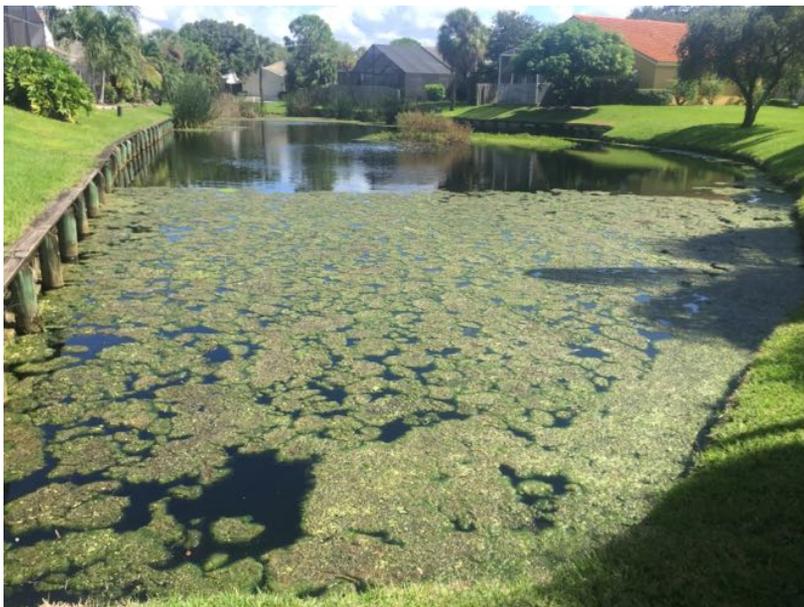
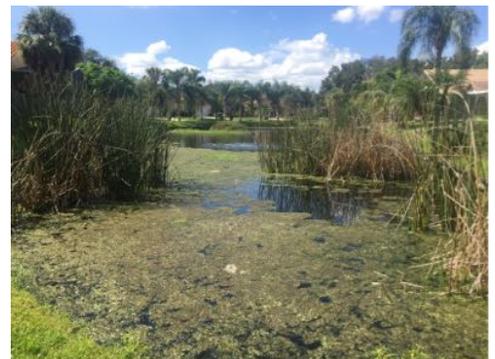
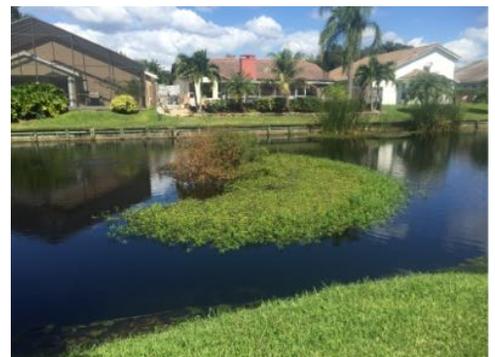
Site: 6

**Comments:** Requires attention

Extensive algae treatment with nutrient reducing agent is to be applied next visit. The Primrose on the floating mat will be physically removed, while the Alligatorweed is to be chemically treated. Dye is recommended for this pond.

6. Extensive algae treatment with nutrient reducing agent is to be applied next visit. The Primrose on the floating mat will be physically removed, while the Alligatorweed is to be chemically treated. Dye is recommended for this pond.

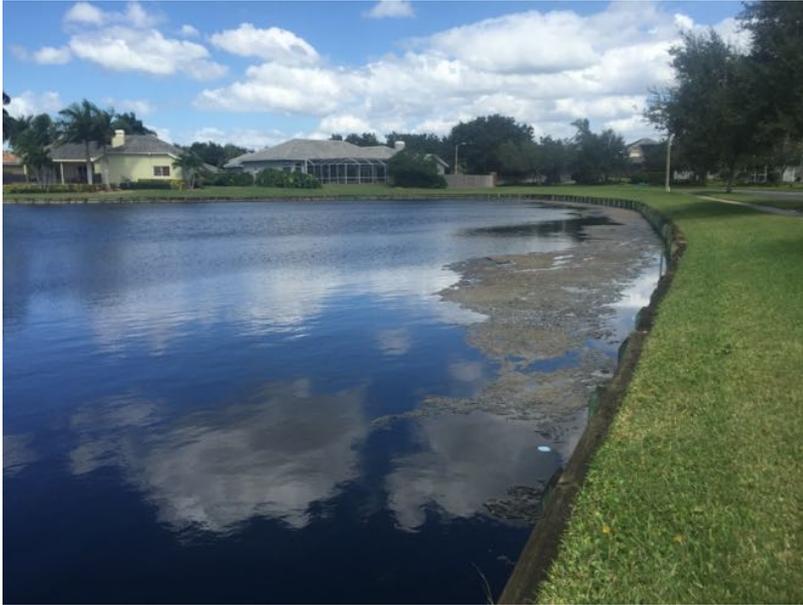
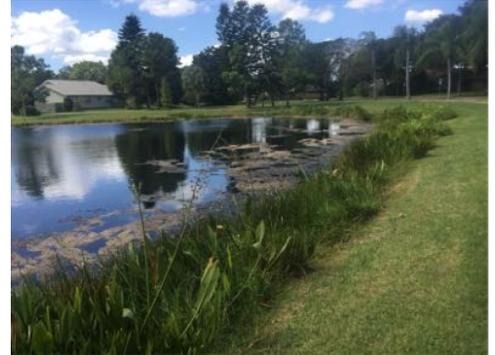
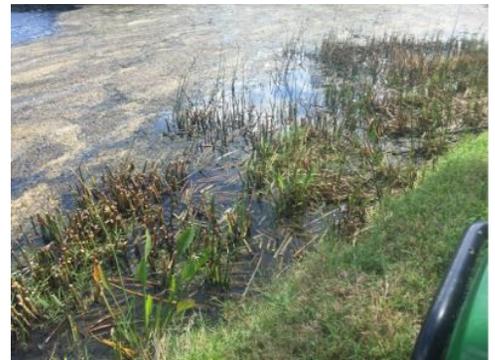
Site: 7

**Comments:** Requires attention

The lighter areas of algae are dying from previous treatment. Follow-up treatment is necessary on this lake. The Bullrush that was physically removed is being controlled with herbicide while young Duckpotato fill in.

7. The lighter areas of algae are dying from previous treatment. Follow-up treatment is necessary on this lake. The Bullrush that was physically removed is being controlled with herbicide while young Duckpotato fill in.

7. Follow-up treatment is necessary on the filamentous algae due to the fact I saw 50% dying. Spot spraying along the perimeter is necessary to reduce invasives growing with the beneficials.

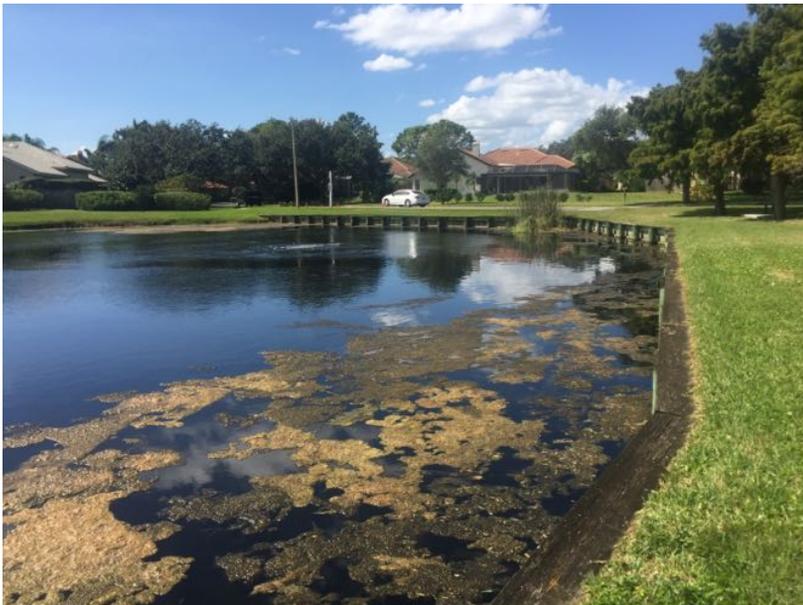
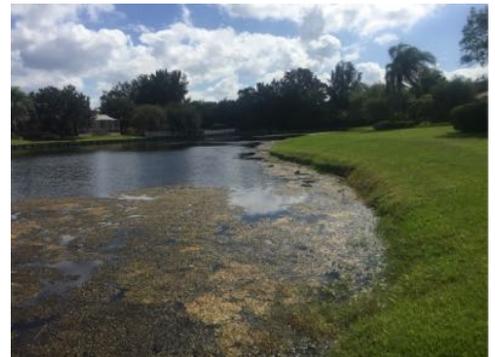
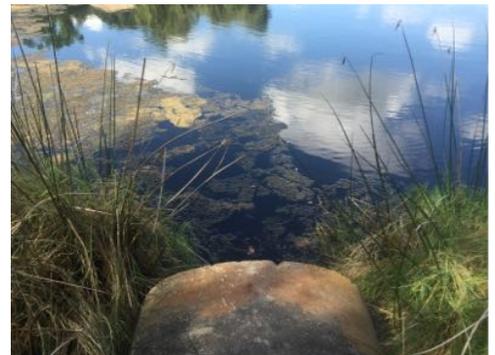
Site: 8

**Comments:** Requires attention

The lighter areas of algae are dying from previous treatment. Follow-up treatment is necessary on this lake. Areas on each side of outflow pipe are recommended to be treated. Torpedograss along perimeter is decomposing from prior treatment.

8. The lighter areas of algae are dying from previous treatment. Follow-up treatment is necessary on this lake. Areas on each side of outflow pipe are recommended to be treated. Torpedograss along perimeter is decomposing from prior treatment.

8. Follow-up treatment with algaecide is needed. Allow the dying Torpedograss to decompose inside the pond. Next month we should spray the Torpedograss and Bulrush growing on either side of the outflow pipe.

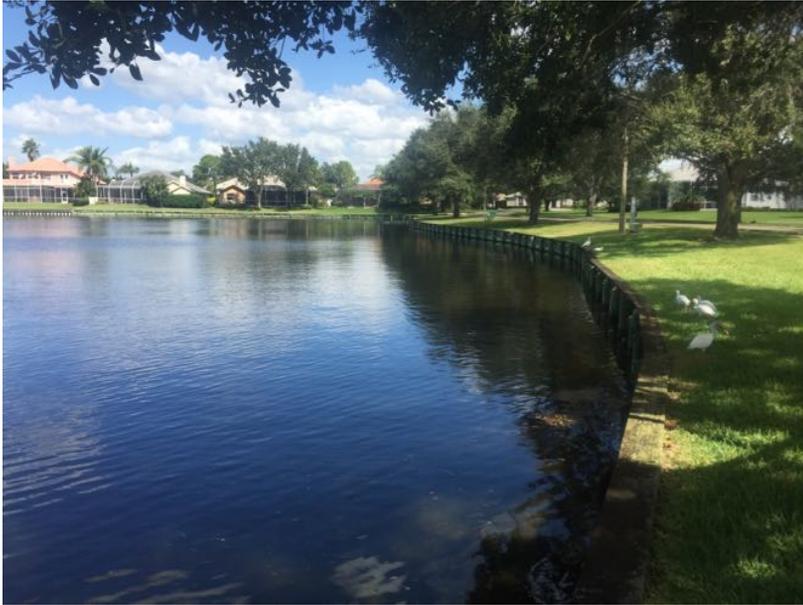
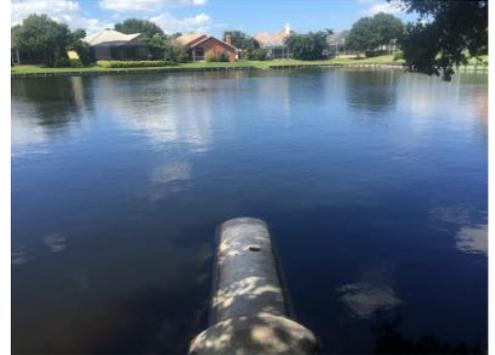
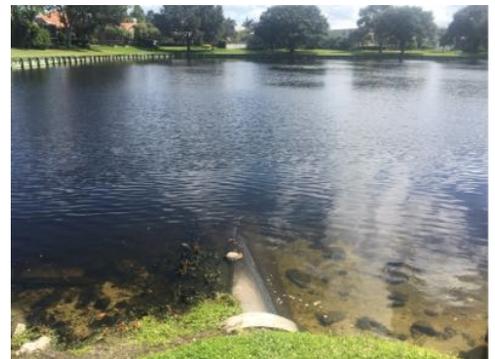
Site: 9

**Comments:** Site looks good

The pond looks great. I've notice very clear water clarity and native mollusks inside pond. Area along inflow pipe that had a Cattail removal remains clear of obstruction.

9. The pond looks great. I've notice very clear water clarity and native mollusks inside pond. Area along inflow pipe that had a Cattail removal remains clear of obstruction.

9. Monitor inflow pipe for future Cattail growth.
10. No action at this time.

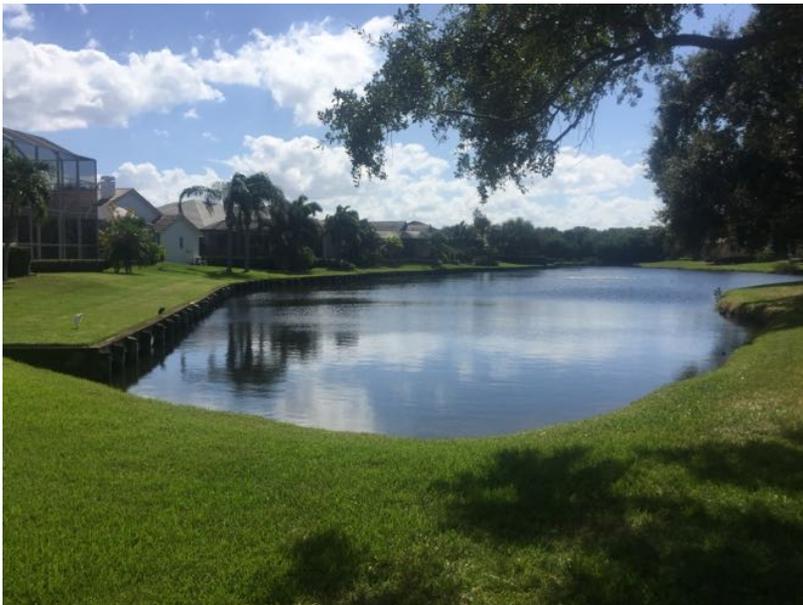
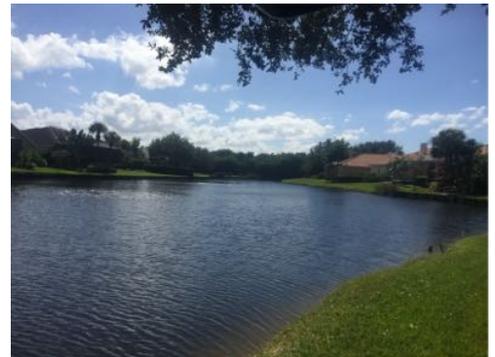
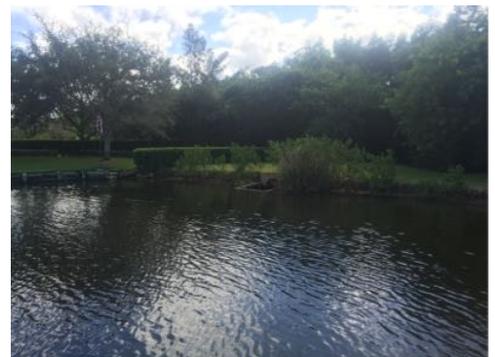
Site: 10

**Comments:** Site looks good

Lake is free of algae and shoreline grass. We will continue to monitor pond at this time.

10. Lake is free of algae and shoreline grass. We will continue to monitor pond at this time.
