# Placido Bayou Community Association Waterway Inspection Report

**Reason for Inspection:** Routine Scheduled - Monthly

**Inspection Date:** 4/3/2017

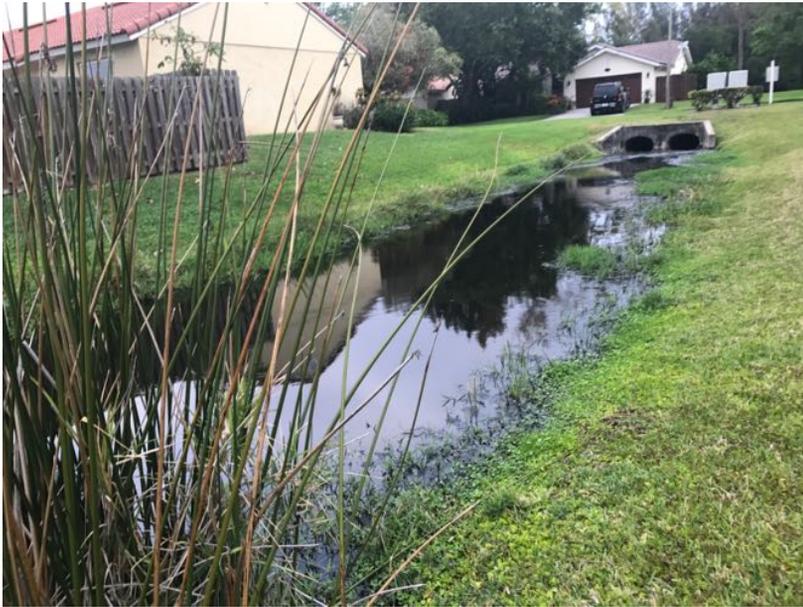
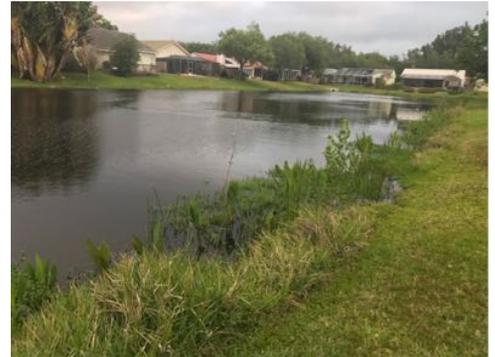
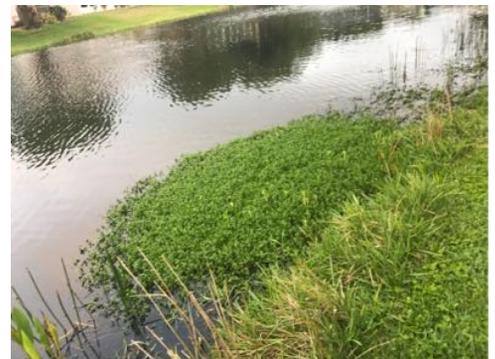
Site: 1

**Comments:** Site looks good

St. Augustine grass is beginning to choke out beneficial plants. Also, I'm noticing some yellowing and browning of Gulf Spikerush. I recommend a salinity test to be sent out to our lab. ASI will cover costs. I will provide an update with possible TIGR use next month.

1. Salinity test/no charge water sample. Selectively treat with TIGR, if herbicide becomes available. Continue not using herbicides on this pond.
2. Alum treatment.
3. Alum treatment and submersed Naiad treatment next scheduled treatment.
4. Alum treatment and probiotic treatments. Monitor recent planting.
5. Alum treatment and monitor future algae growth.
6. Alum treatment and probiotic treatments. Recommend allowing shedding leaves of Bulrush to slowly fall and decompose inside the pond.
7. Alum treatment and submersed Hydrilla treatment next scheduled treatment. Continue to monitor for algae growth and keep established buffer line between terrestrial areas and aquatic areas.
8. Monitor recent planting.
9. No action required.
10. Monitor Smooth Cordgrass.

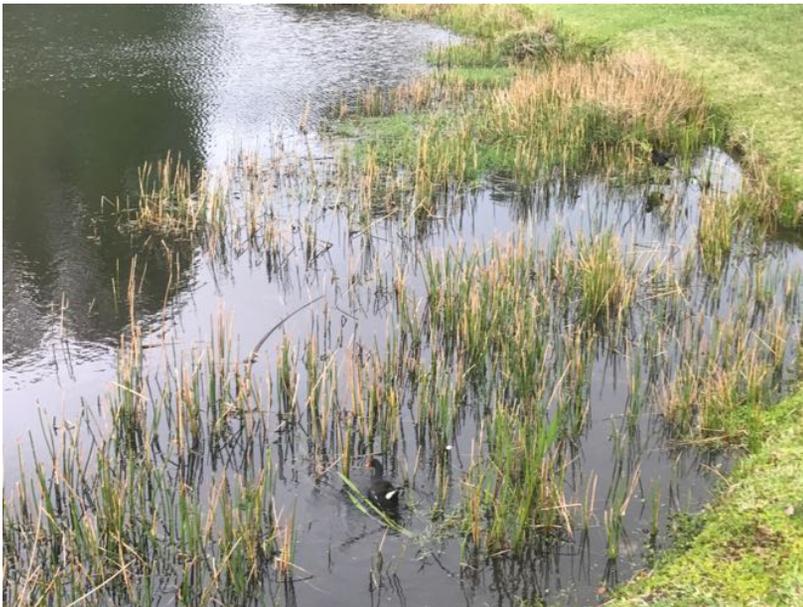
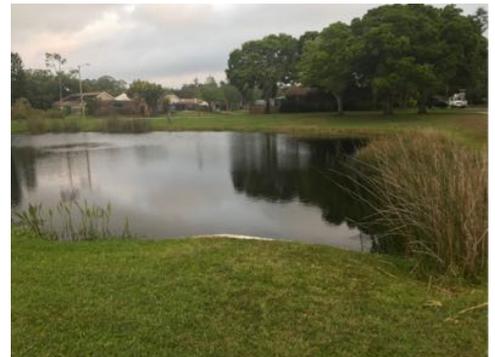
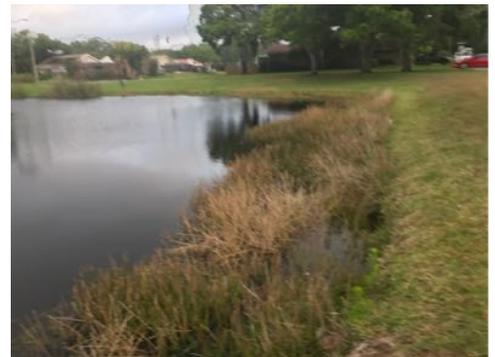
Site: 2

**Comments:** Site looks good

No action required.

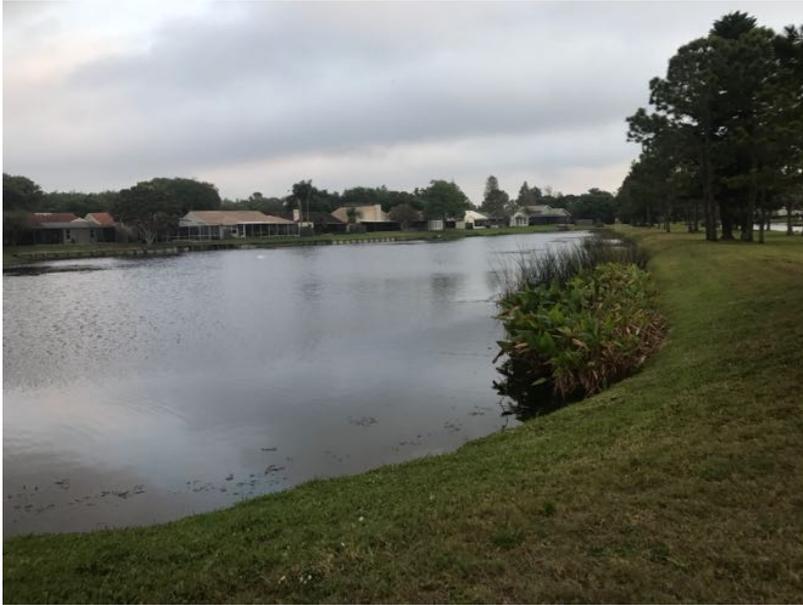
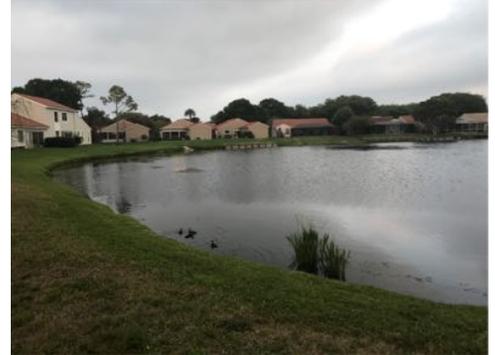
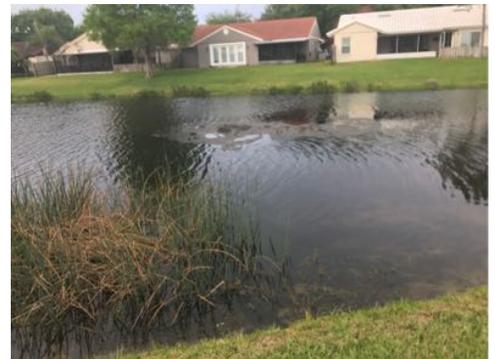
Site: 3

**Comments:** Treatment in progress

Filamentous algae is currently being treated, especially in wind blown areas of the lake. New appearance of Naiad is showing in the pond and will be treated next scheduled visit.

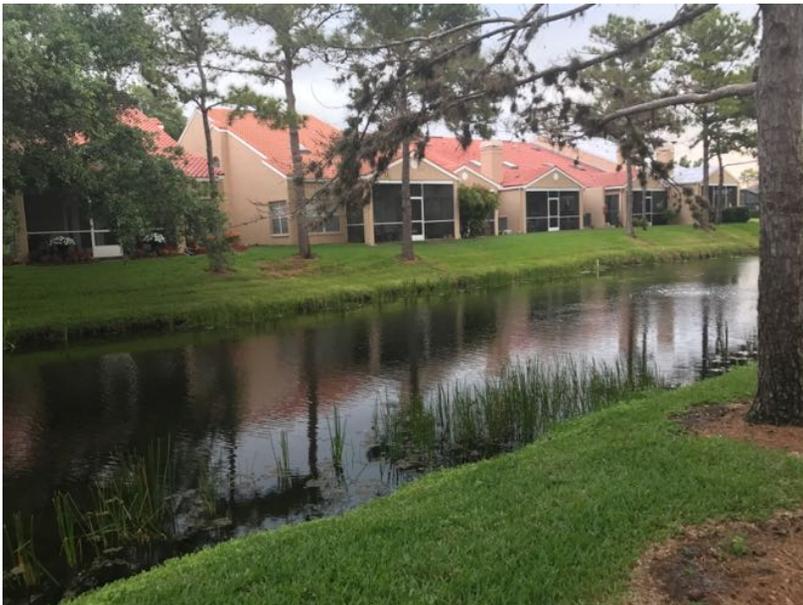
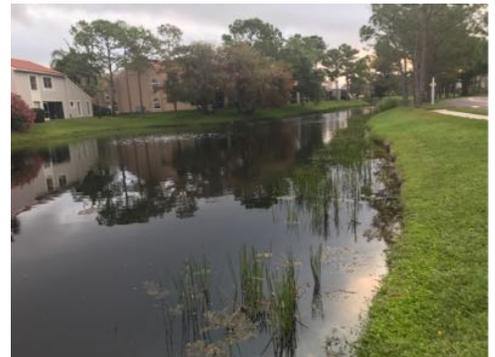
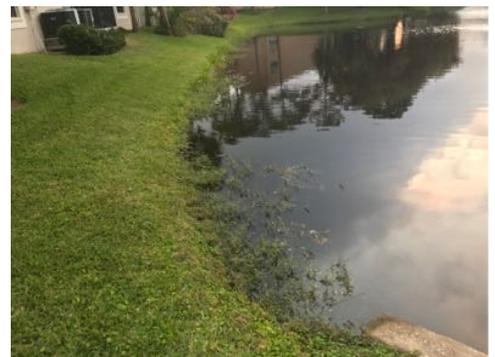
Site: 4

**Comments:** Normal growth observed

Torpedograss along backside of lake was treated this month. Trace amounts of algae were also targeted. Aquatic planting is filling in nicely, especially the Gulf Spikerush. Continued use of probiotic treatments.

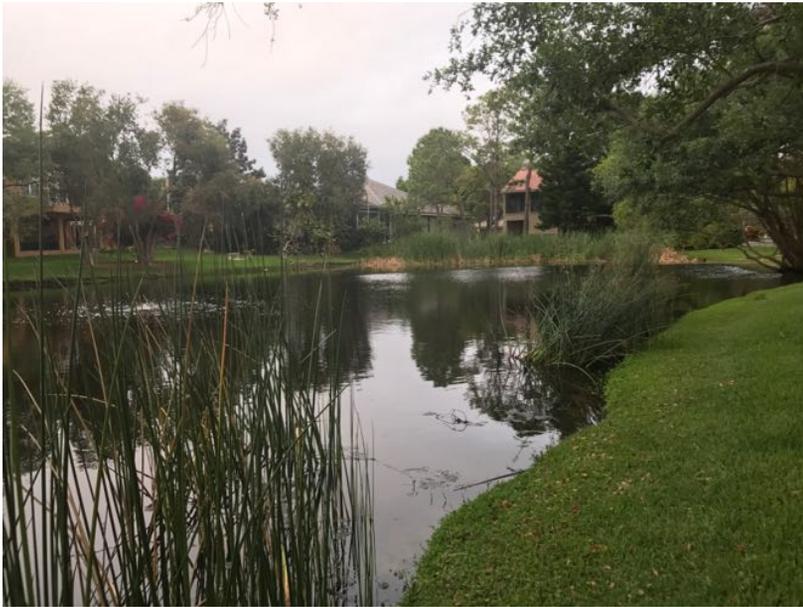
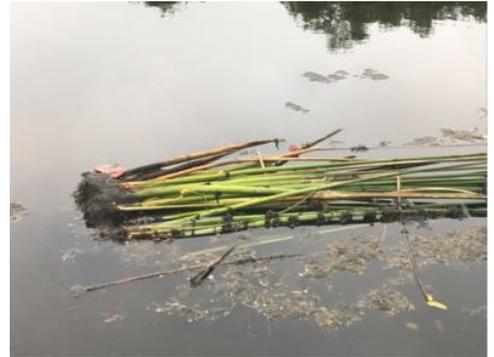
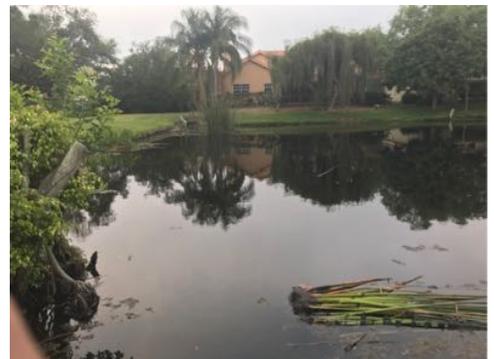
Site: 5

**Comments:** Requires attention

Stand of Bulrush has floated to the shoreline. Bulrush was broken down into smaller pieces and physically removed at no cost to the community. Trace amounts of algae were treated in April.

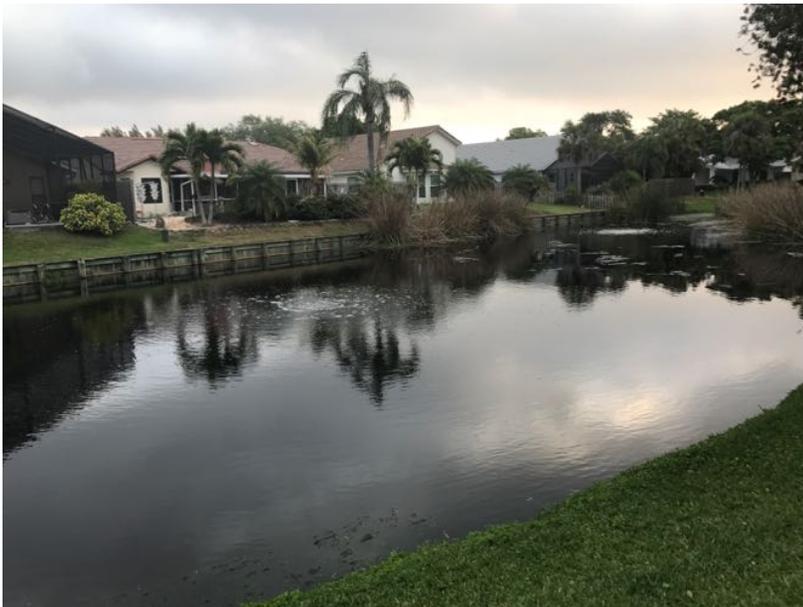
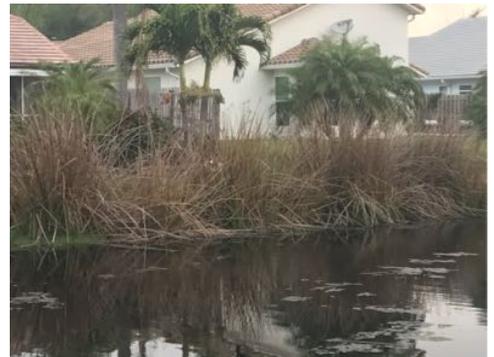
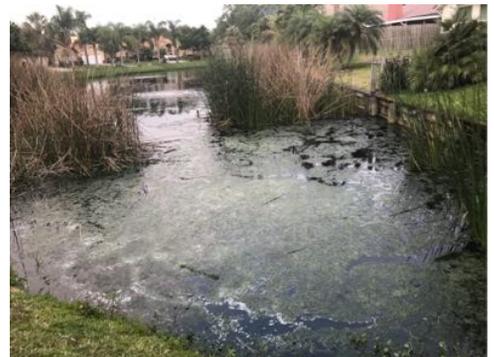
Site: 6

**Comments:** Treatment in progress

Algae had collected in the back cove and was treated in April. Bulrush is showing dead leaves as it sheds its old growth before Spring. Probiotics are continued.

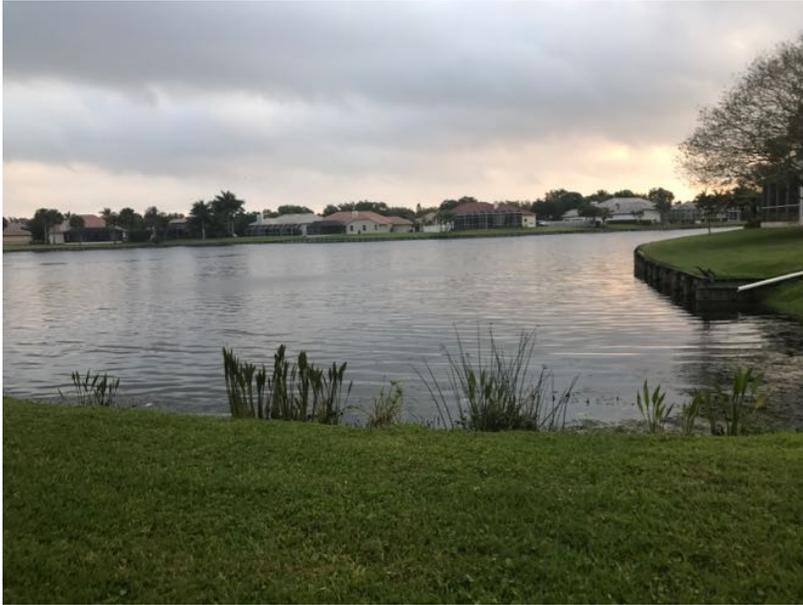
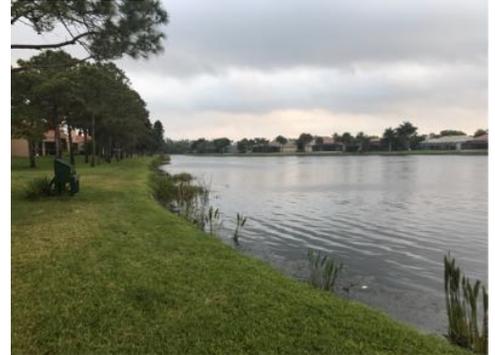
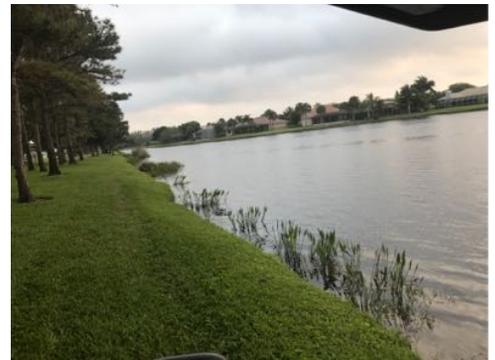
Site: 7

**Comments:** Normal growth observed

Filamentous algae is currently being treated, especially in wind blown areas of the lake. New appearance of Hydrilla is showing in the pond and will be treated next scheduled visit.

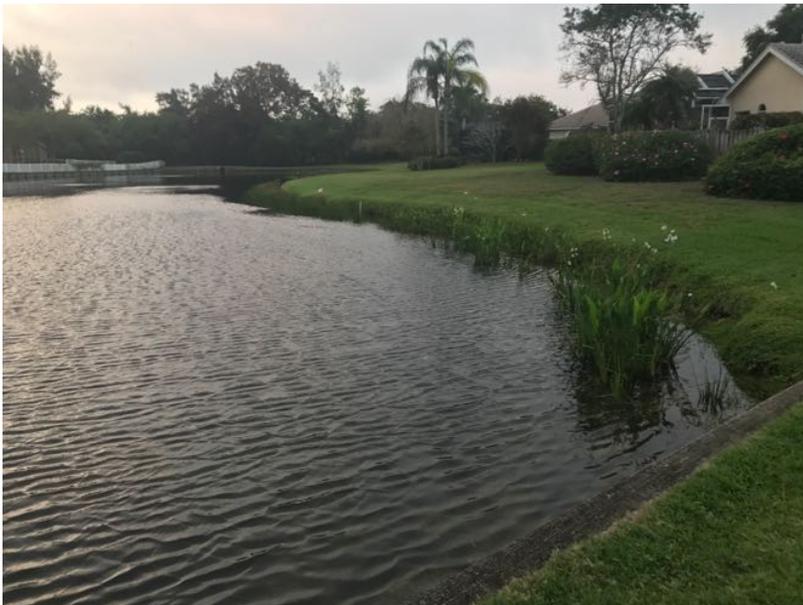
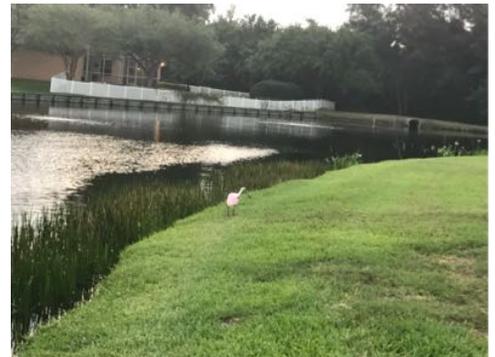
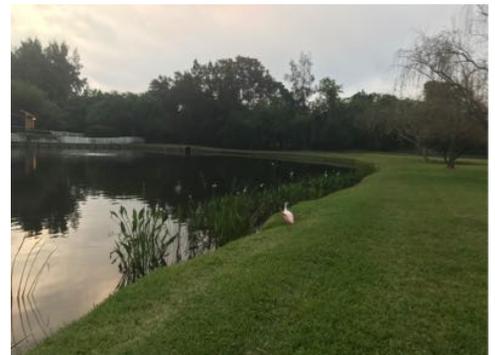
Site: 8

**Comments:** Site looks good

Beneficial plants have grown extremely fast in this pond. This is one of the greatest bare root plantings I have ever seen. Gulf Spikerush and Duck Potato at a 50/50 ratio.

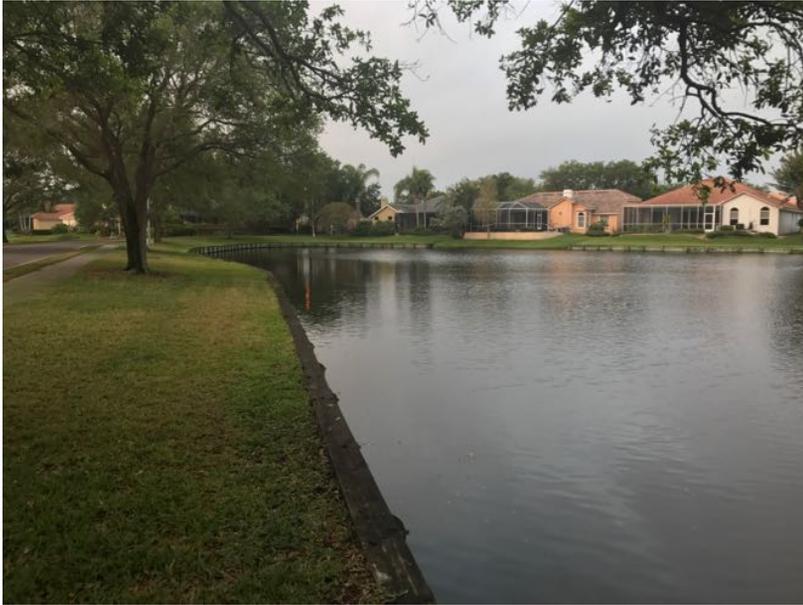
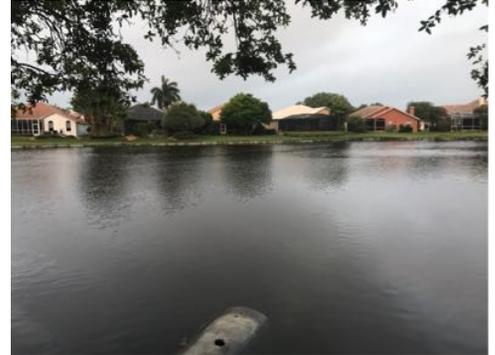
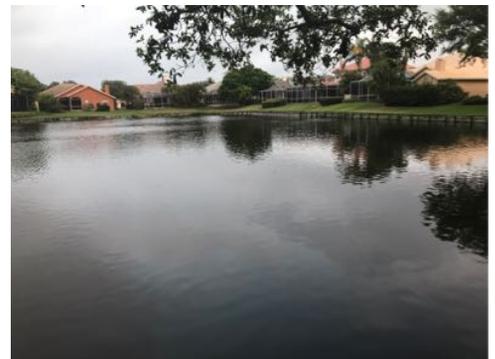
Site: 9

**Comments:** Site looks good

No action required.

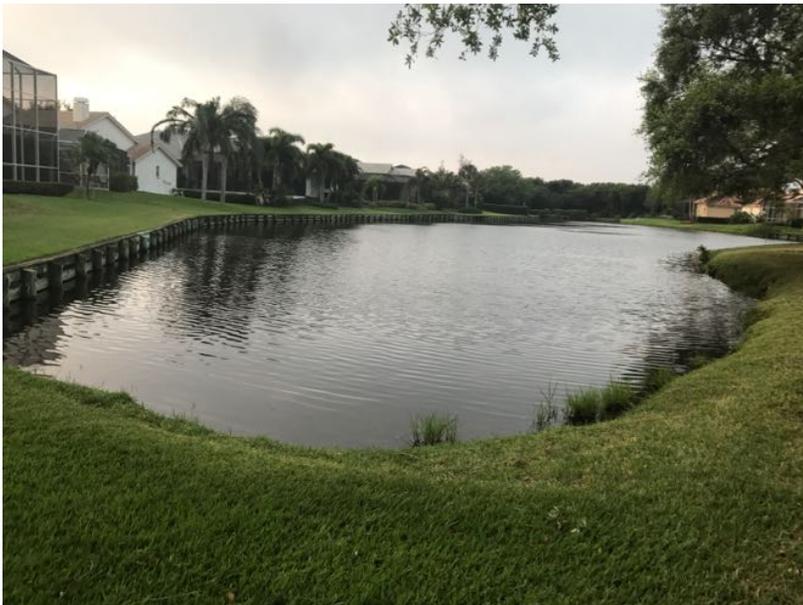
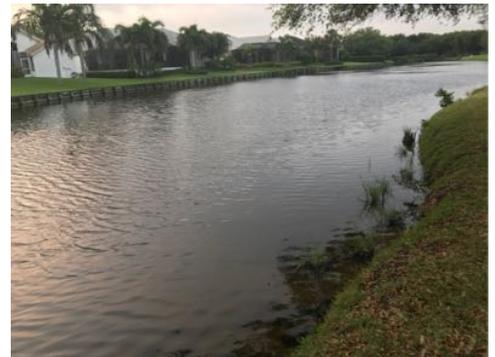
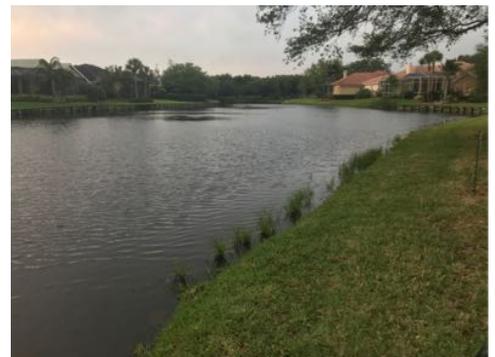
Site: 10

**Comments:** Site looks good

No action required. Smooth Cordgrass has survived any winter chill and will go into the Summer with full momentum. The halophyte is slower growing, but we can see how fast it will spread.
