Placido Bayou Community Association Waterway Inspection Report

Inspection Date:

2/4/2022

Placido Bayou Community

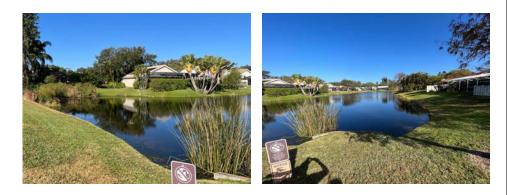
<u>Pond 1</u>

Normal Growth Observed

Planting is to occur in the Spring to fill in some areas without Florida native aquatic plants. These plants help filtrate the water, stabilize banks, reduce wave induced erosion and provide native habitat for fish and waterfowl.

Pond 1,4,5,6,7,8) Advanced Aquatic will prep planting areas for the Spring. Pond 8) Monitor Hydrilla and treat as necessary next month.

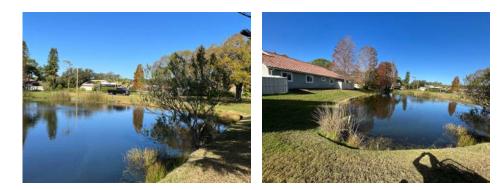
Pond 2

Site Looks Good

No action required.

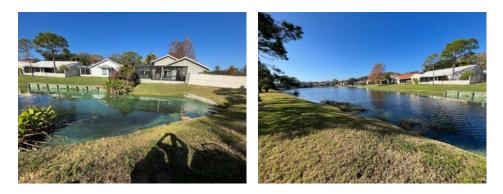
Pond 3

Treatment In Progress

Bluegreen algae was in bloom and wind blown in the corner. When blooms get large enough, the lake can emit foul smelling odors. I followed up on 2.23 and the algae treatment from 2.4 was successful.

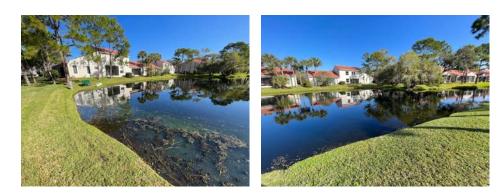
Pond 4

Treatment In Progress

Planting is to occur in the Spring to fill in some areas without Florida native aquatic plants. These plants help filtrate the water, stabilize banks, reduce wave induced erosion and provide native habitat for fish and waterfowl. Algae was treated with an algicide.

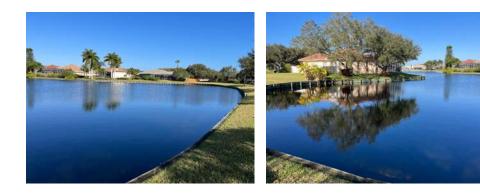
<u>Pond 7</u>

Treatment In Progress

Planting is to occur in the Spring to fill in some areas without Florida native aquatic plants. These plants help filtrate the water, stabilize banks, reduce wave induced erosion and provide native habitat for fish and waterfowl.

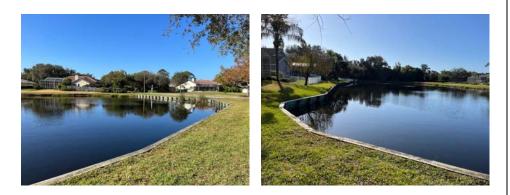
Pond 8

Treatment In Progress

Planting is to occur in the Spring to fill in some areas without Florida native aquatic plants. These plants help filtrate the water, stabilize banks, reduce wave induced erosion and provide native habitat for fish and waterfowl. Hydrilla is showing in the lake. We will monitor and treat when appropriate.

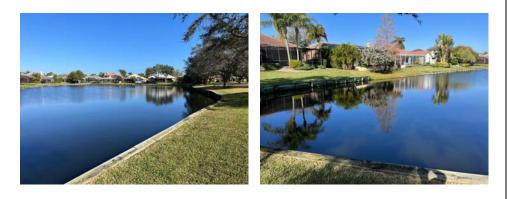
Pond 9

Site Looks Good

No action required.
