# Placido Bayou Community Association Waterway Inspection Report

**Reason for Inspection:**  
Quality Assurance

**Inspection Date:**  
5/22/2023

**Prepared for:**  
Placido Bayou  
Community Association

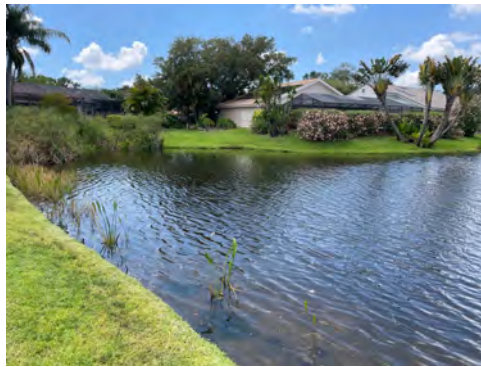
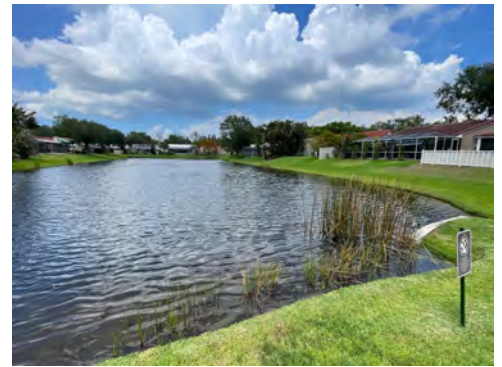
**Pond 1**

Site Looks Good

Trace amounts of filamentous algae.

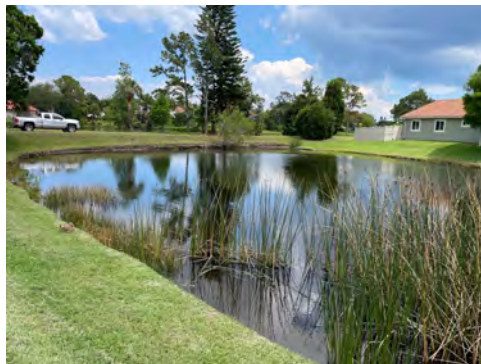
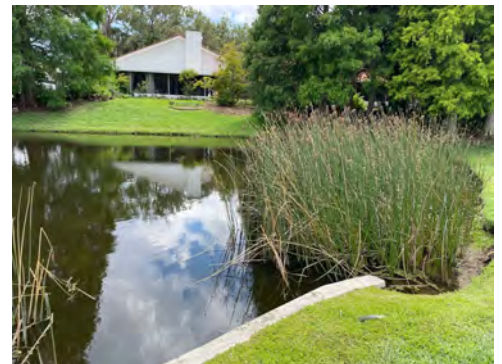
**Pond 2**

Site Looks Good

Healthy pockets of native aquatic plant growth.

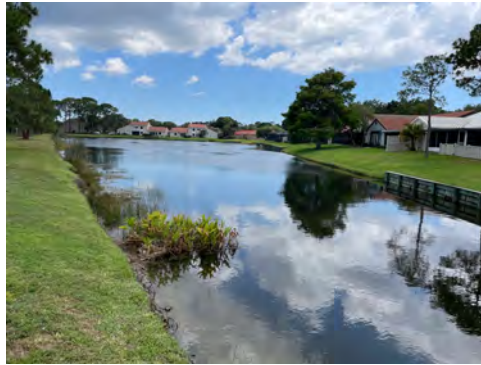
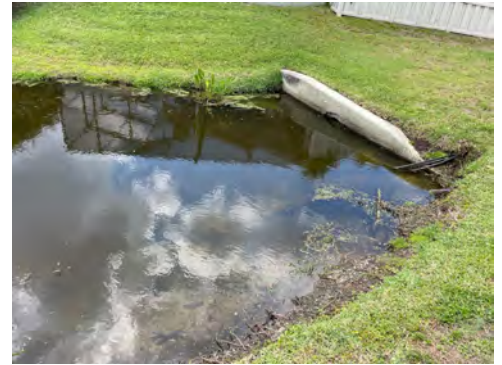
**Pond 3**

Site Looks Good

Minimal algae present. Trace amount of Torpedograss.

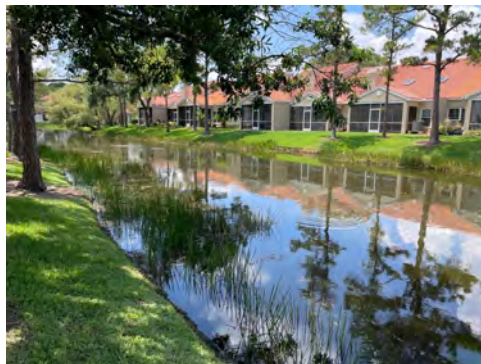
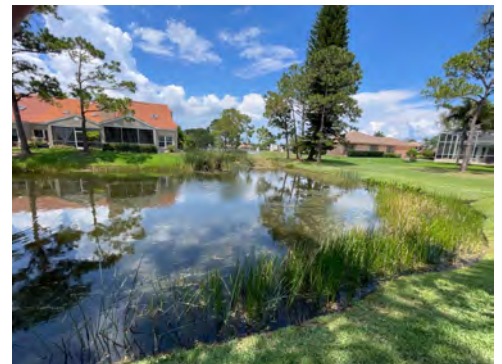
**Pond 4**

Site Looks Good

Grass clippings present in pond. Site of recent Bullrush removal.

Healthy patches of native Gulf Spikerush observed.

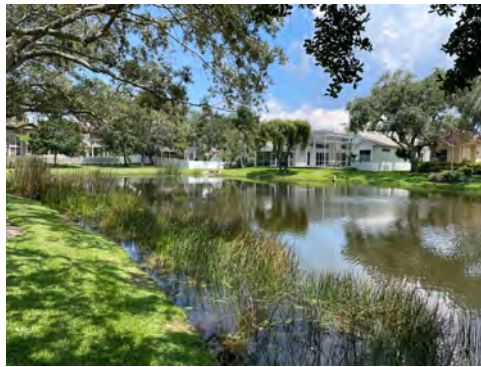
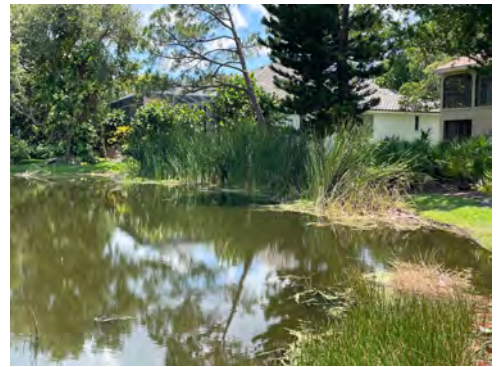
**Pond 5**

Normal Growth Observed

Recently removed Cattail on east side of pond. Trace amount of Planktonic algae.

Healthy patches of native Gulf Spikerush observed.

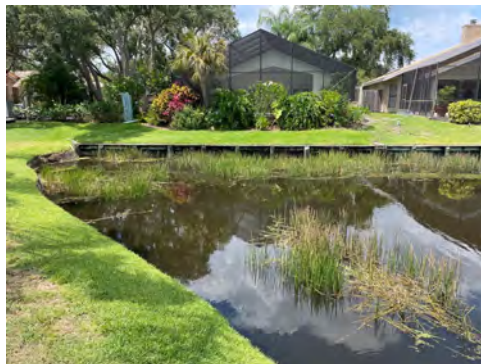
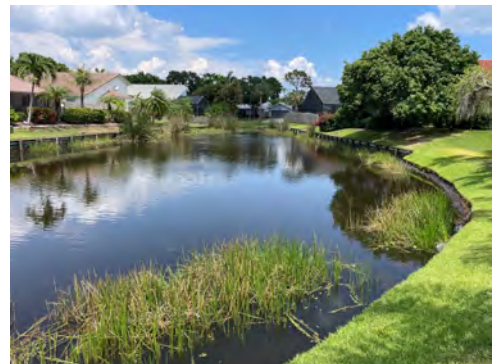
**Pond 6**

Site Looks Good

Trace amount of filamentous algae.

Healthy patches of native Gulf Spikerush observed.

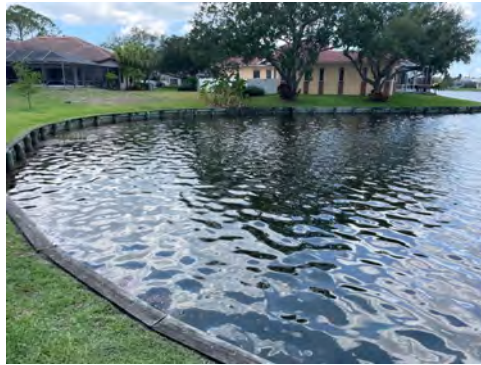
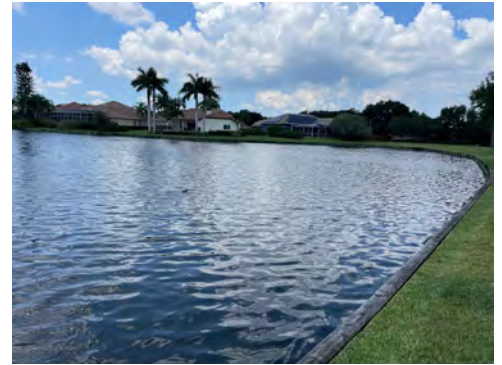
### Pond 7

Site Looks Good

Trace amount of Filamentous algae recently treated.

Appears as though the algae species have mostly transitioned from Blue Green (Planktonic) algae to Green Algae (Filamentous). This is a very positive development over the past few months!

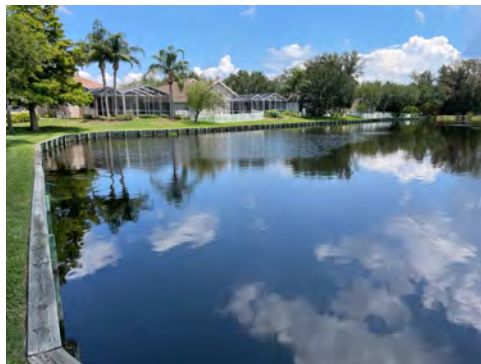
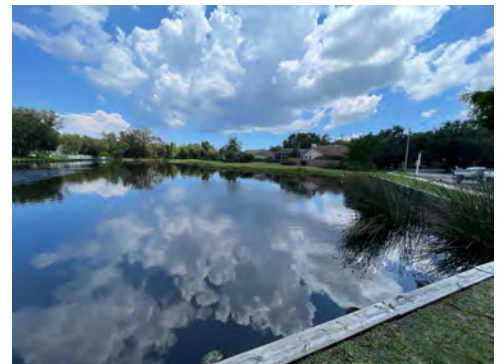
### Pond 8

Site Looks Good

Advanced Aquatic removed dead fish from this pond over the past 30 days after a singular fish mortality event.

Appears as though there was a recent pond turnover event that brought saline water into this pond ecosystem.

We are compiling a Dissolved Oxygen profile and a salinity test to follow up on the condition of this pond.

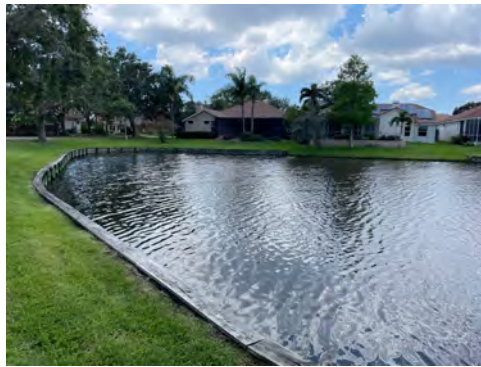
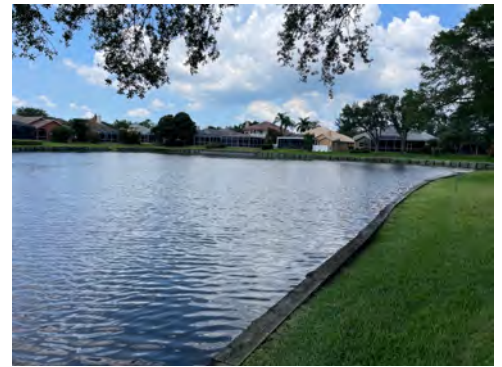
**Pond 9**

Site Looks Good

Very minor amount of filamentous algae observed and treated.

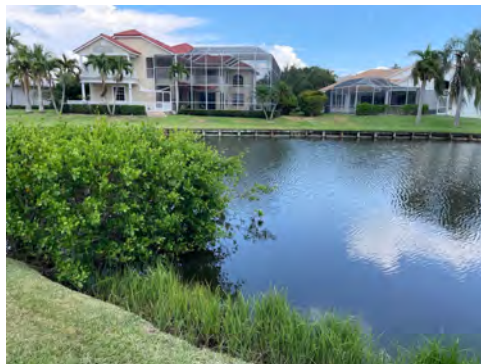
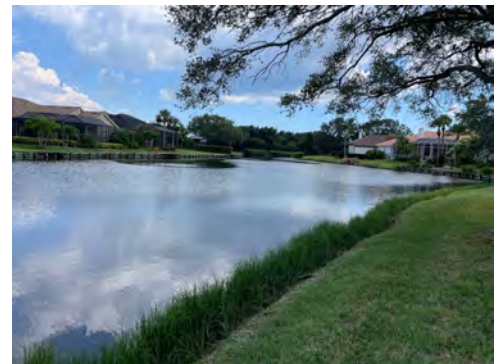
**Pond 10**

Site Looks Good

Very minor amount of filamentous algae observed and treated.

Healthy patches of native Gulf Spikerush observed.
